Prepared for **Bega Valley Shire Council**

# Limited Preliminary Site Investigation

## Bega Structure Plans

June 2023

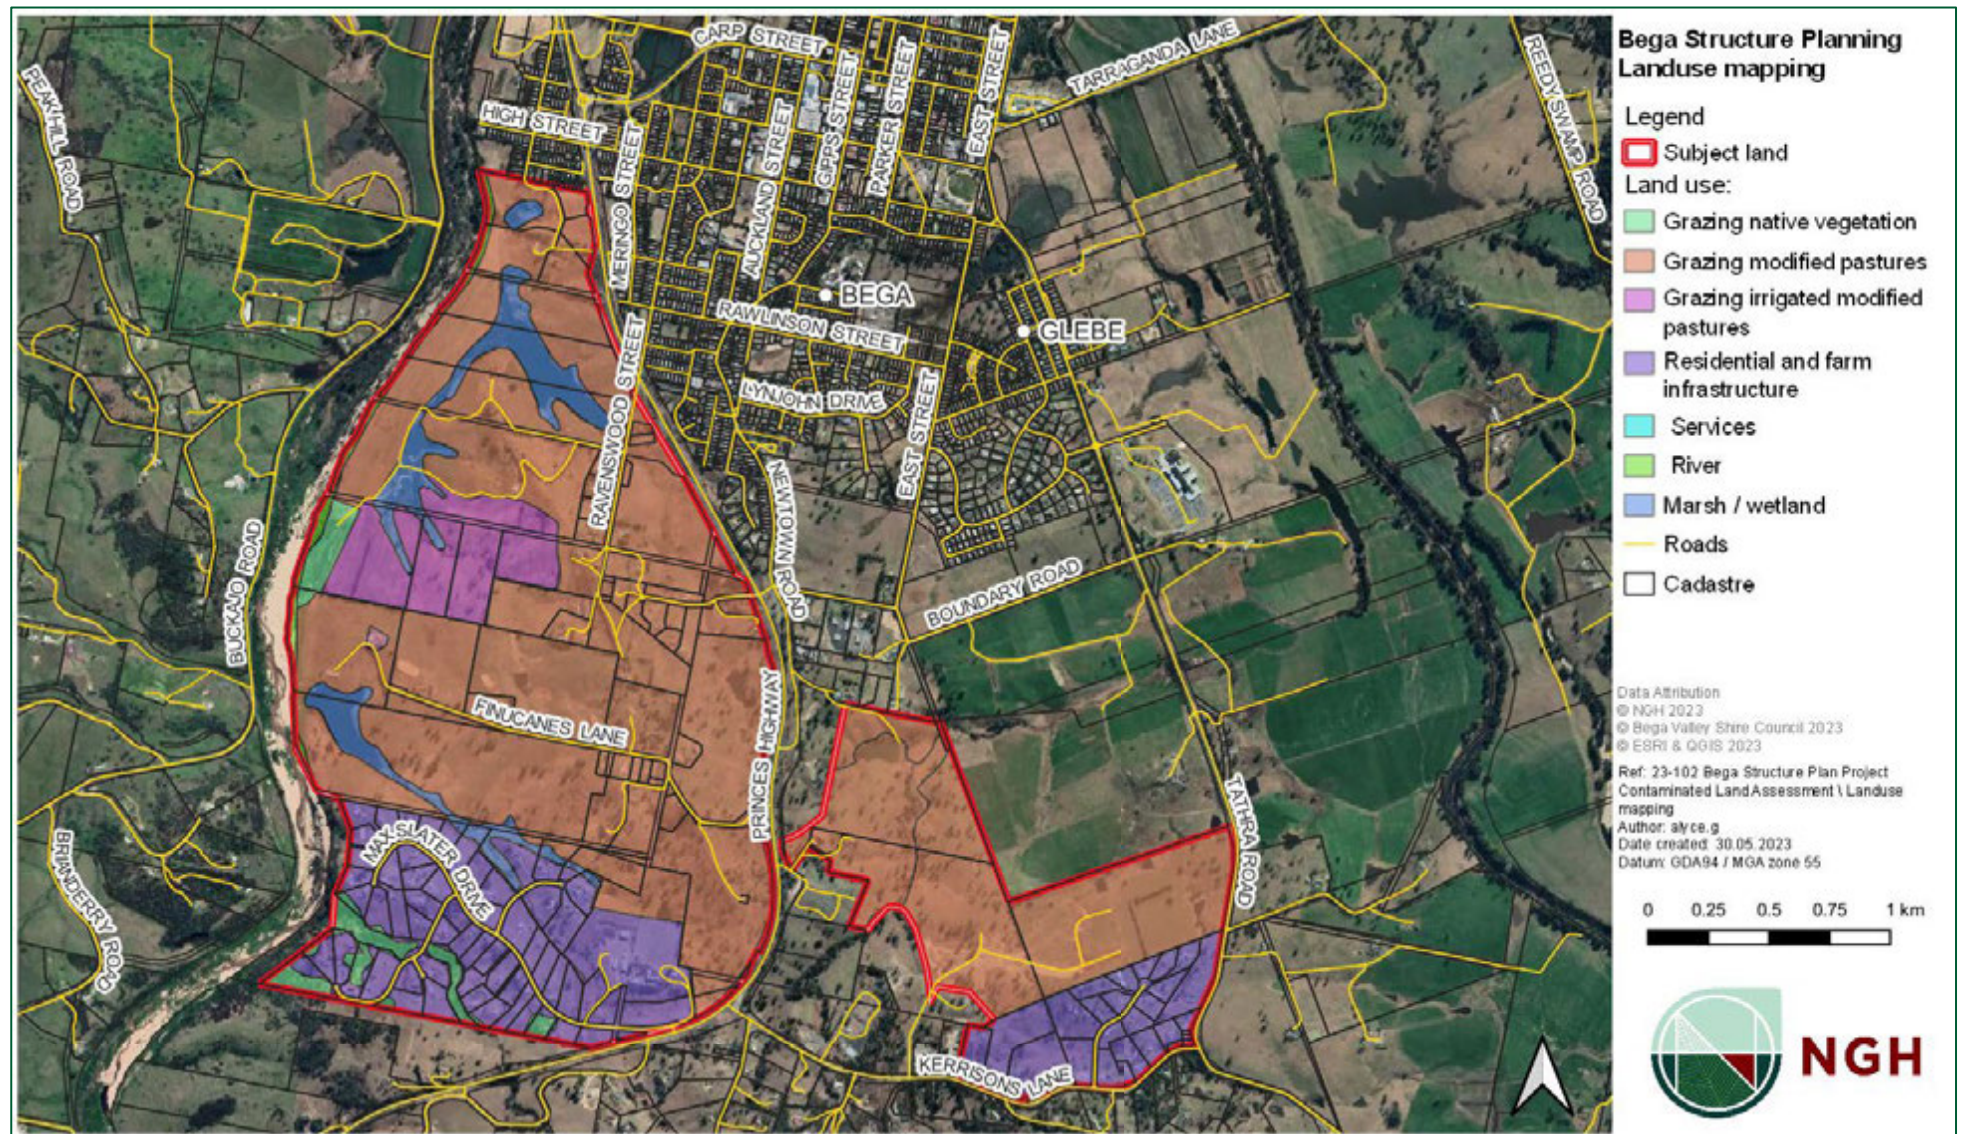
Figure 2-1 Land use within the subject land

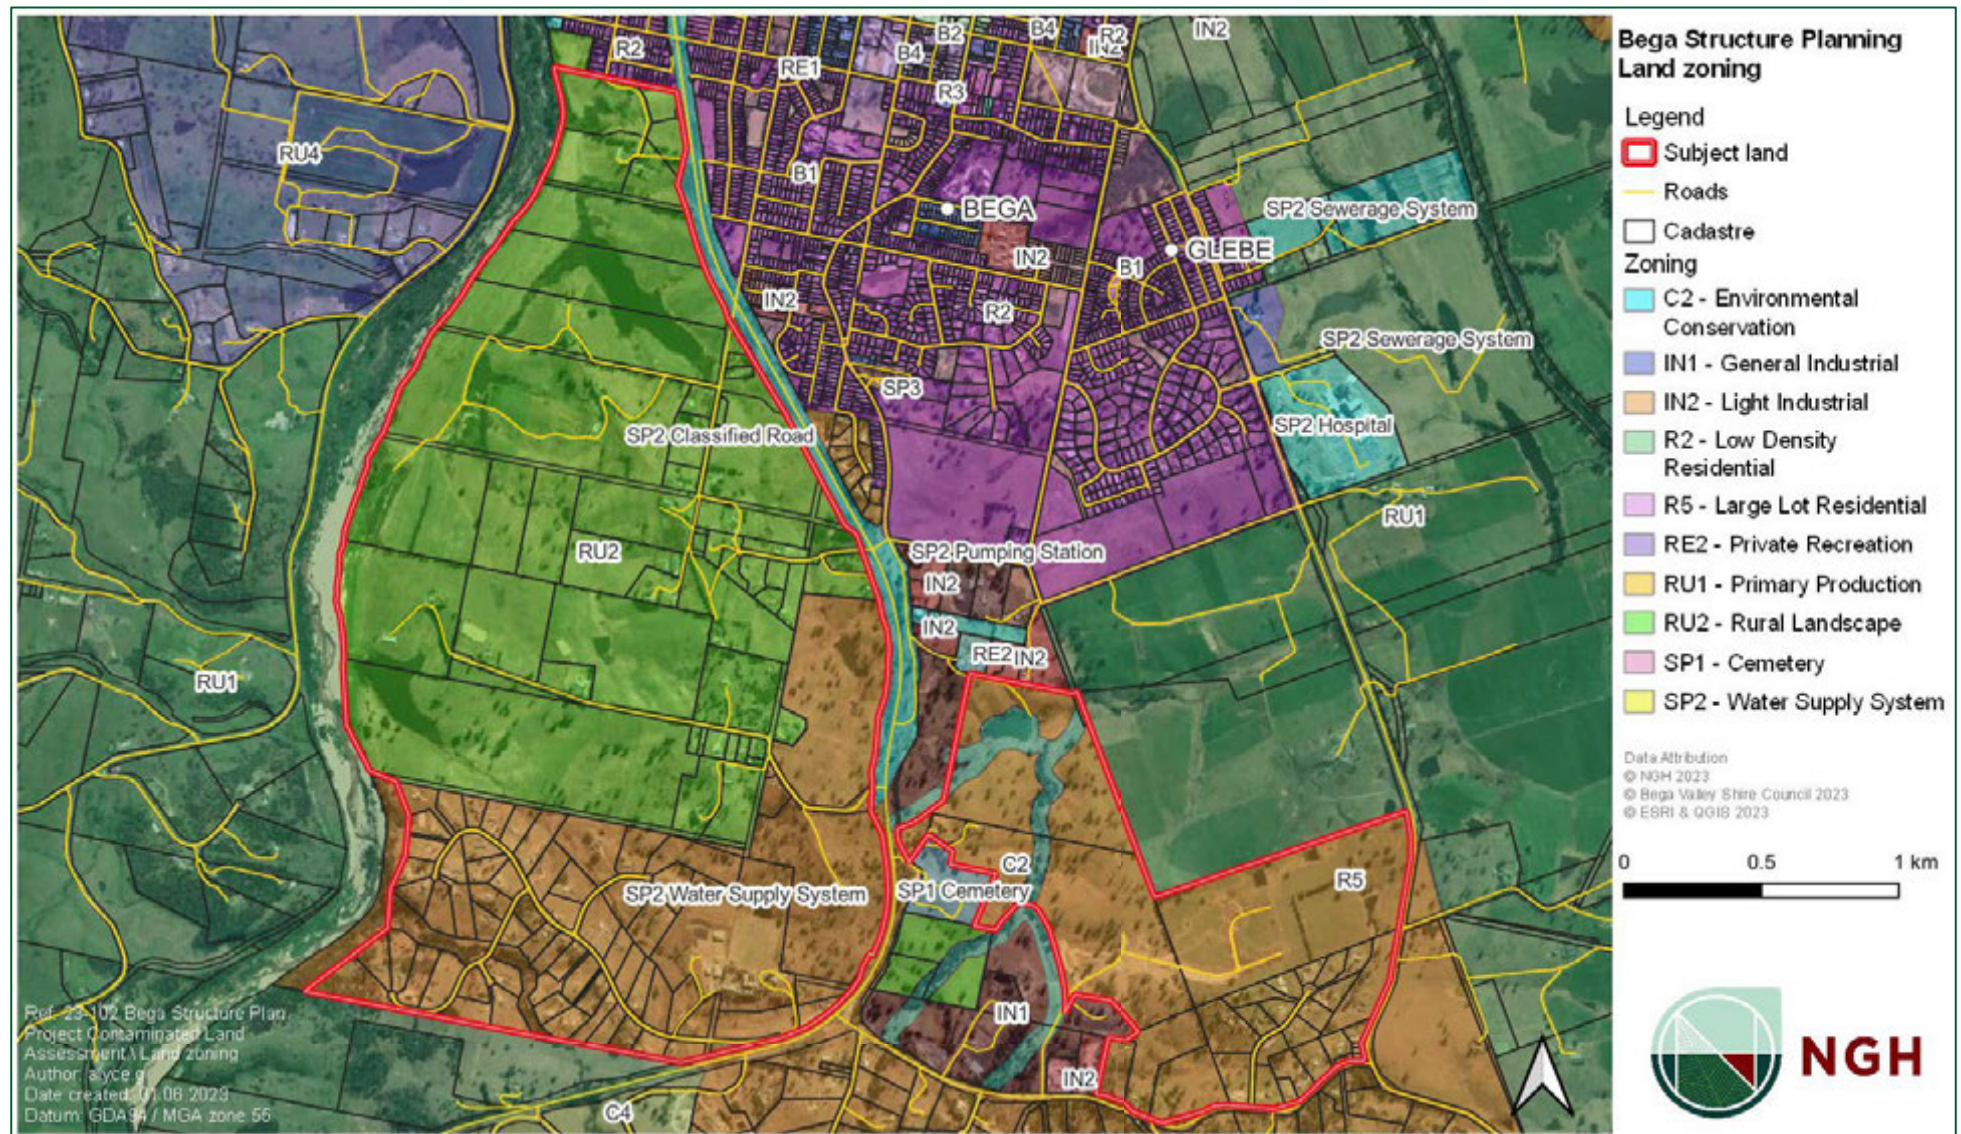
| Item | Detail |
|---|---|
| | and SP2 Water Supply System.<br><br>Refer to Figure 2-2 for land zoning. |

Figure 2-2 Land zoning within the subject land

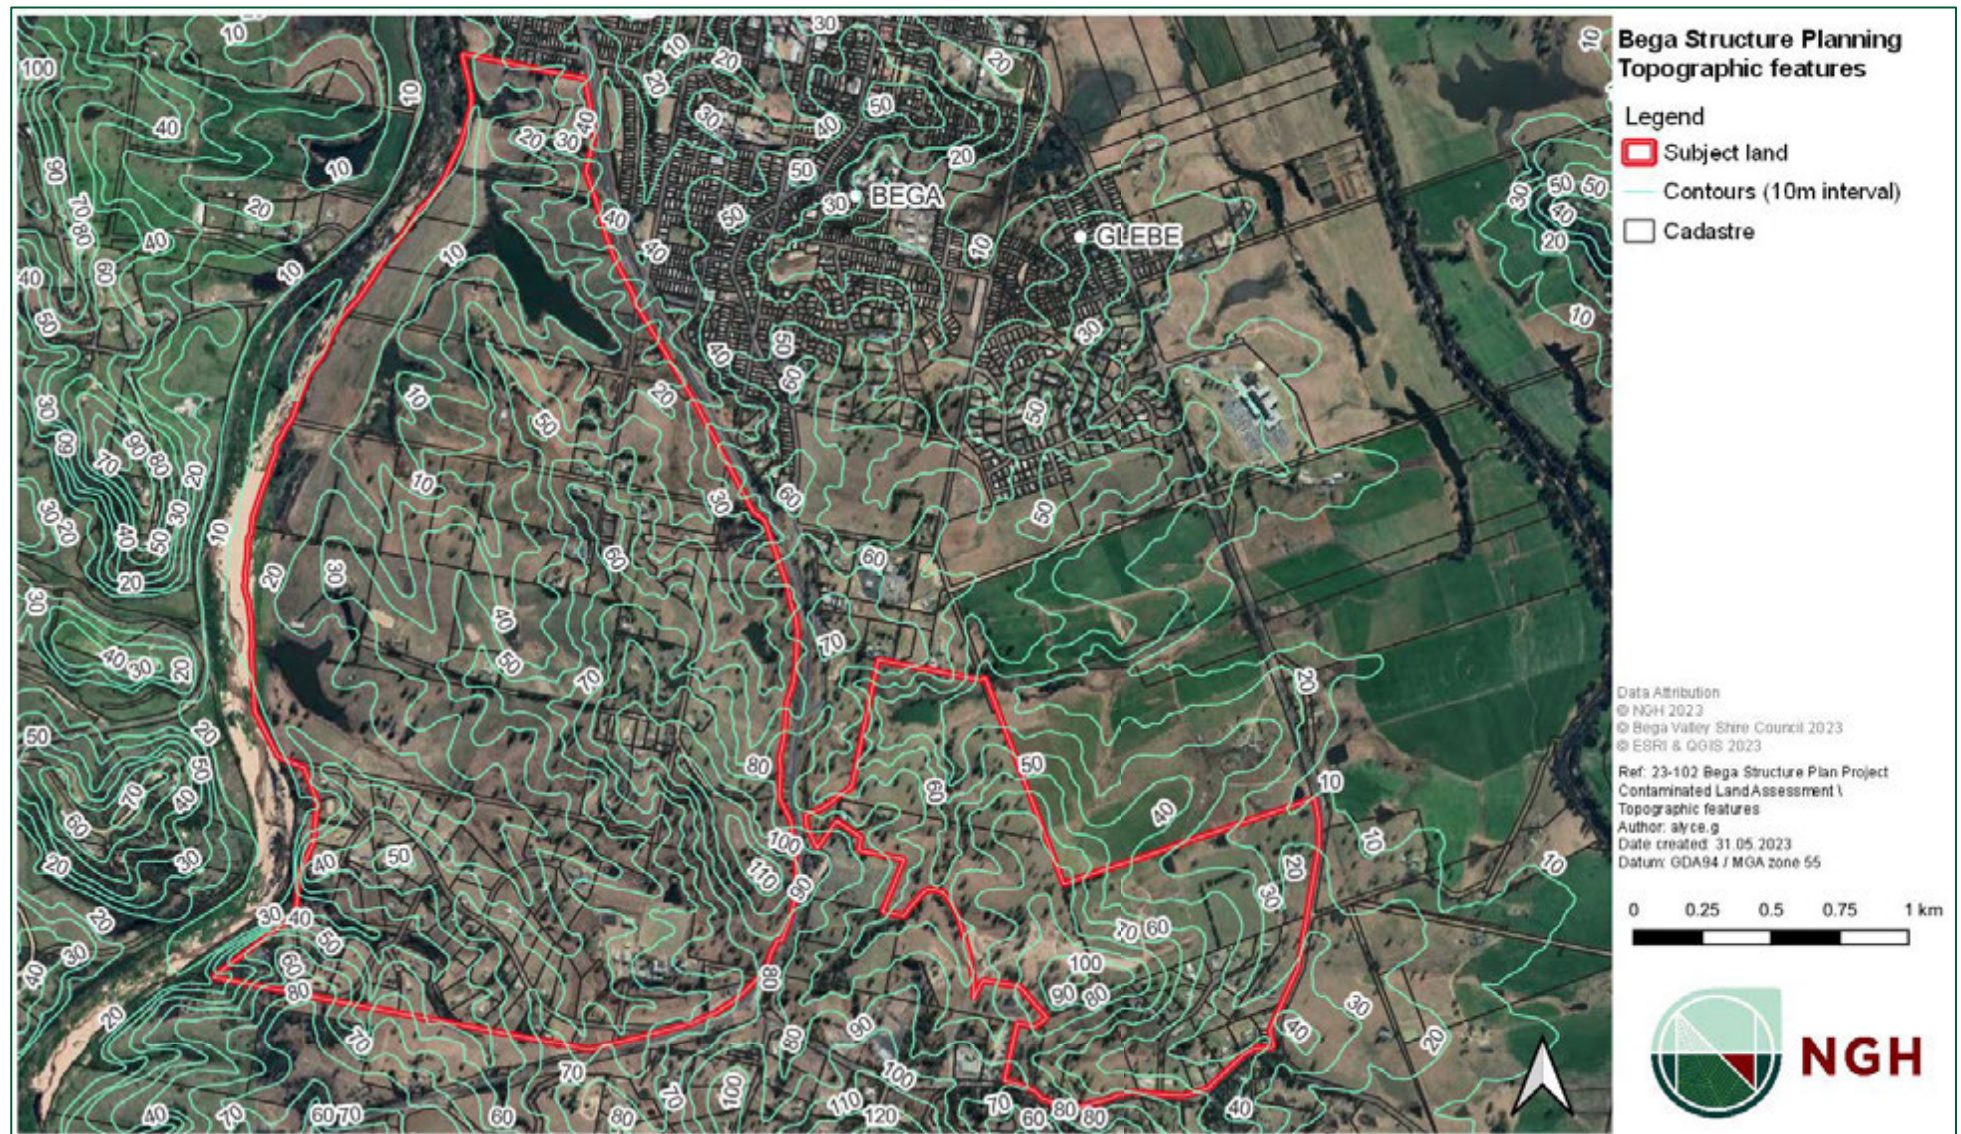
Figure 4-1 Topographic features

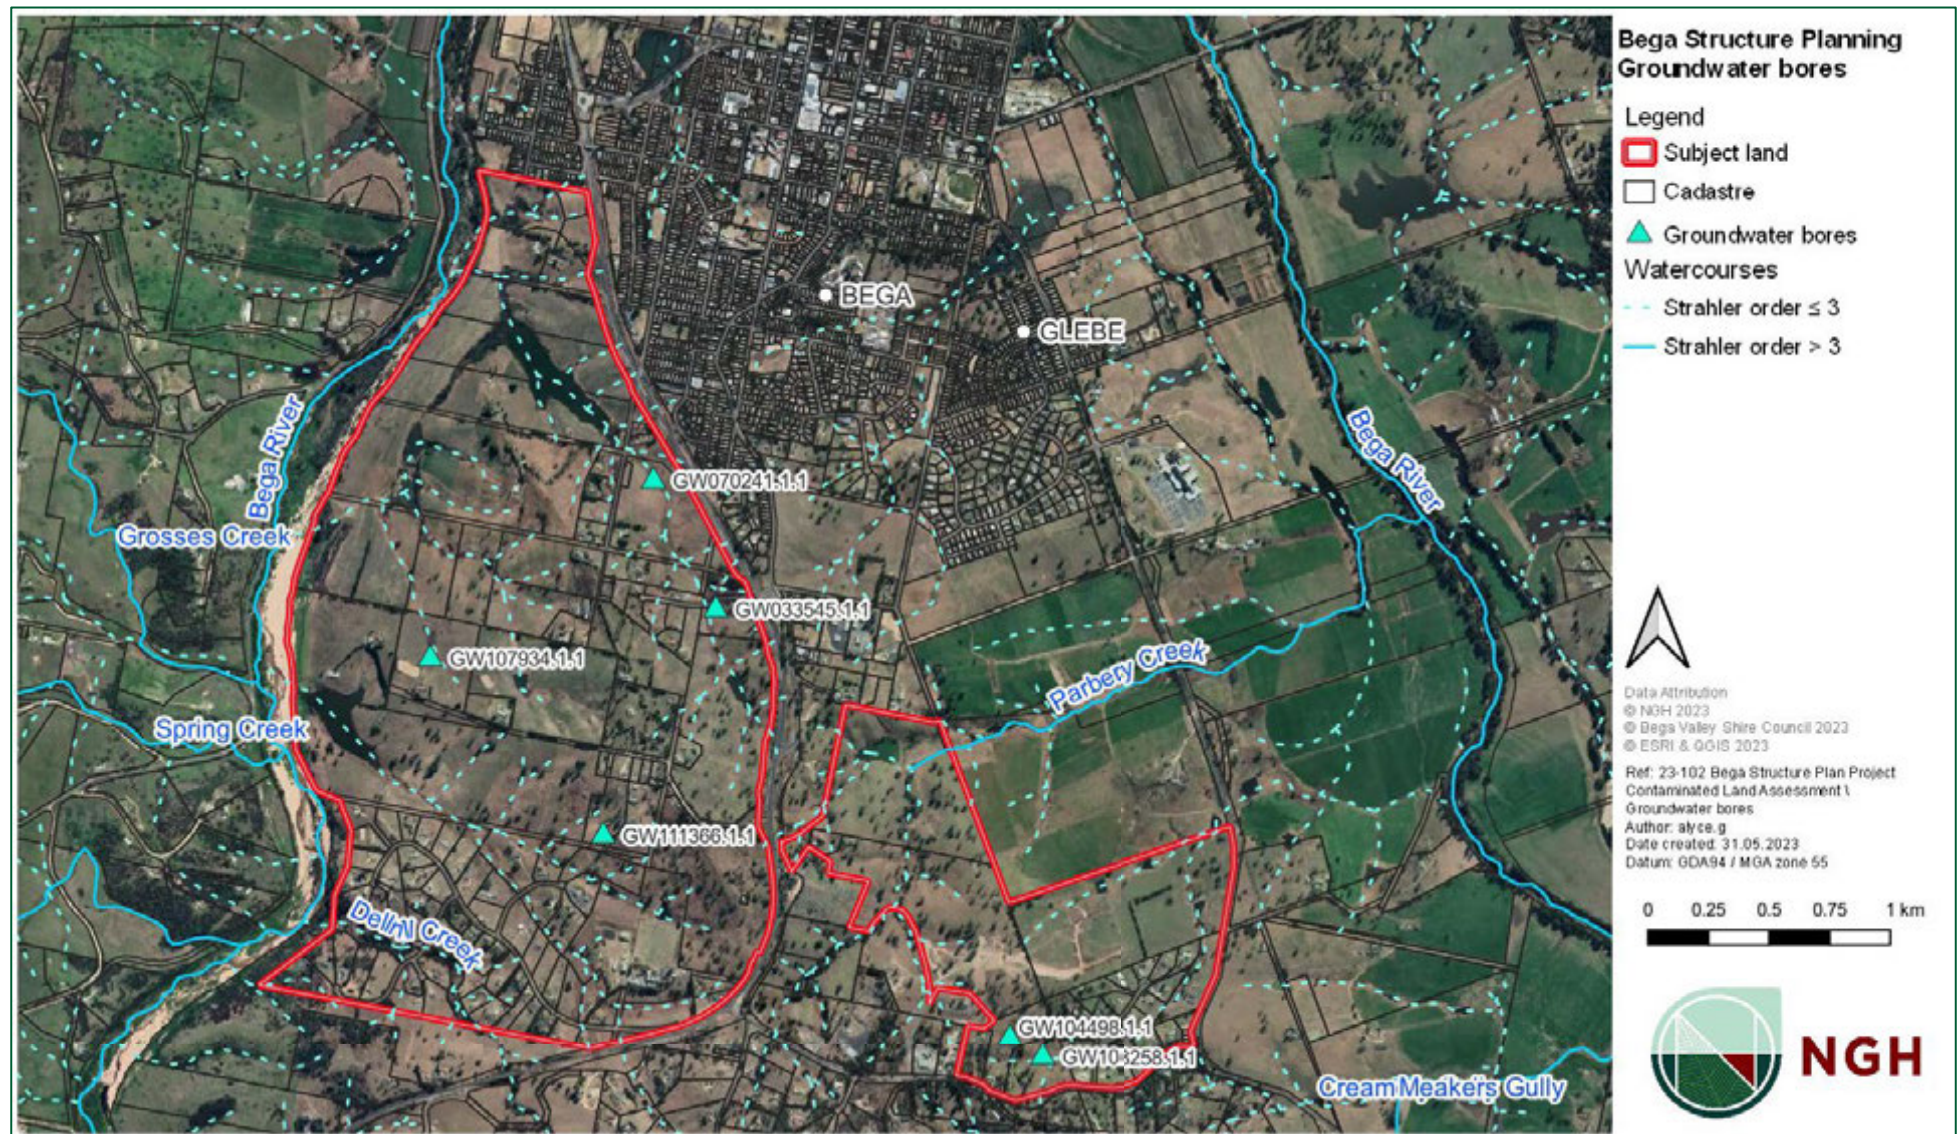
The subject land is mapped as containing porous, extensive, highly producing aquifers, as well as fractured or fissured, extensive aquifers of low to moderate productivity.

Figure 4-2 Groundwater bores located within the subject land

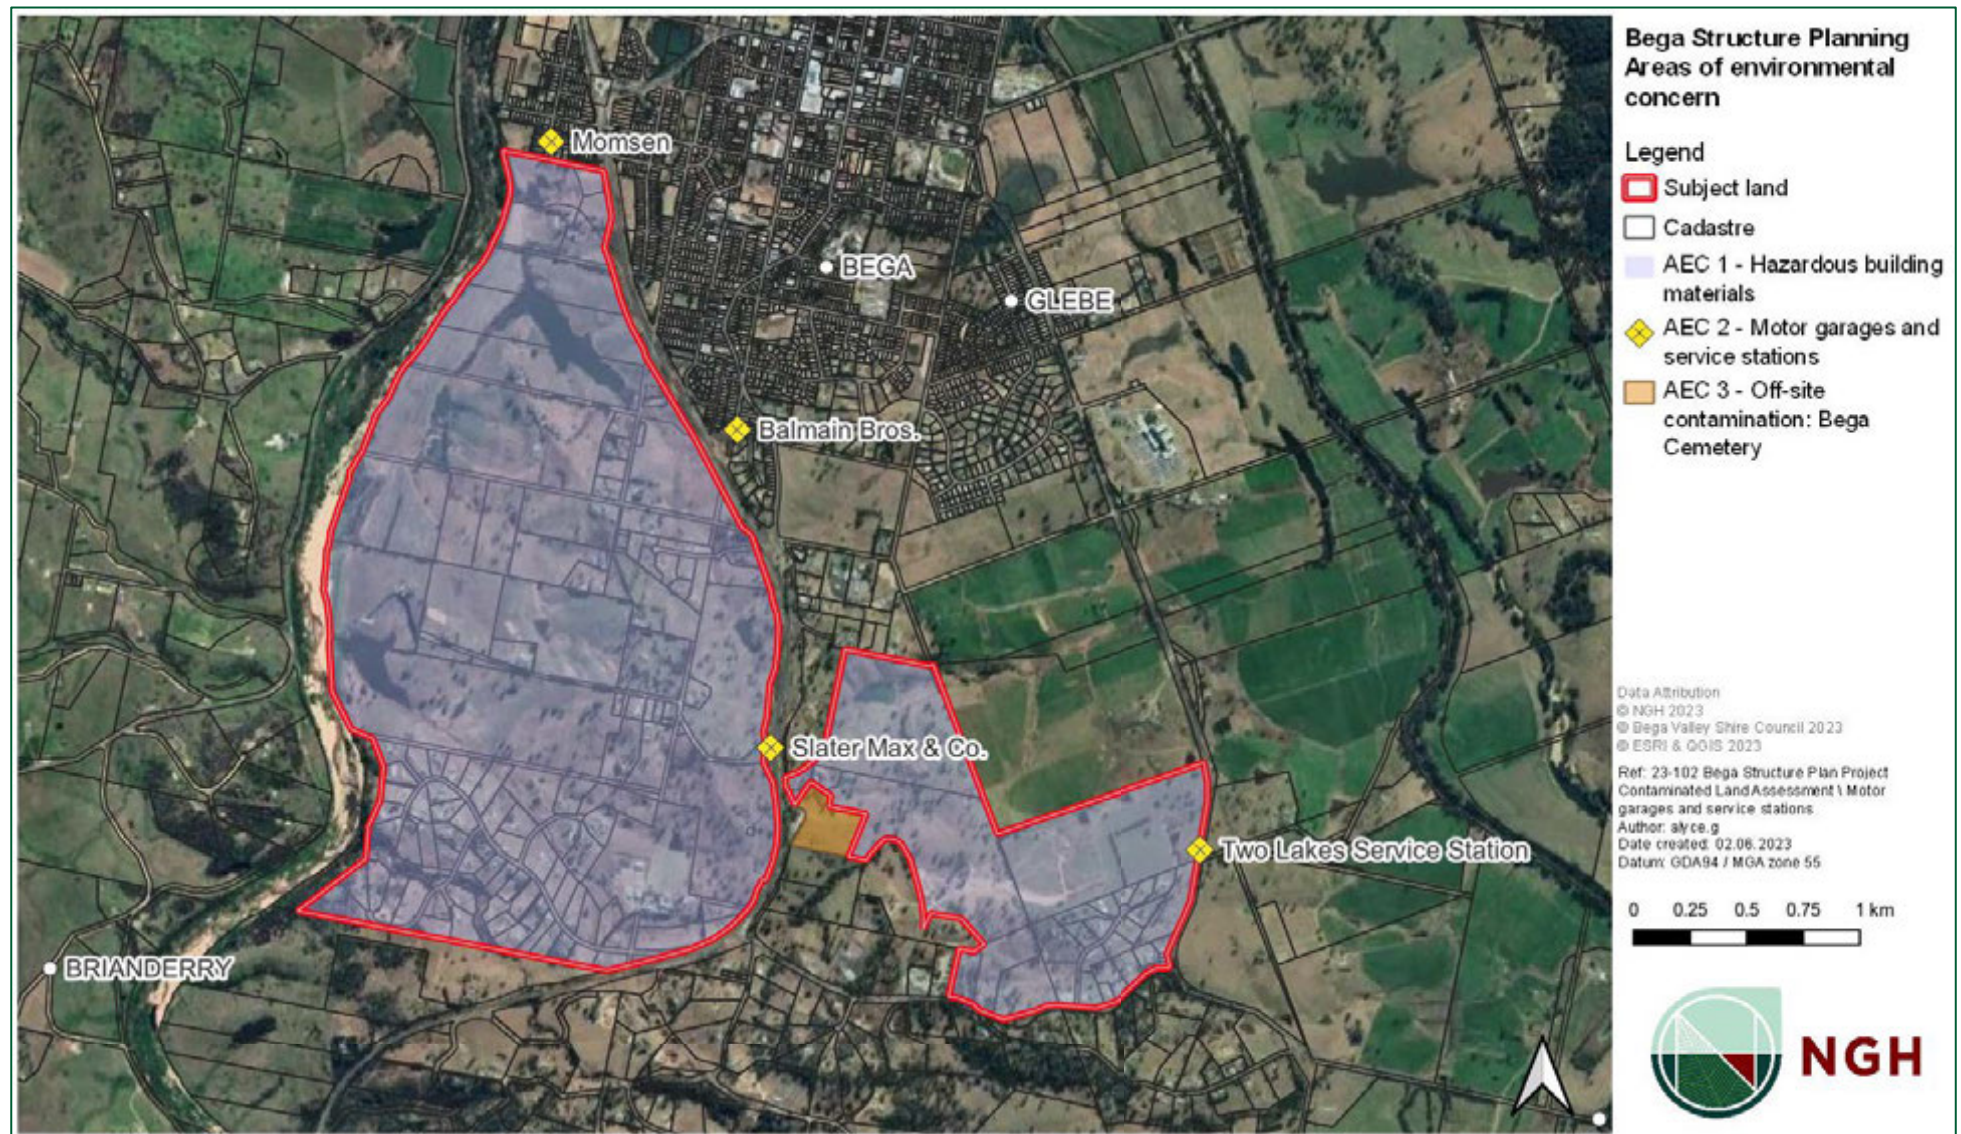
- AEC1 – Hazardous building materials
- AEC2 – On and offsite contamination from motor garages and service stations
- AEC3 – Offsite contamination from the upgradient cemetery

Figure 5-1 AECs for the subject land

Based on the findings of the PSI, it is recommended that a targeted site walkover be conducted, to determine:

- The location and extent of the two on-site motor garages / service stations
- The presence / absence of hazardous building materials within developed areas of the subject land.
