# Merimbula Boardwalk and Foreshore Path

EASTERN ENTRY AND CARPARK UPGRADE.

### Design Development Principles

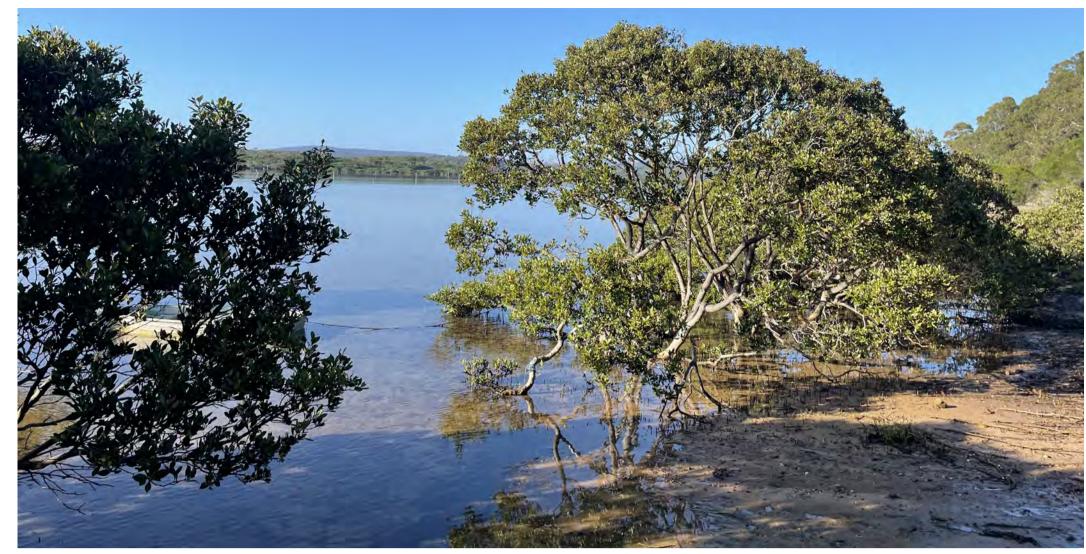
It is important to protect the high quality natural visual character of Merimbula Lake both from and back towards the boardwalk. Visitors and locals are attracted to the boardwalk for the immersive experience.

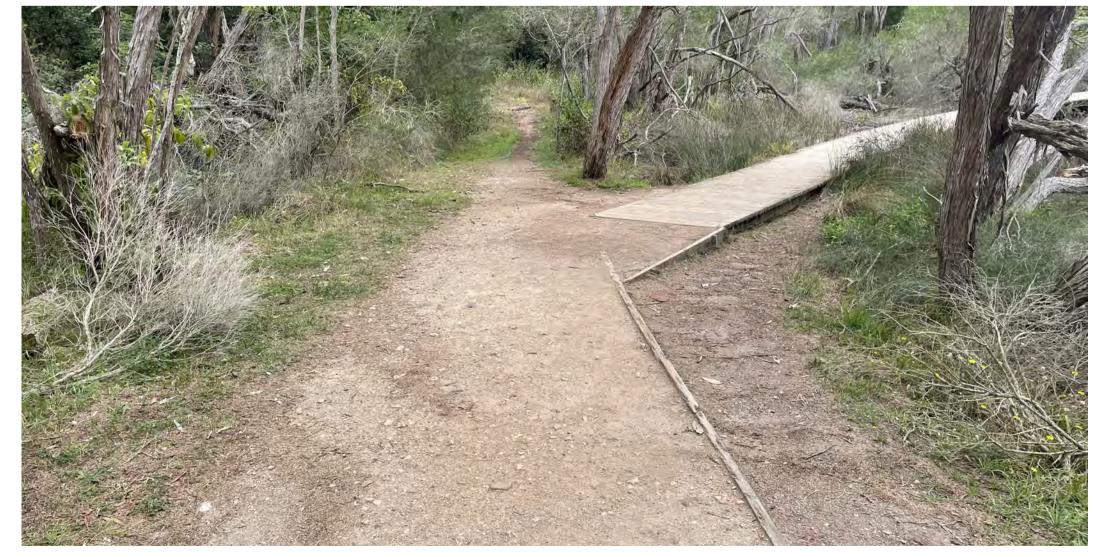
The existing features such as the western jetty will be replaced in the same locations, as this is where they have become well loved and used. The character of the walk will not be radically changed.

While in urgent need of repair, the character will be inspired by the existing with far better accessibility, durability and high quality finished. The clarity of wayfinding will be improved.

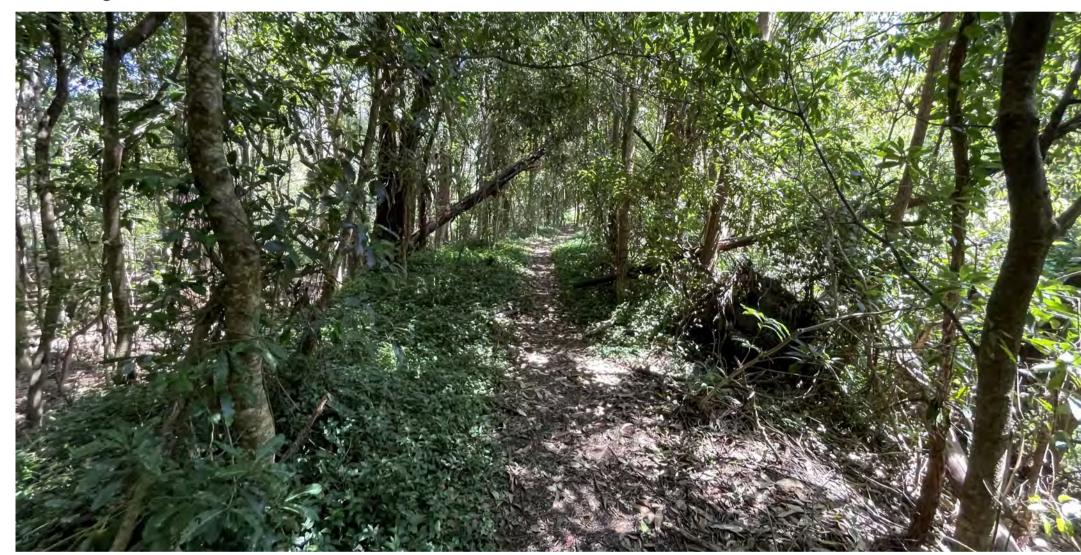
Offline nature walks will be largely unchanged, though improved where steep terrain, creeklines and boggy areas limit access and minimise damage. Access to the littoral rainforest enriches and informs the experience.

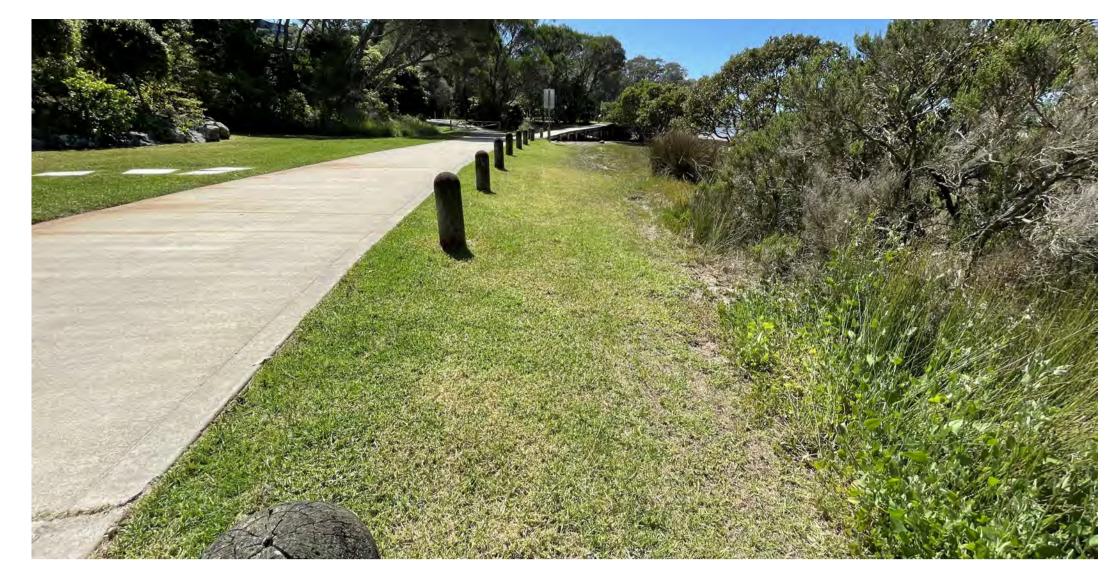
Kikuyu grass, mown and unmown along the shore edge is a threat to the salt-marsh and intertidal indigenous plant communities. It should be removed to return the boardwalk experience to a nature based one.

- Minimisation of concrete footpaths to avoid damage to the environment caused using concrete construction equipment along remote parts of the trail.
- Closing unnecessary shortcuts with post and wire strand fencing and re-vegetating.
- Post and wire strand fencing to protect vulnerable salt marsh areas from people and dogs walking off trail.
- Addressing the threat on vegetation communities from the Kikuyu grass by removing weeds along the water edge of the path and re-vegetating with appropriate species.

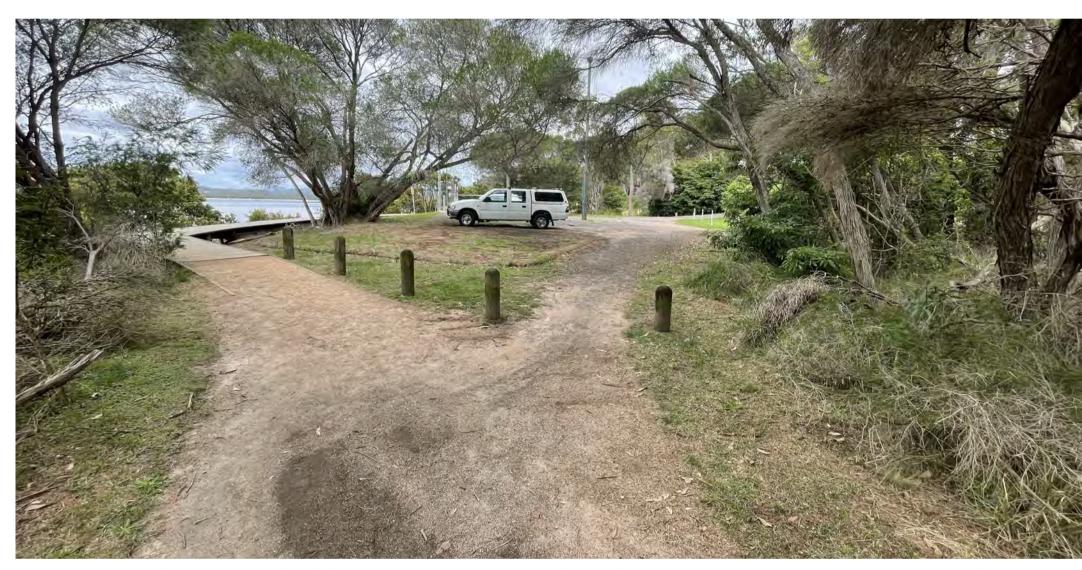
Unnecessary shortcuts and will be removed to restore the indigenous vegetation communities and restrict damage.

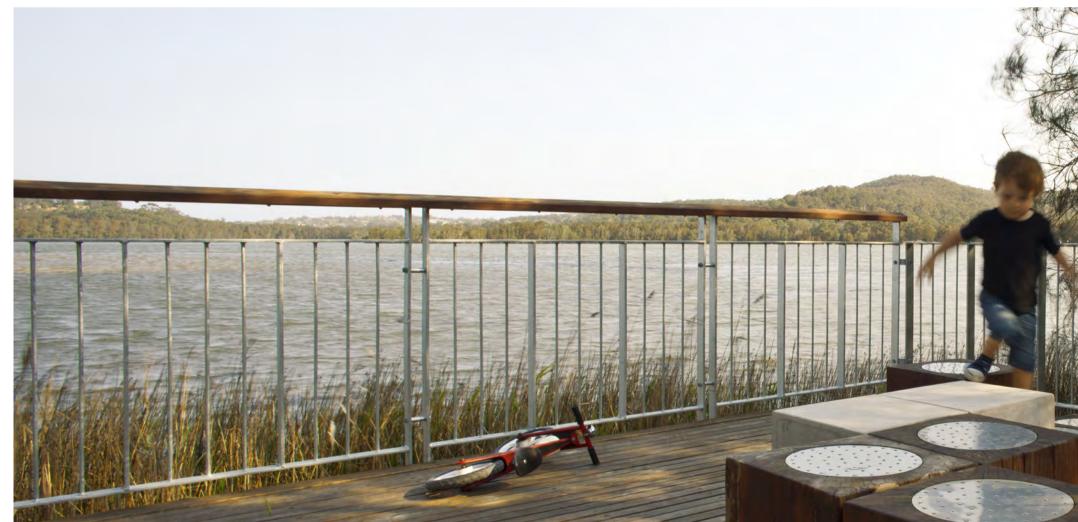
A Type A handrail, similar to what will be required in particular locations where Australian Standards requires.

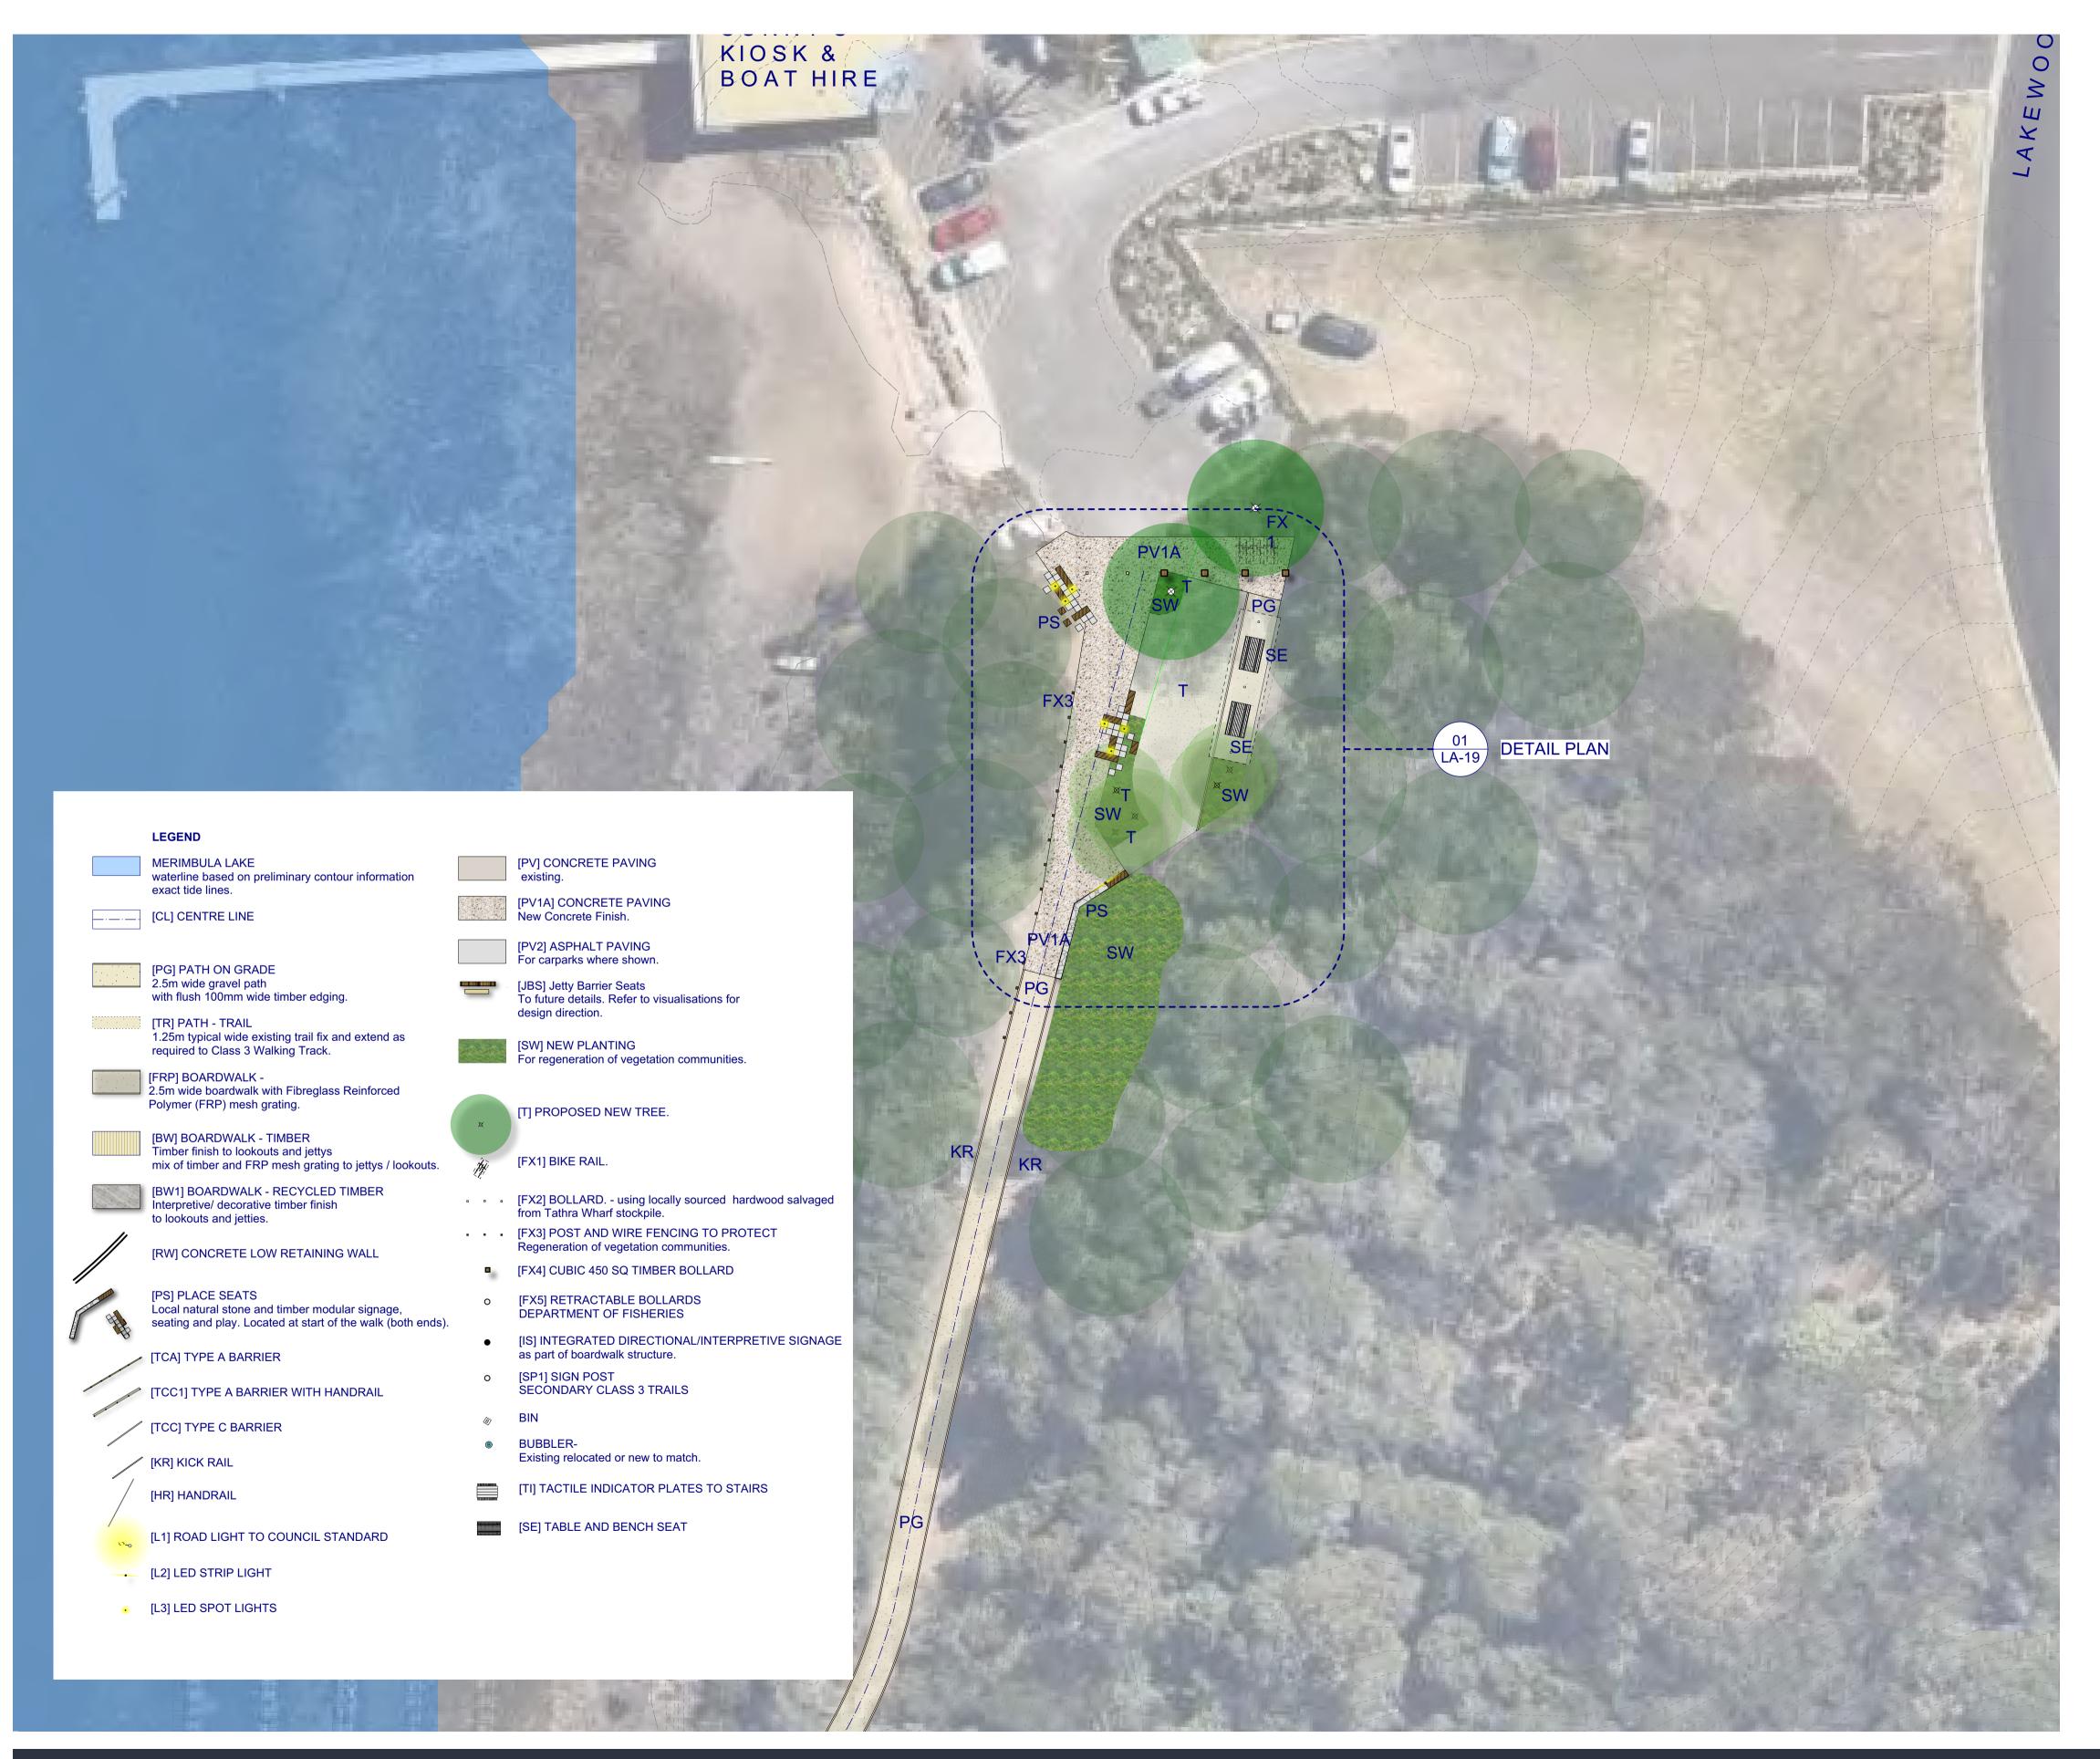
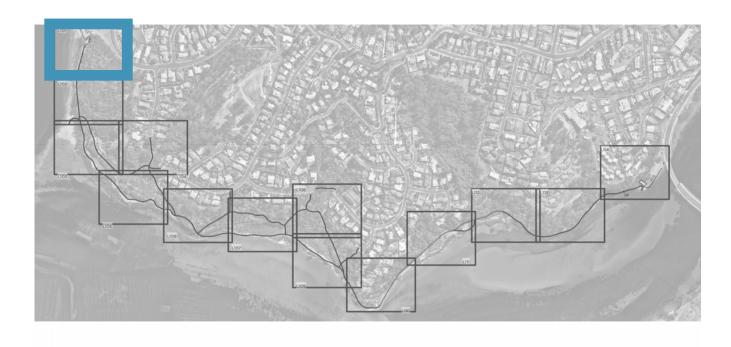
The pocket park may relate to the public space adjacent to the carpark as much as the boardwalk. Its identity is strengthened. Its identity as its own small park will be better defined.

- The small park will be upgraded to including two picnic tables with combined shade structure to replace the two existing picnic tables and single shelter.

- Existing carpark, toilet and boat ramp functions well and is to remain unchanged.
- The existing post and wire strand fence repaired to limit access to Swamp Oak Forest and Mangrove vegetation communities.

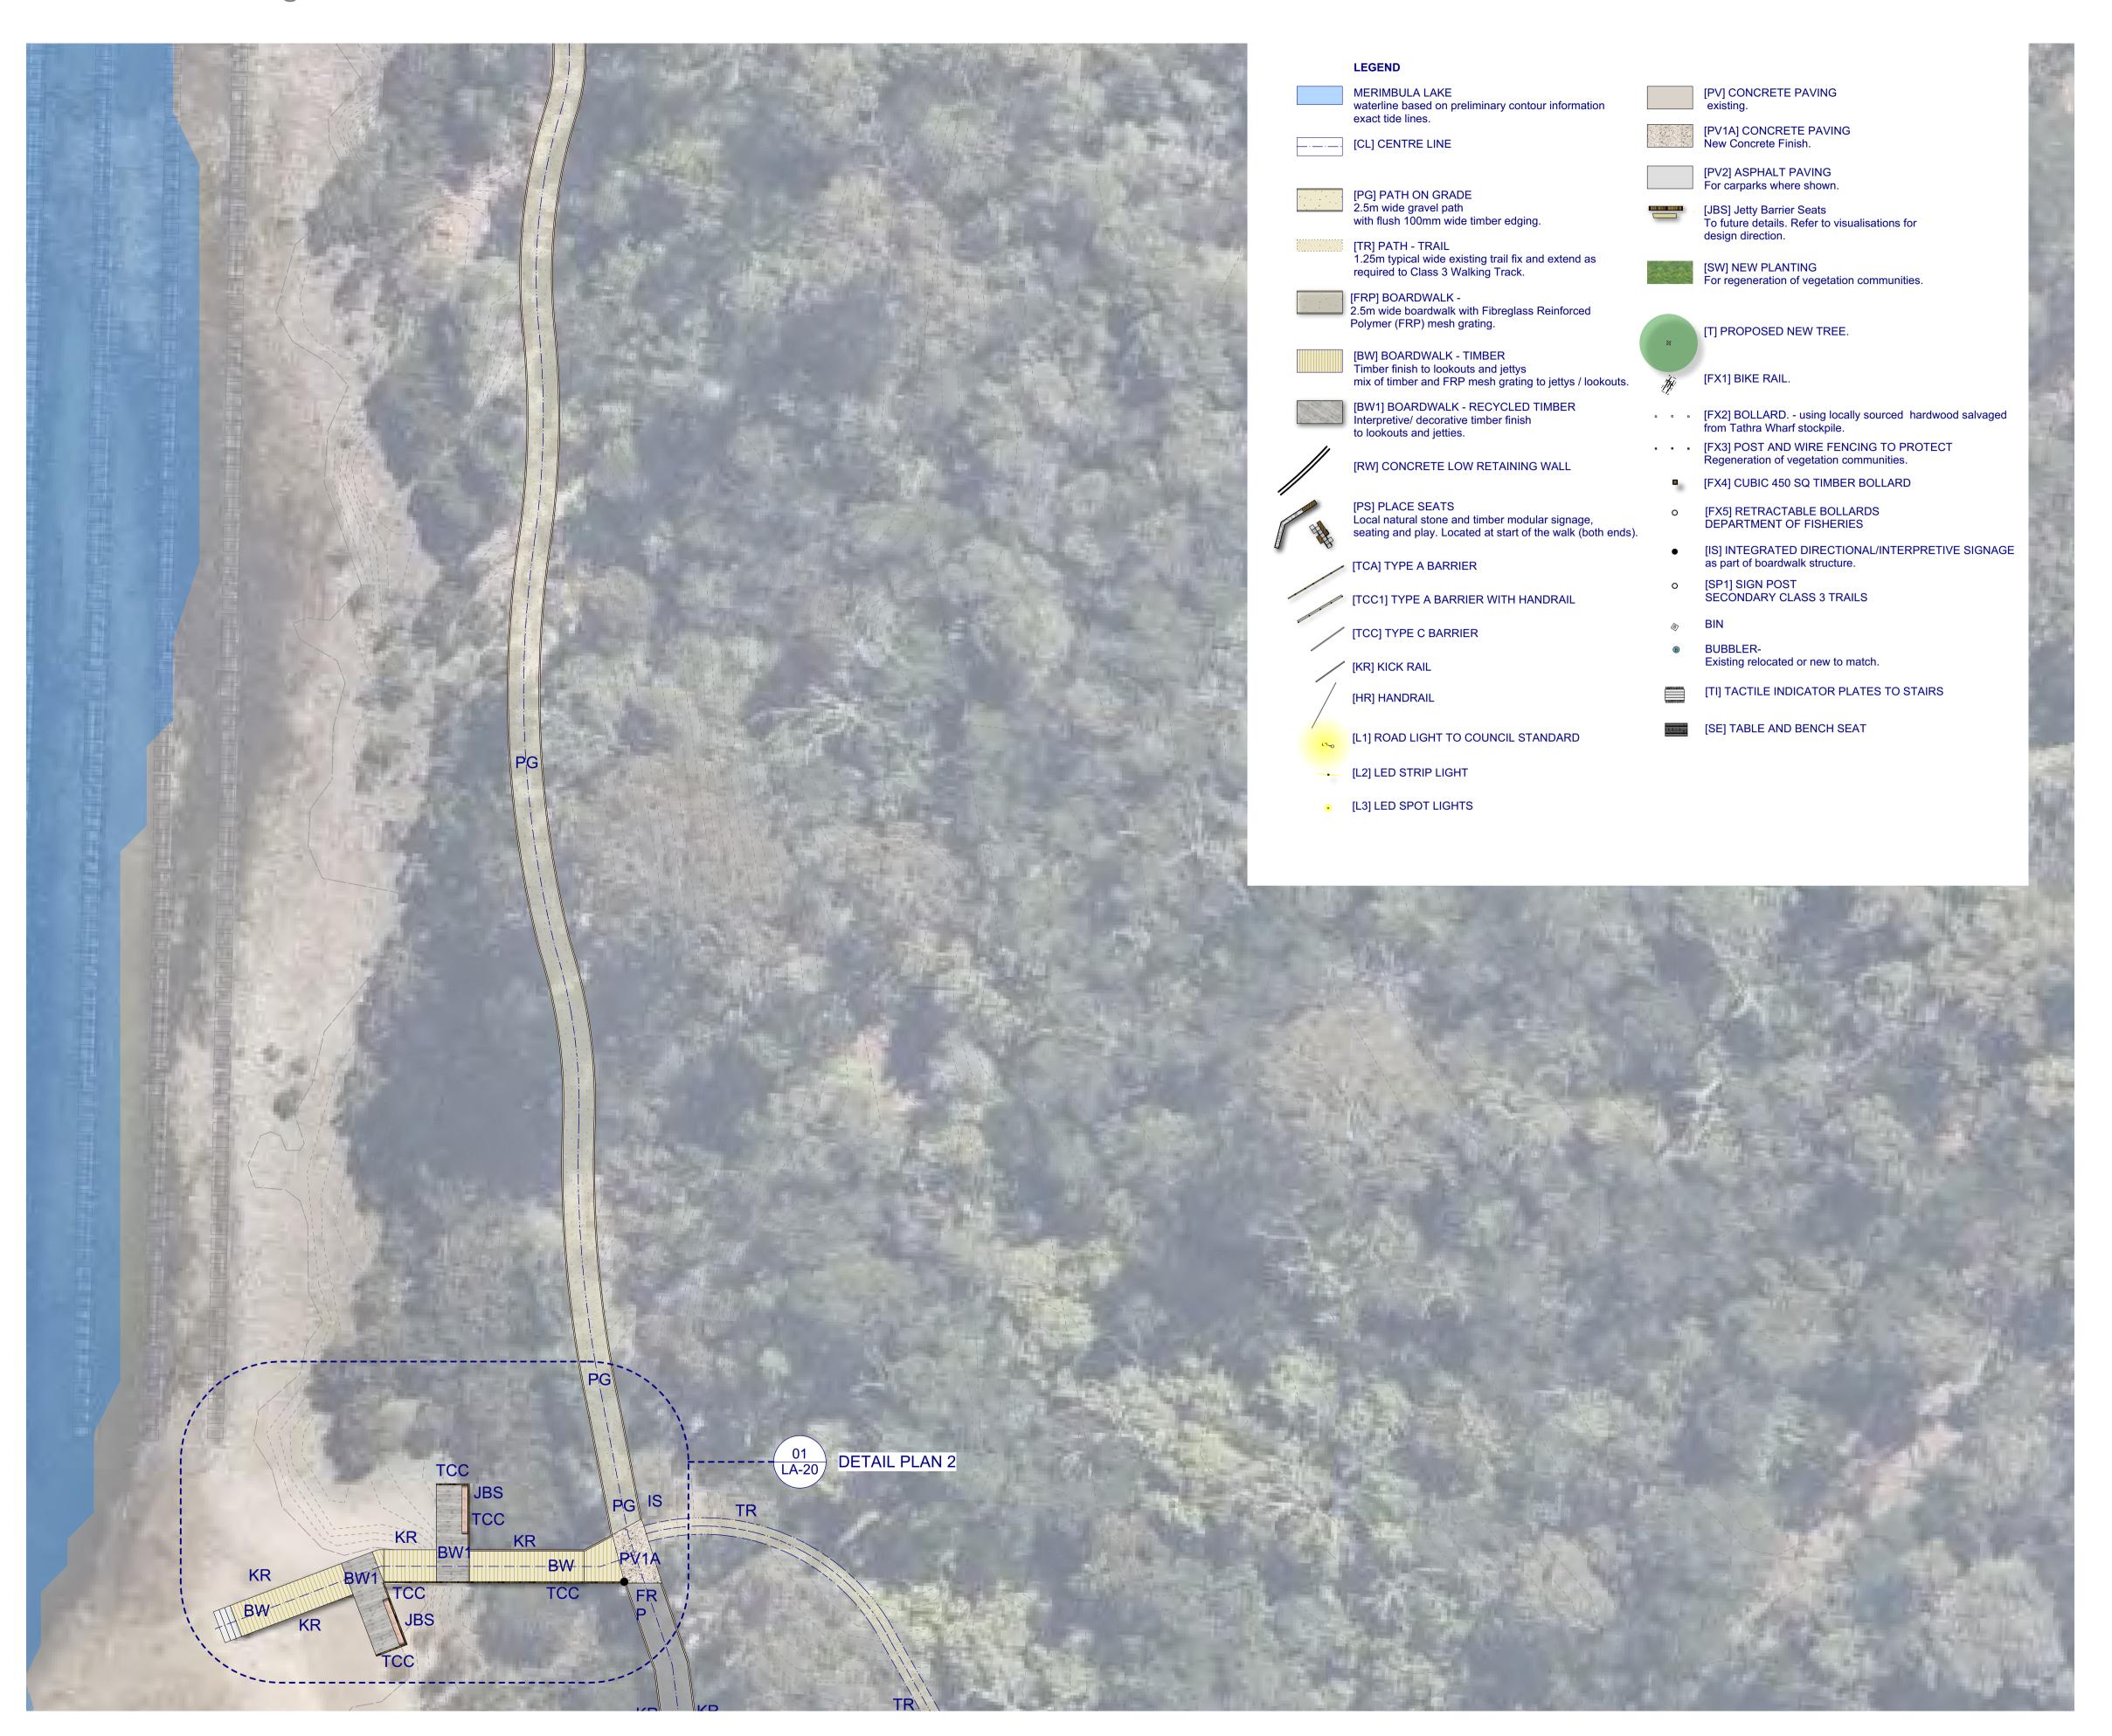
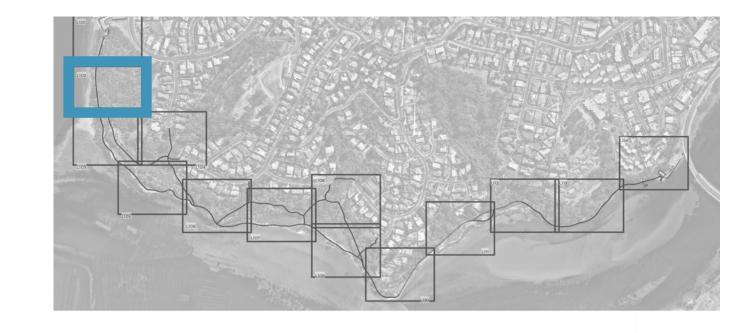
- The existing jetty is located in a tranquil and popular spot that provides excellent views of the sunset. It is proposed that the jetty is upgraded to be wider and provide more seating opportunities. The jetty will be rebuilt in a consistent geometry to existing to retain character.

- Its character will be of simple post and timber rail balustrade on one side typical of jetties found in many coastal bays in NSW. This will retain a sense of familiarity.

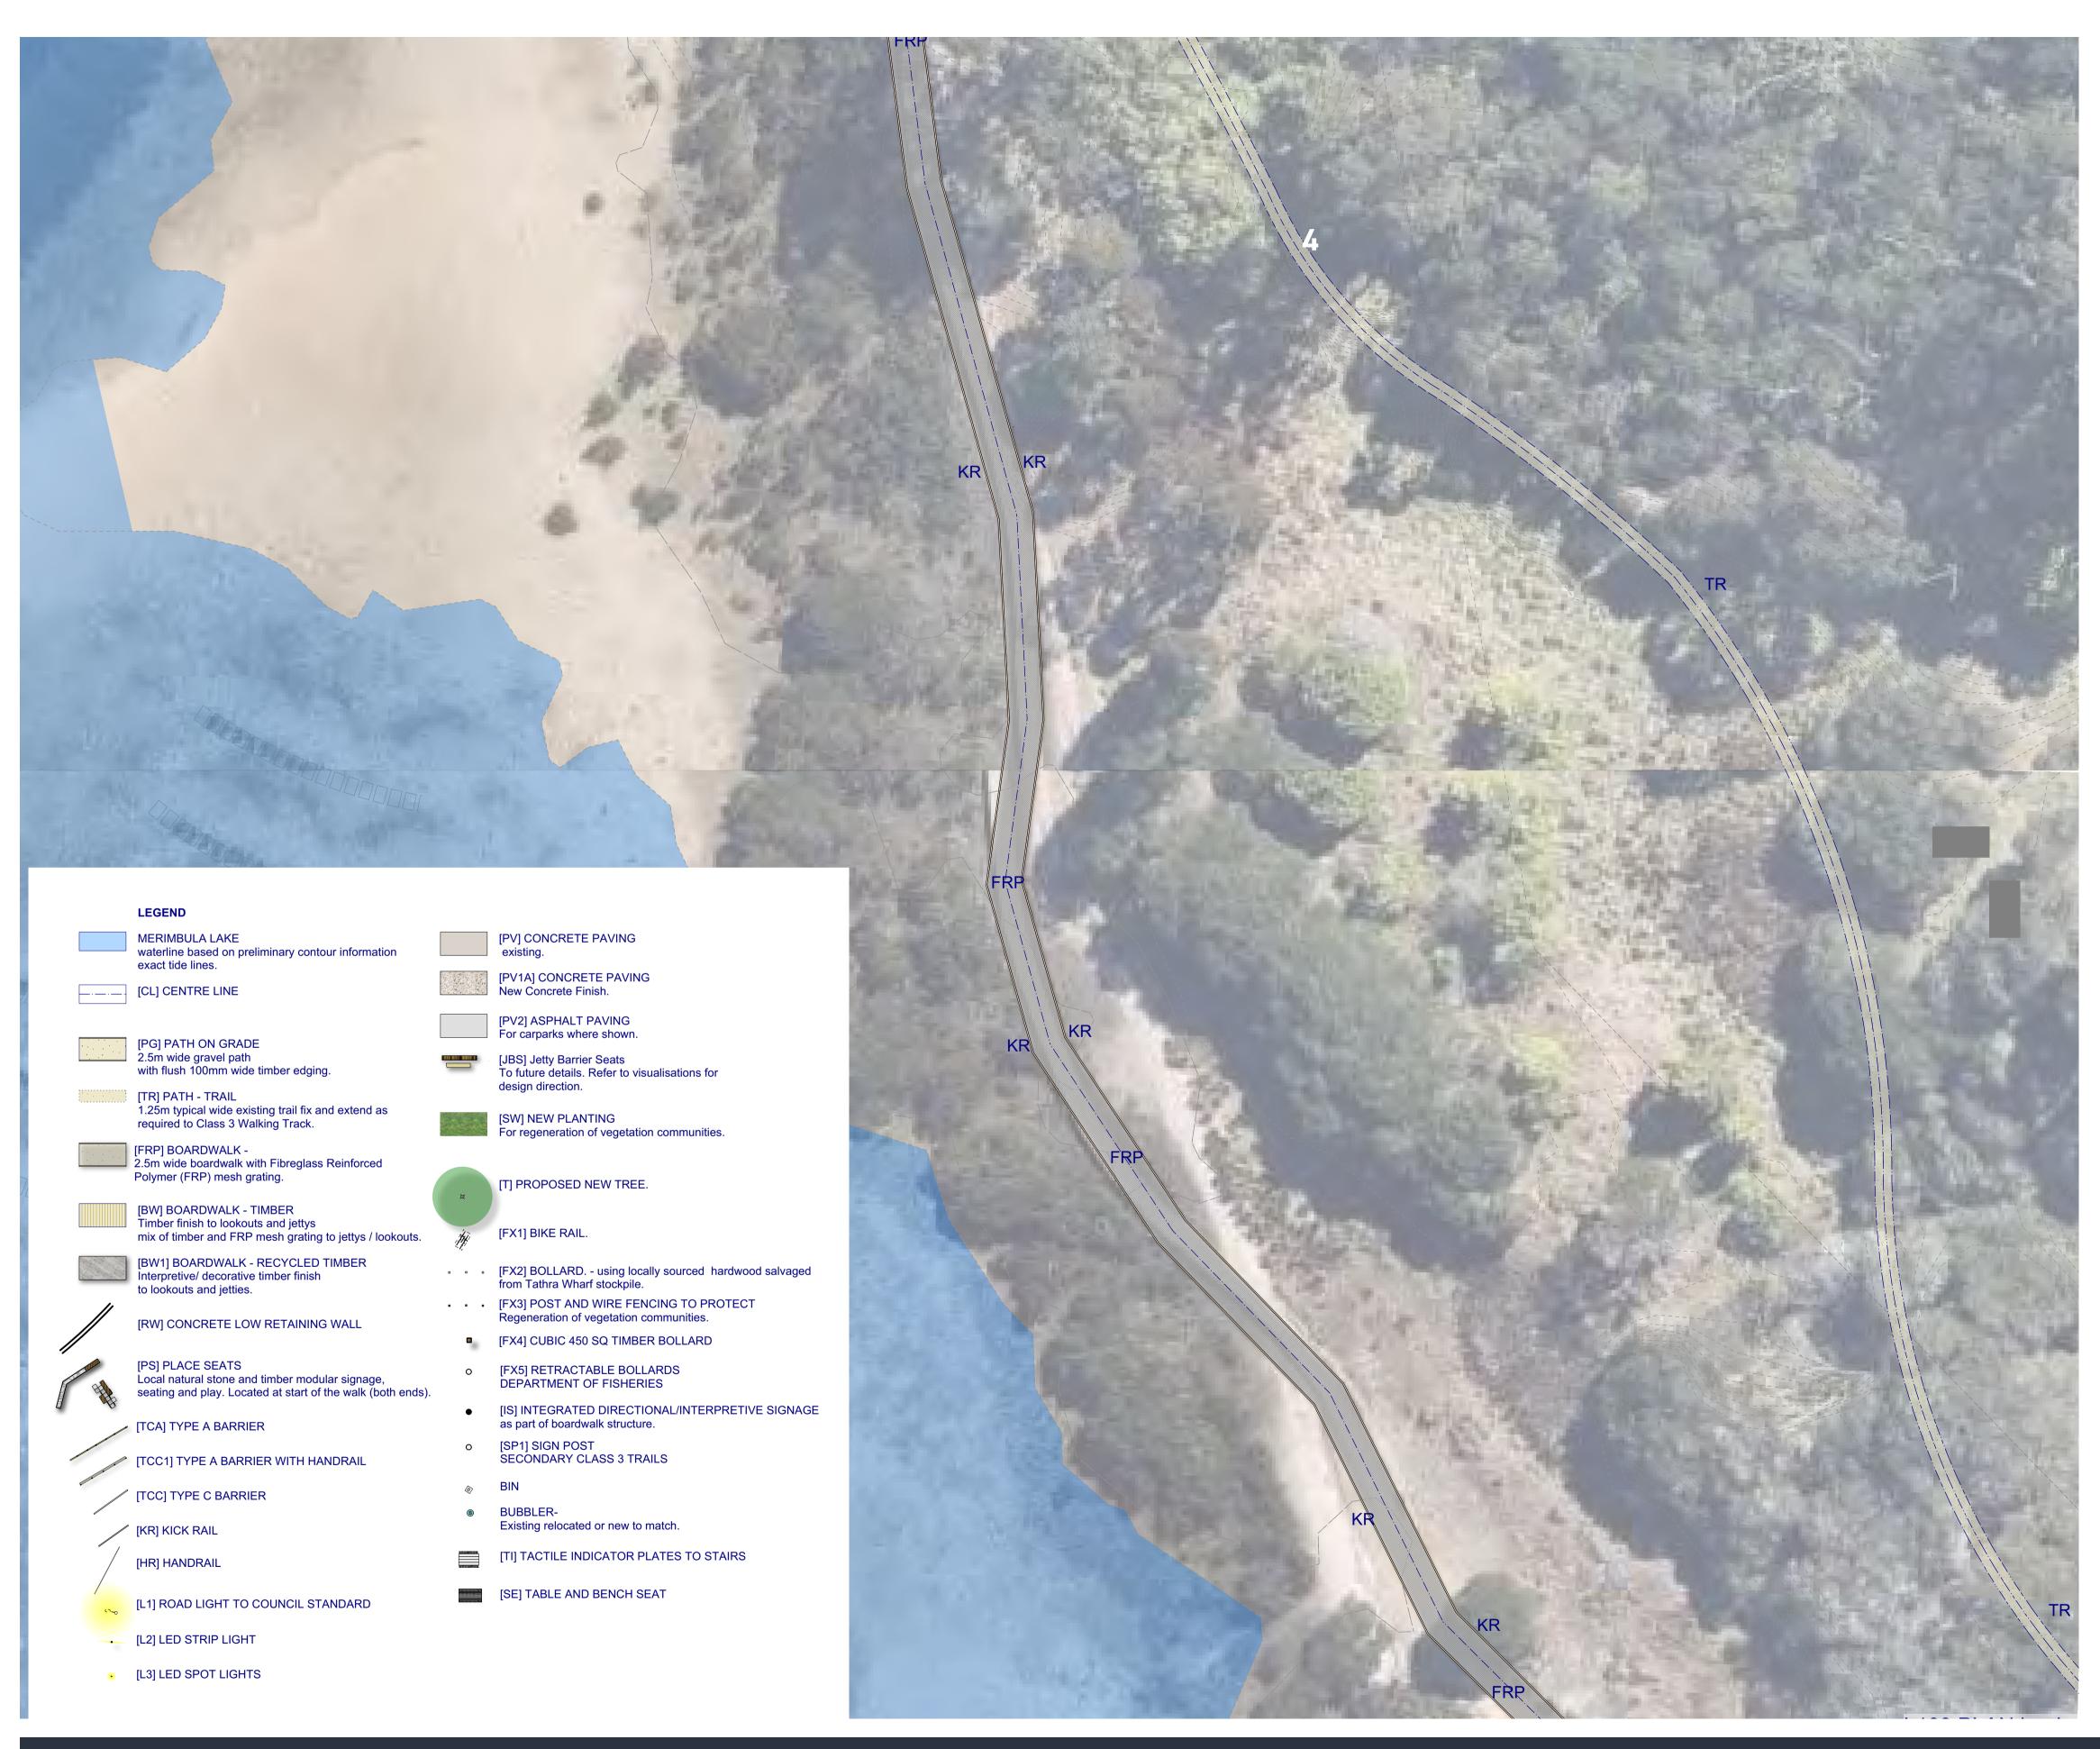
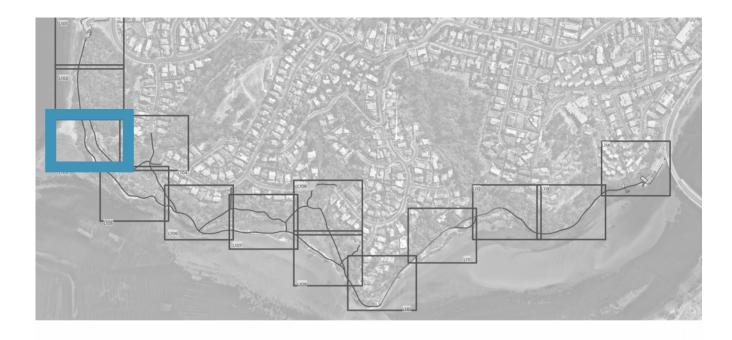
- The boardwalk traverses three vegetation communities in this area including Mangrove, Saltmarsh and Swamp Oak Forest.
- There are opportunities to hop off the boardwalk onto the beaches as currently occurs however this is not to be formalised. As is the case currently.
- The nature trail extends beyond the salt-marsh .Bush track paths will be repaired as required to Class 3/4 standards. Any additional subsurface drainage and culverts, raising or boardwalks over creek and drainage lines are to be determined by the contractor and agreed to by Council.
- Extent and setout of these is paths to be assessed with ecological consultant, however they will likely follow the existing tracks.

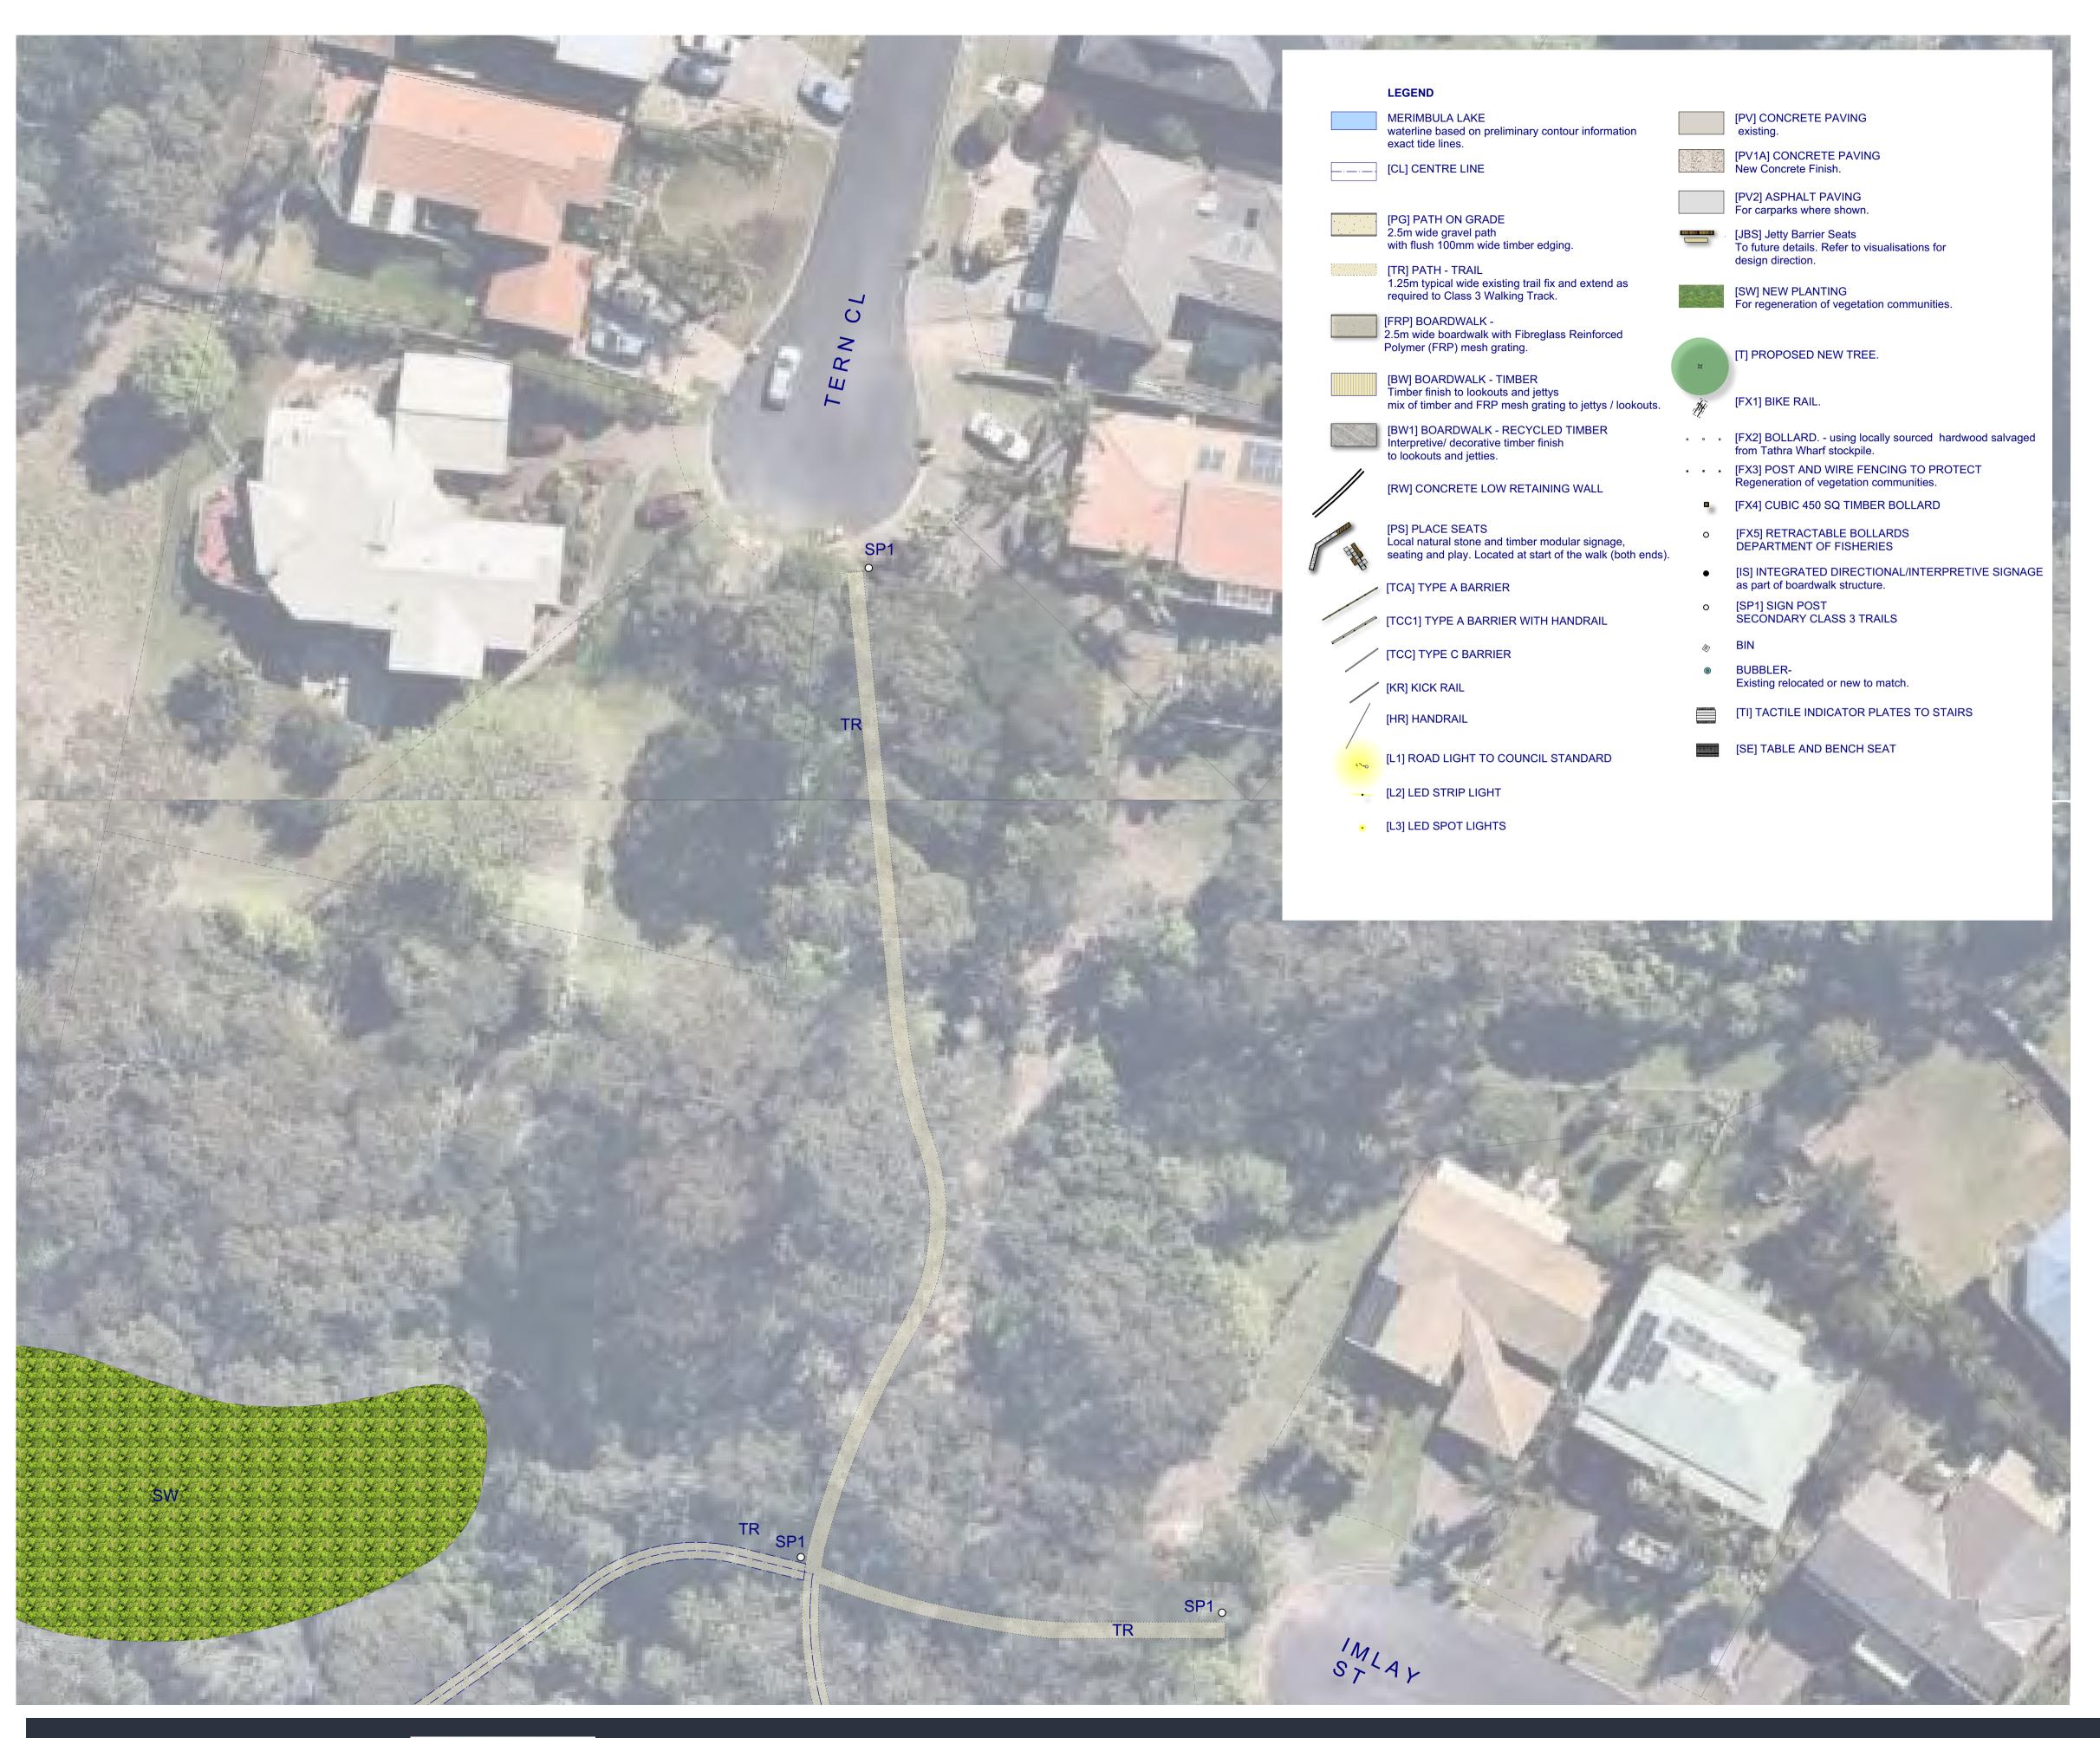
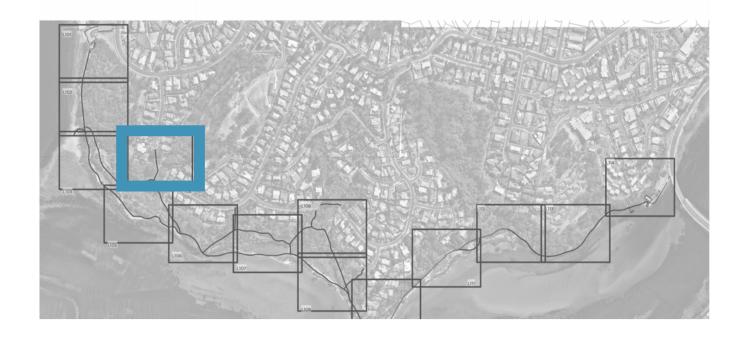
- The nature trail continues through closed forest and will skirt and existing fenced detention basin.
- There is an opportunity for this detention basis to be restored to its original function to manage stormwater quality to the salt-marsh downstream.
- Simple timber wayfinding plinths direct walkers to exits at Tern Close and Imlay Street where the nature trail branches off.
- Appropriately subtle plinth signage is also included at these street connections to direct walkers to the main boardwalk.
