# Merimbula Boardwalk and Foreshore Path

EASTERN ENTRY AND CARPARK UPGRADE.

### Design Development Principles

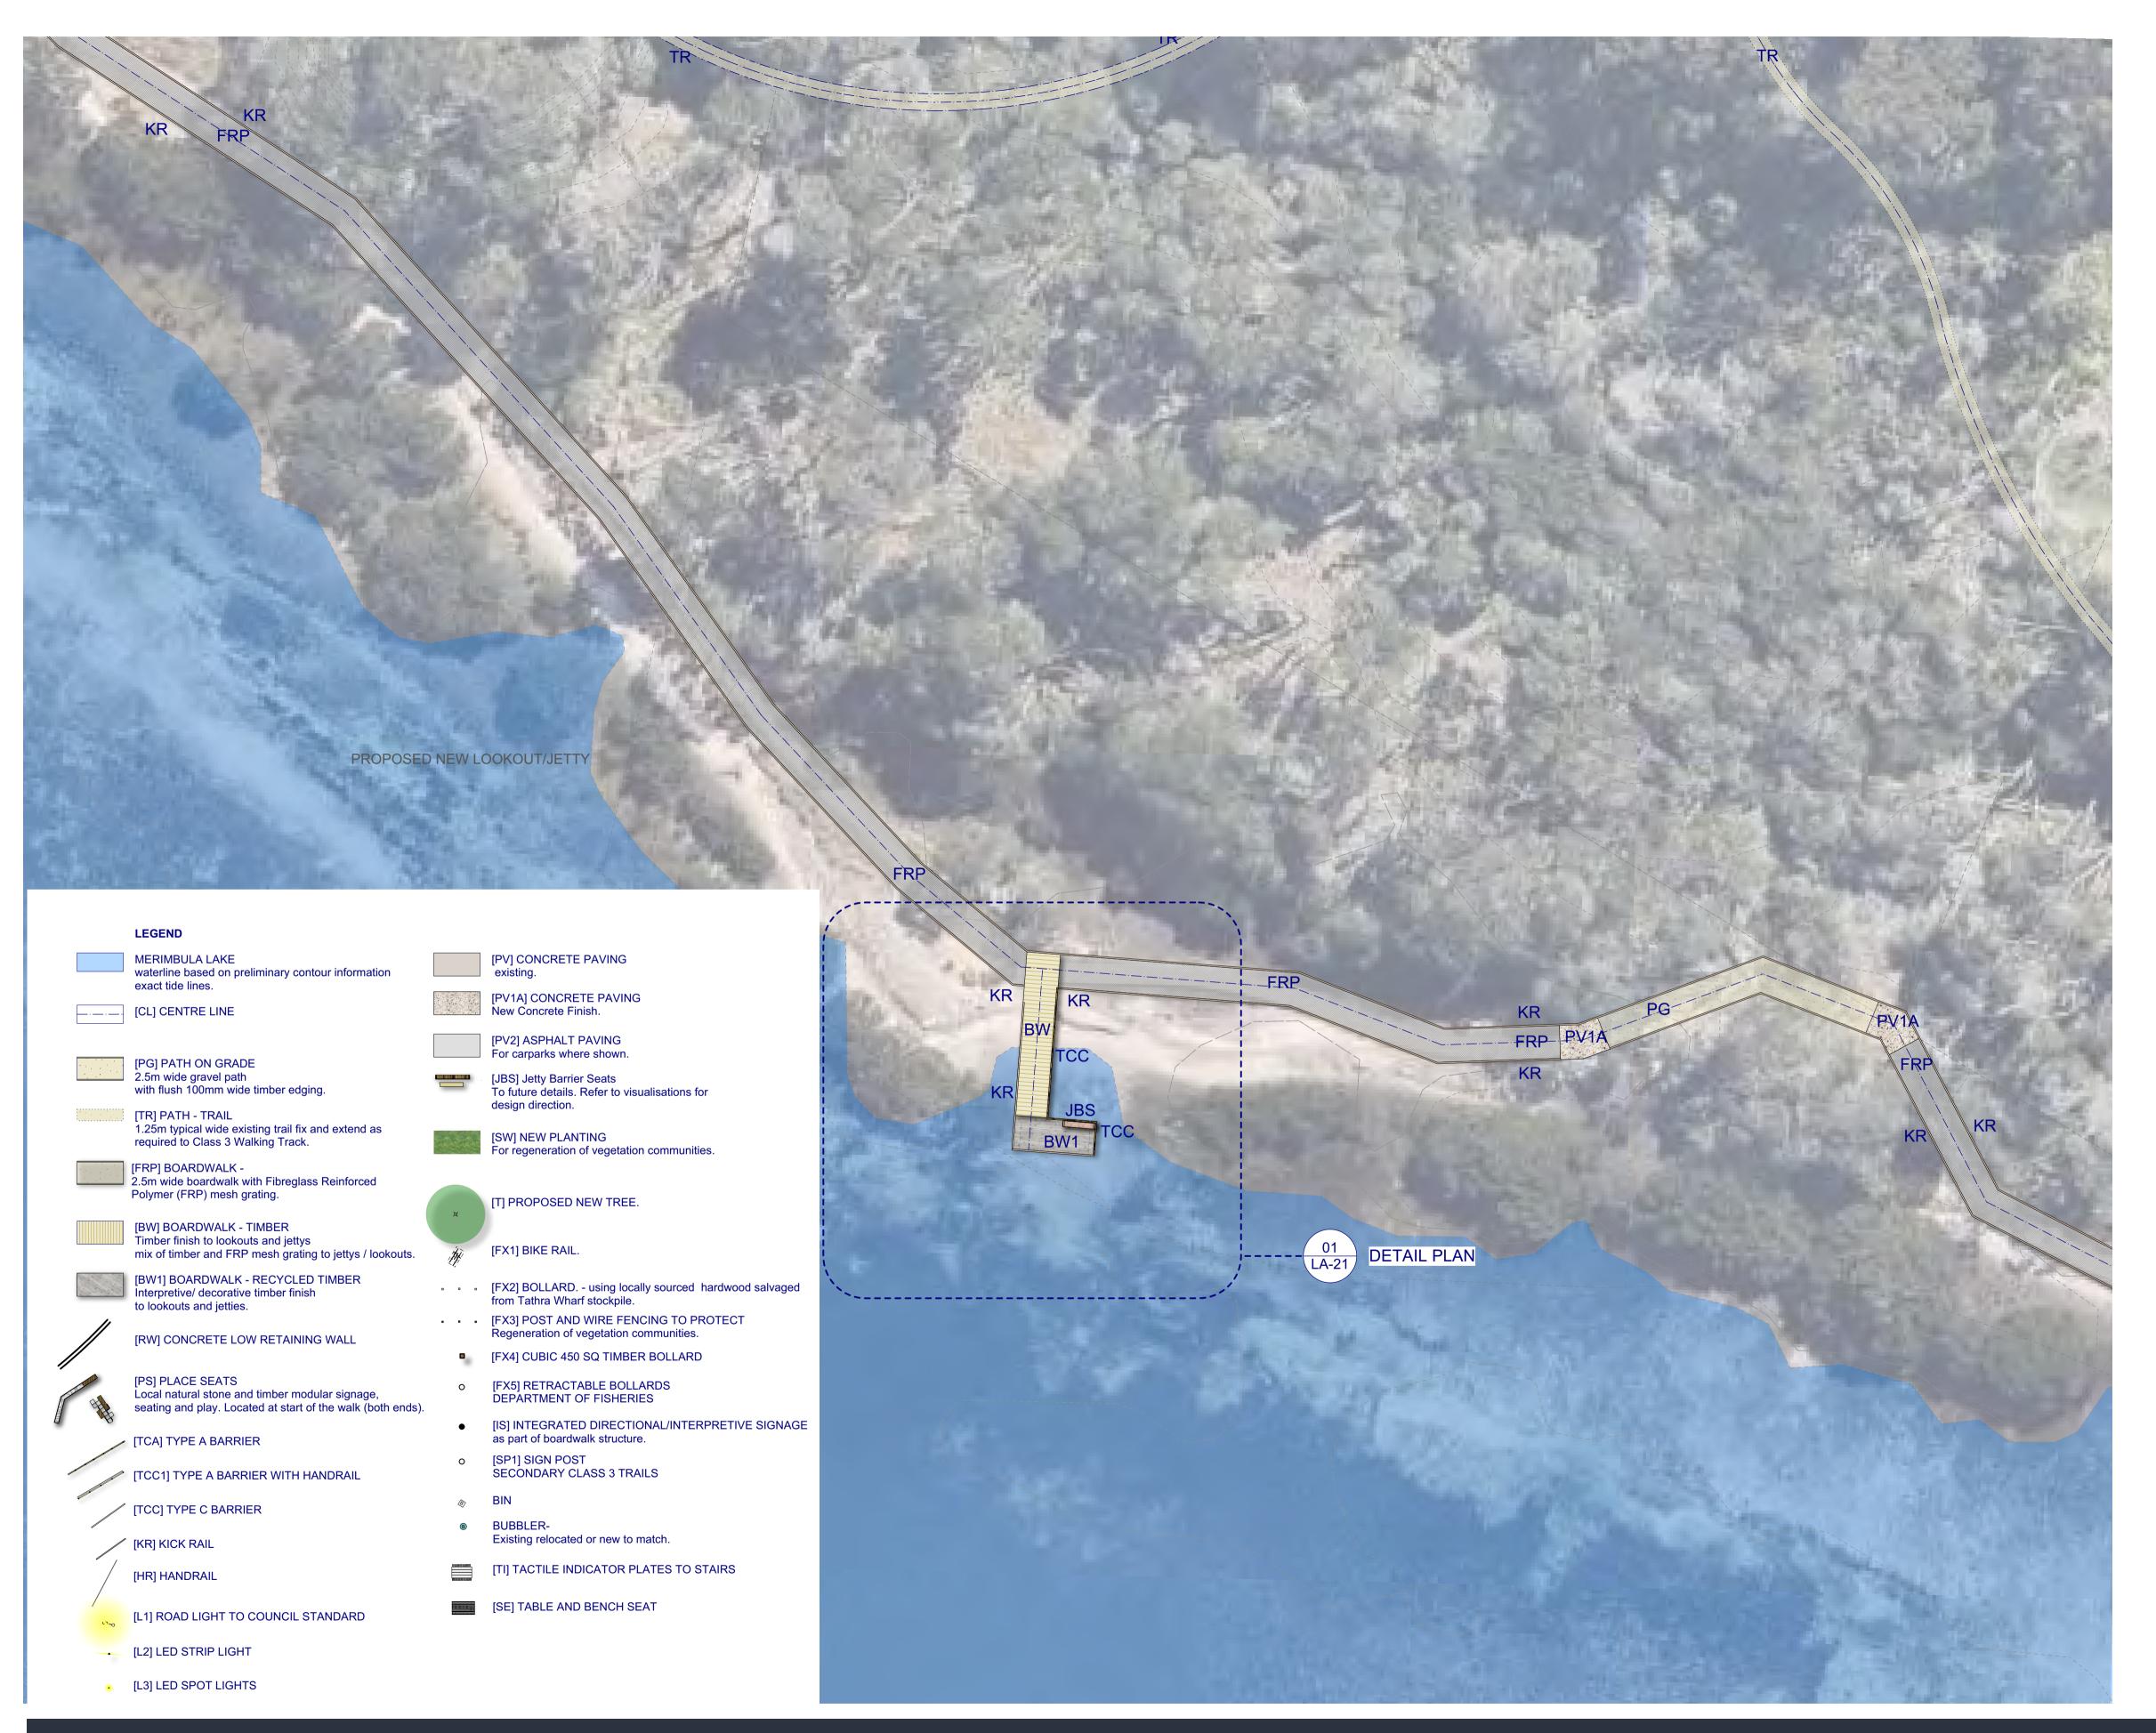
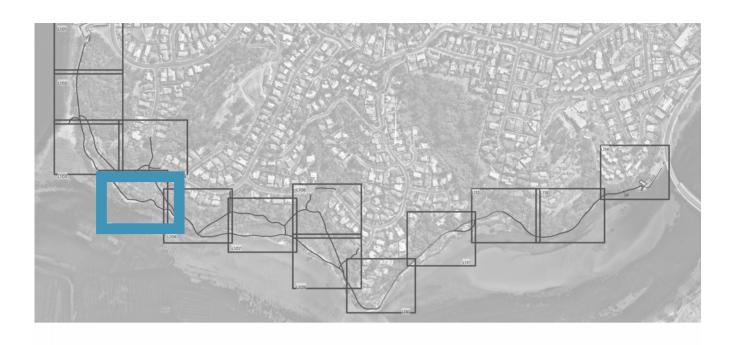
- There is the opportunity for a new lookout almost midway where there is a beach and break within the mangroves.
- This lookout is adjacent to the oyster leases and gives a different perspective and landscape experience with the Lake.
- The Lookout is designed to be consistent with other lookouts along the walk with its construction and character, however is shortened to avoid impact on seagrasses.
- A seat will be included adjacent to the lookout as a rest point, to ensure that sufficient rest points are spaced along the path.
- Stone crazy paved junctions are used where a solid abutment is needed between fibreglass raised boardwalk and on grade gravel path. These demarcate a change of materials and help detailing a change of direction.
- The alignment closely follows the existing boardwalk to avoid large mangrove trees.

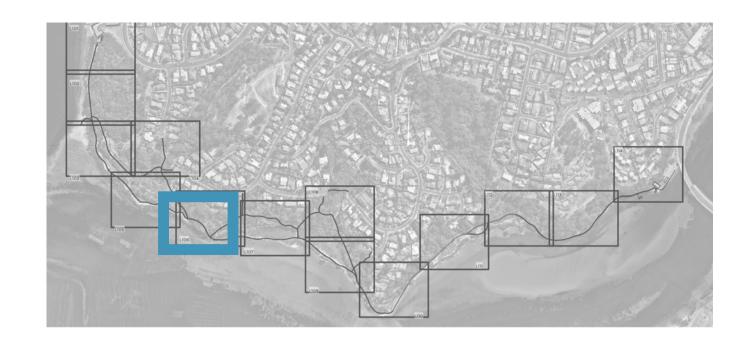
#### **KEY PLAN**

- Rest spots and intersections with the bush tracks on grade are marked with a stone paving pad and signage.
- Signage is included to prevent walkers from accidently losing their way.
- Materials changes are specific and have a clear hierarchy to make the main walk obvious. This includes a timber edge that cuts across side paths following the main path alignment.
- Rest spots are frequently located at existing locations, to retain the character of what has been successful planning of the existing.
- Rest spots alternate between having a seat behind the walk or an undisturbed connection in front of the boardwalk.

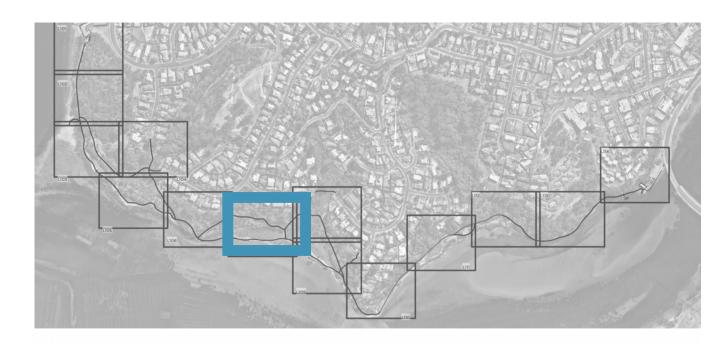
#### **KEY PLAN**

- The FRP boardwalk retains the existing alignment and height across the salt marsh to minimise damage to this important vegetation community.
- The existing rest area is upgraded in the same location. This retains a familiarity with the boardwalk between the existing and upgraded.
- There will be the opportunity for interpretative signage to be included. These will be updated and designed to be more integrated with the furniture and structure.

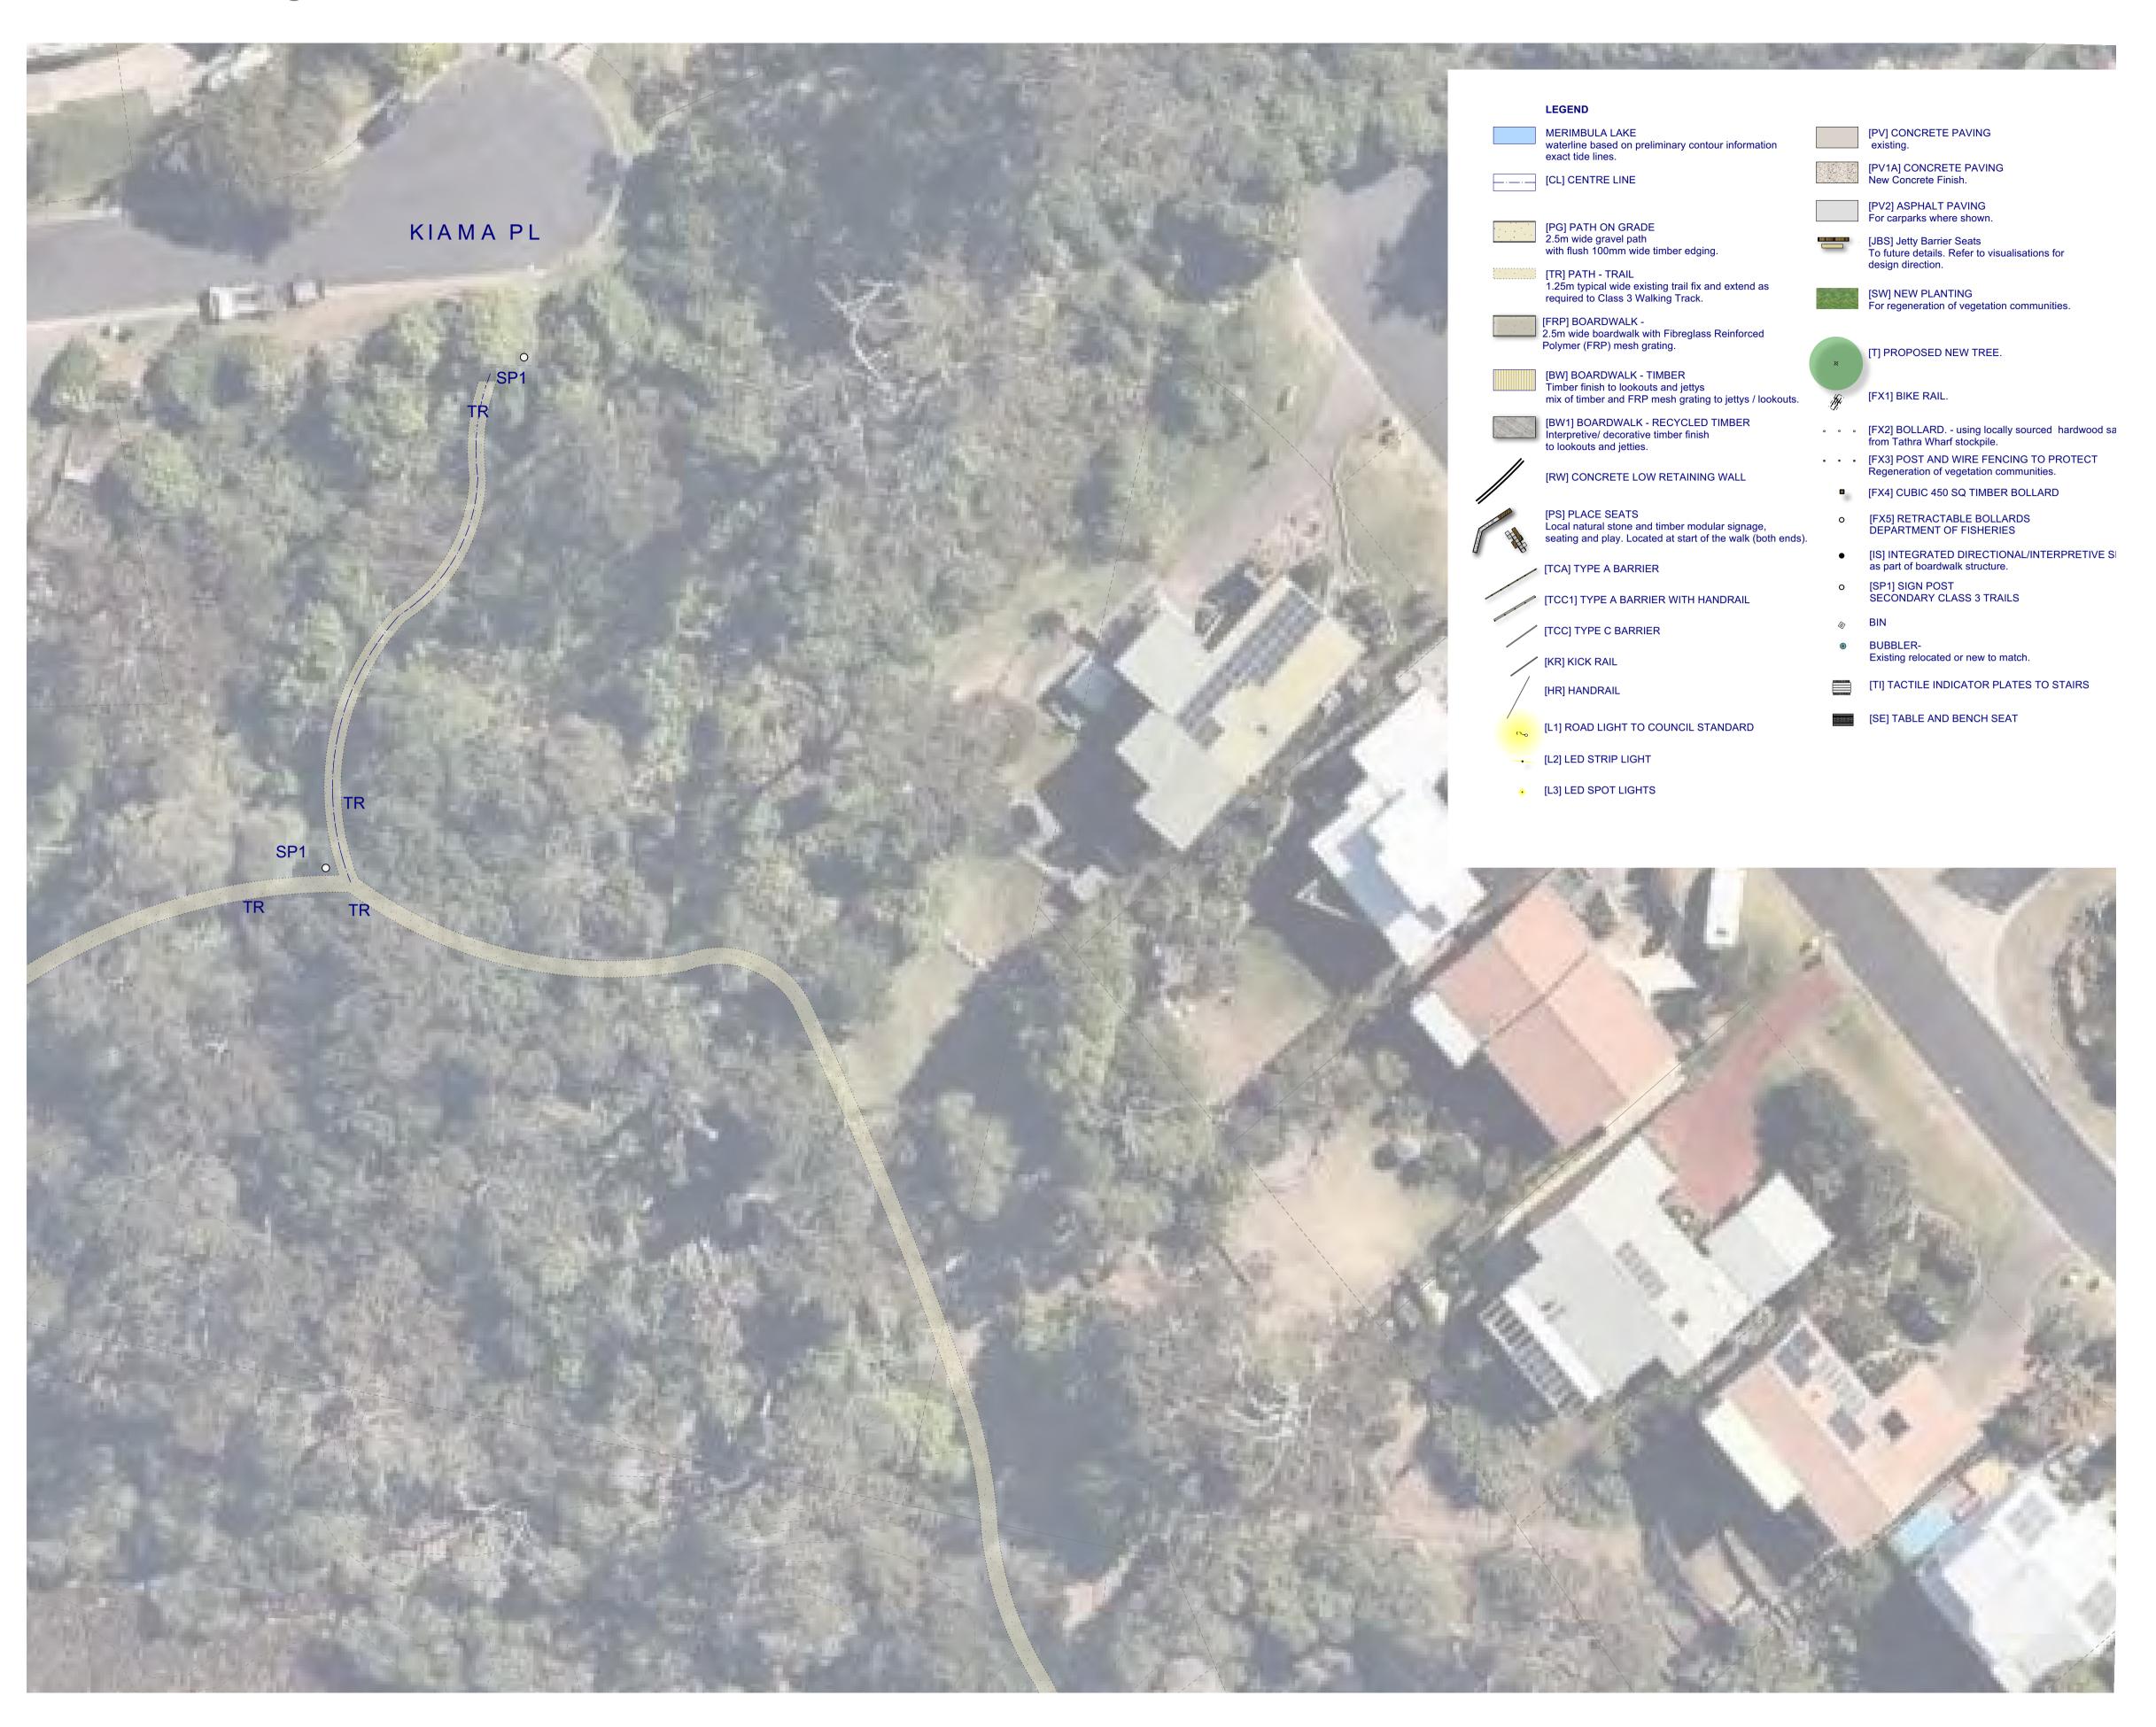
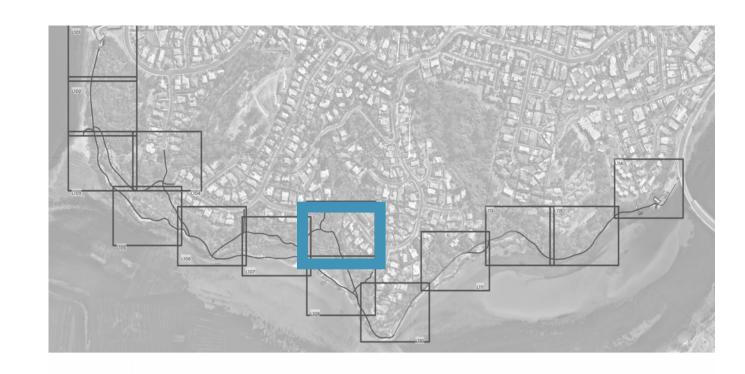
#### **KEY PLAN**

- New wayfinding signage from Kiama Place to the boardwalk.
- Forks in the tracks will all have subtle wayfinding signage.

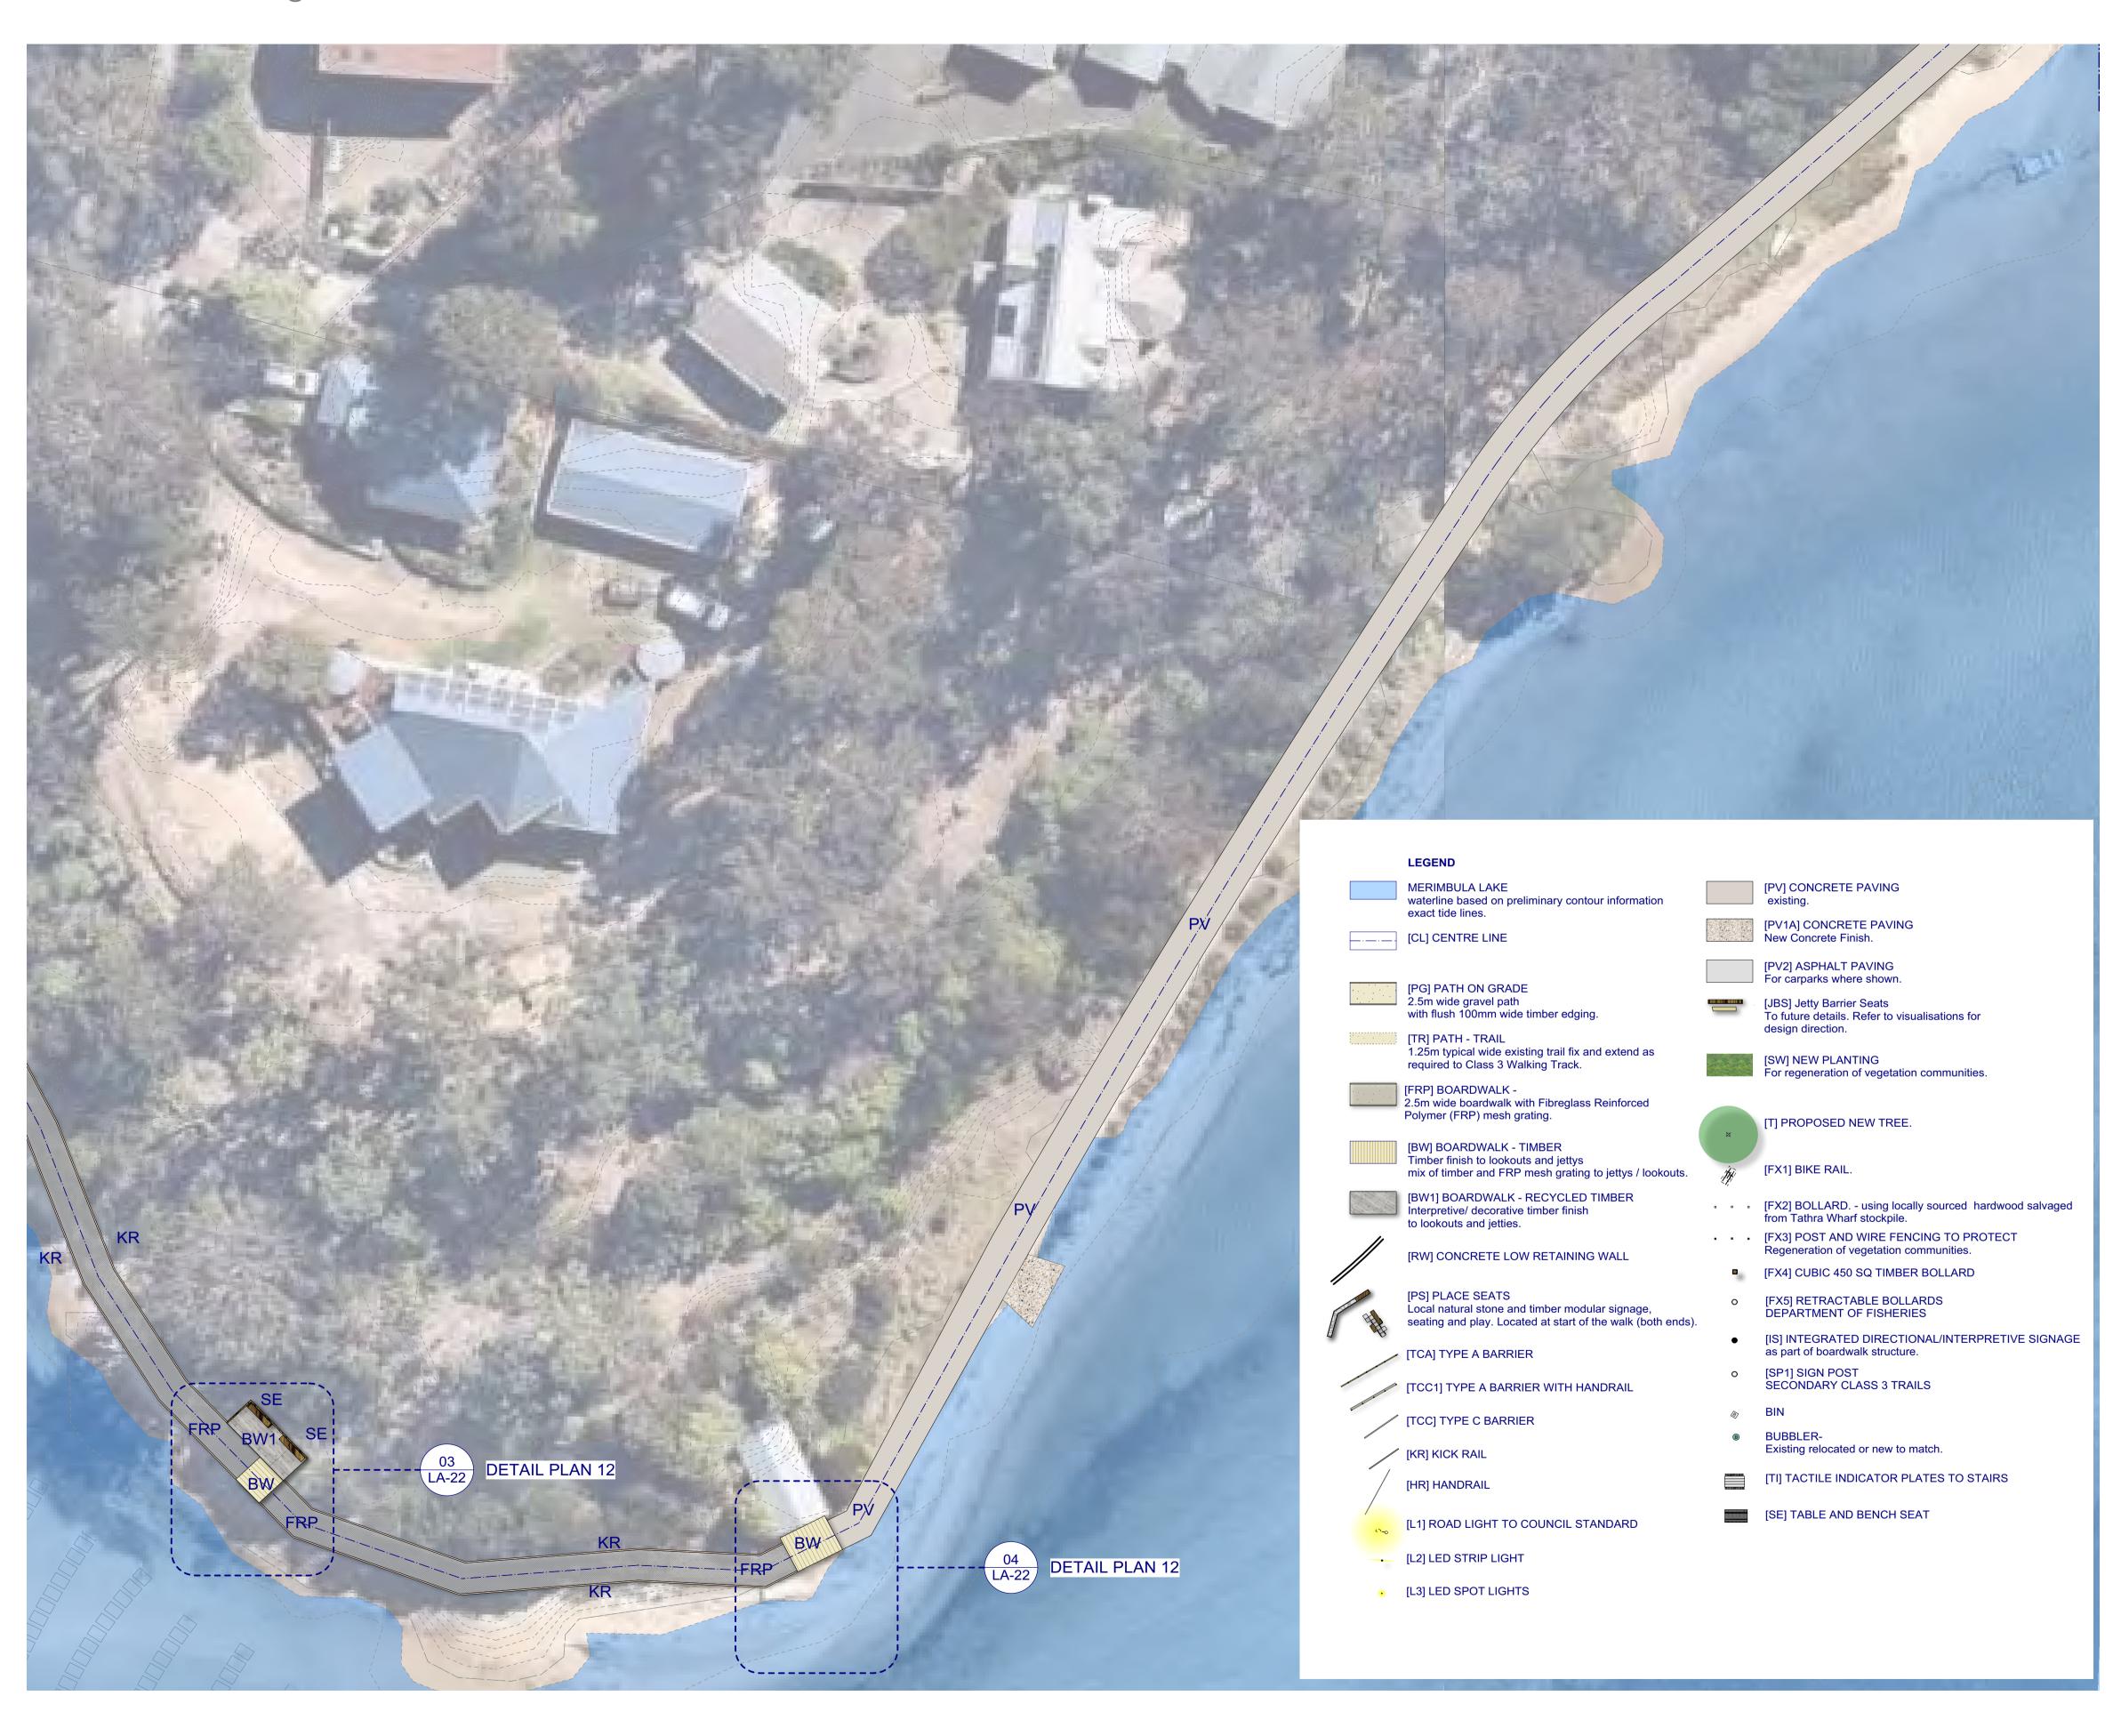
**KEY PLAN**

- The existing concrete path is retained.
- New concrete path extended to kayak ramp. Width of path transitions from 3m existing back to 2.5 metres at the boatshed.
- All kikuyu grass verges to be removed and revegetated to eliminate weed invasion risk of intertidal and salt-marsh vegetation. If necessary, damaged salt-marsh should be fenced off with post and wire fencing. To be confirmed by Ecological Consultant.
- Existing rest point beneath shade tree upgraded.
- Existing kayak ramp retained.

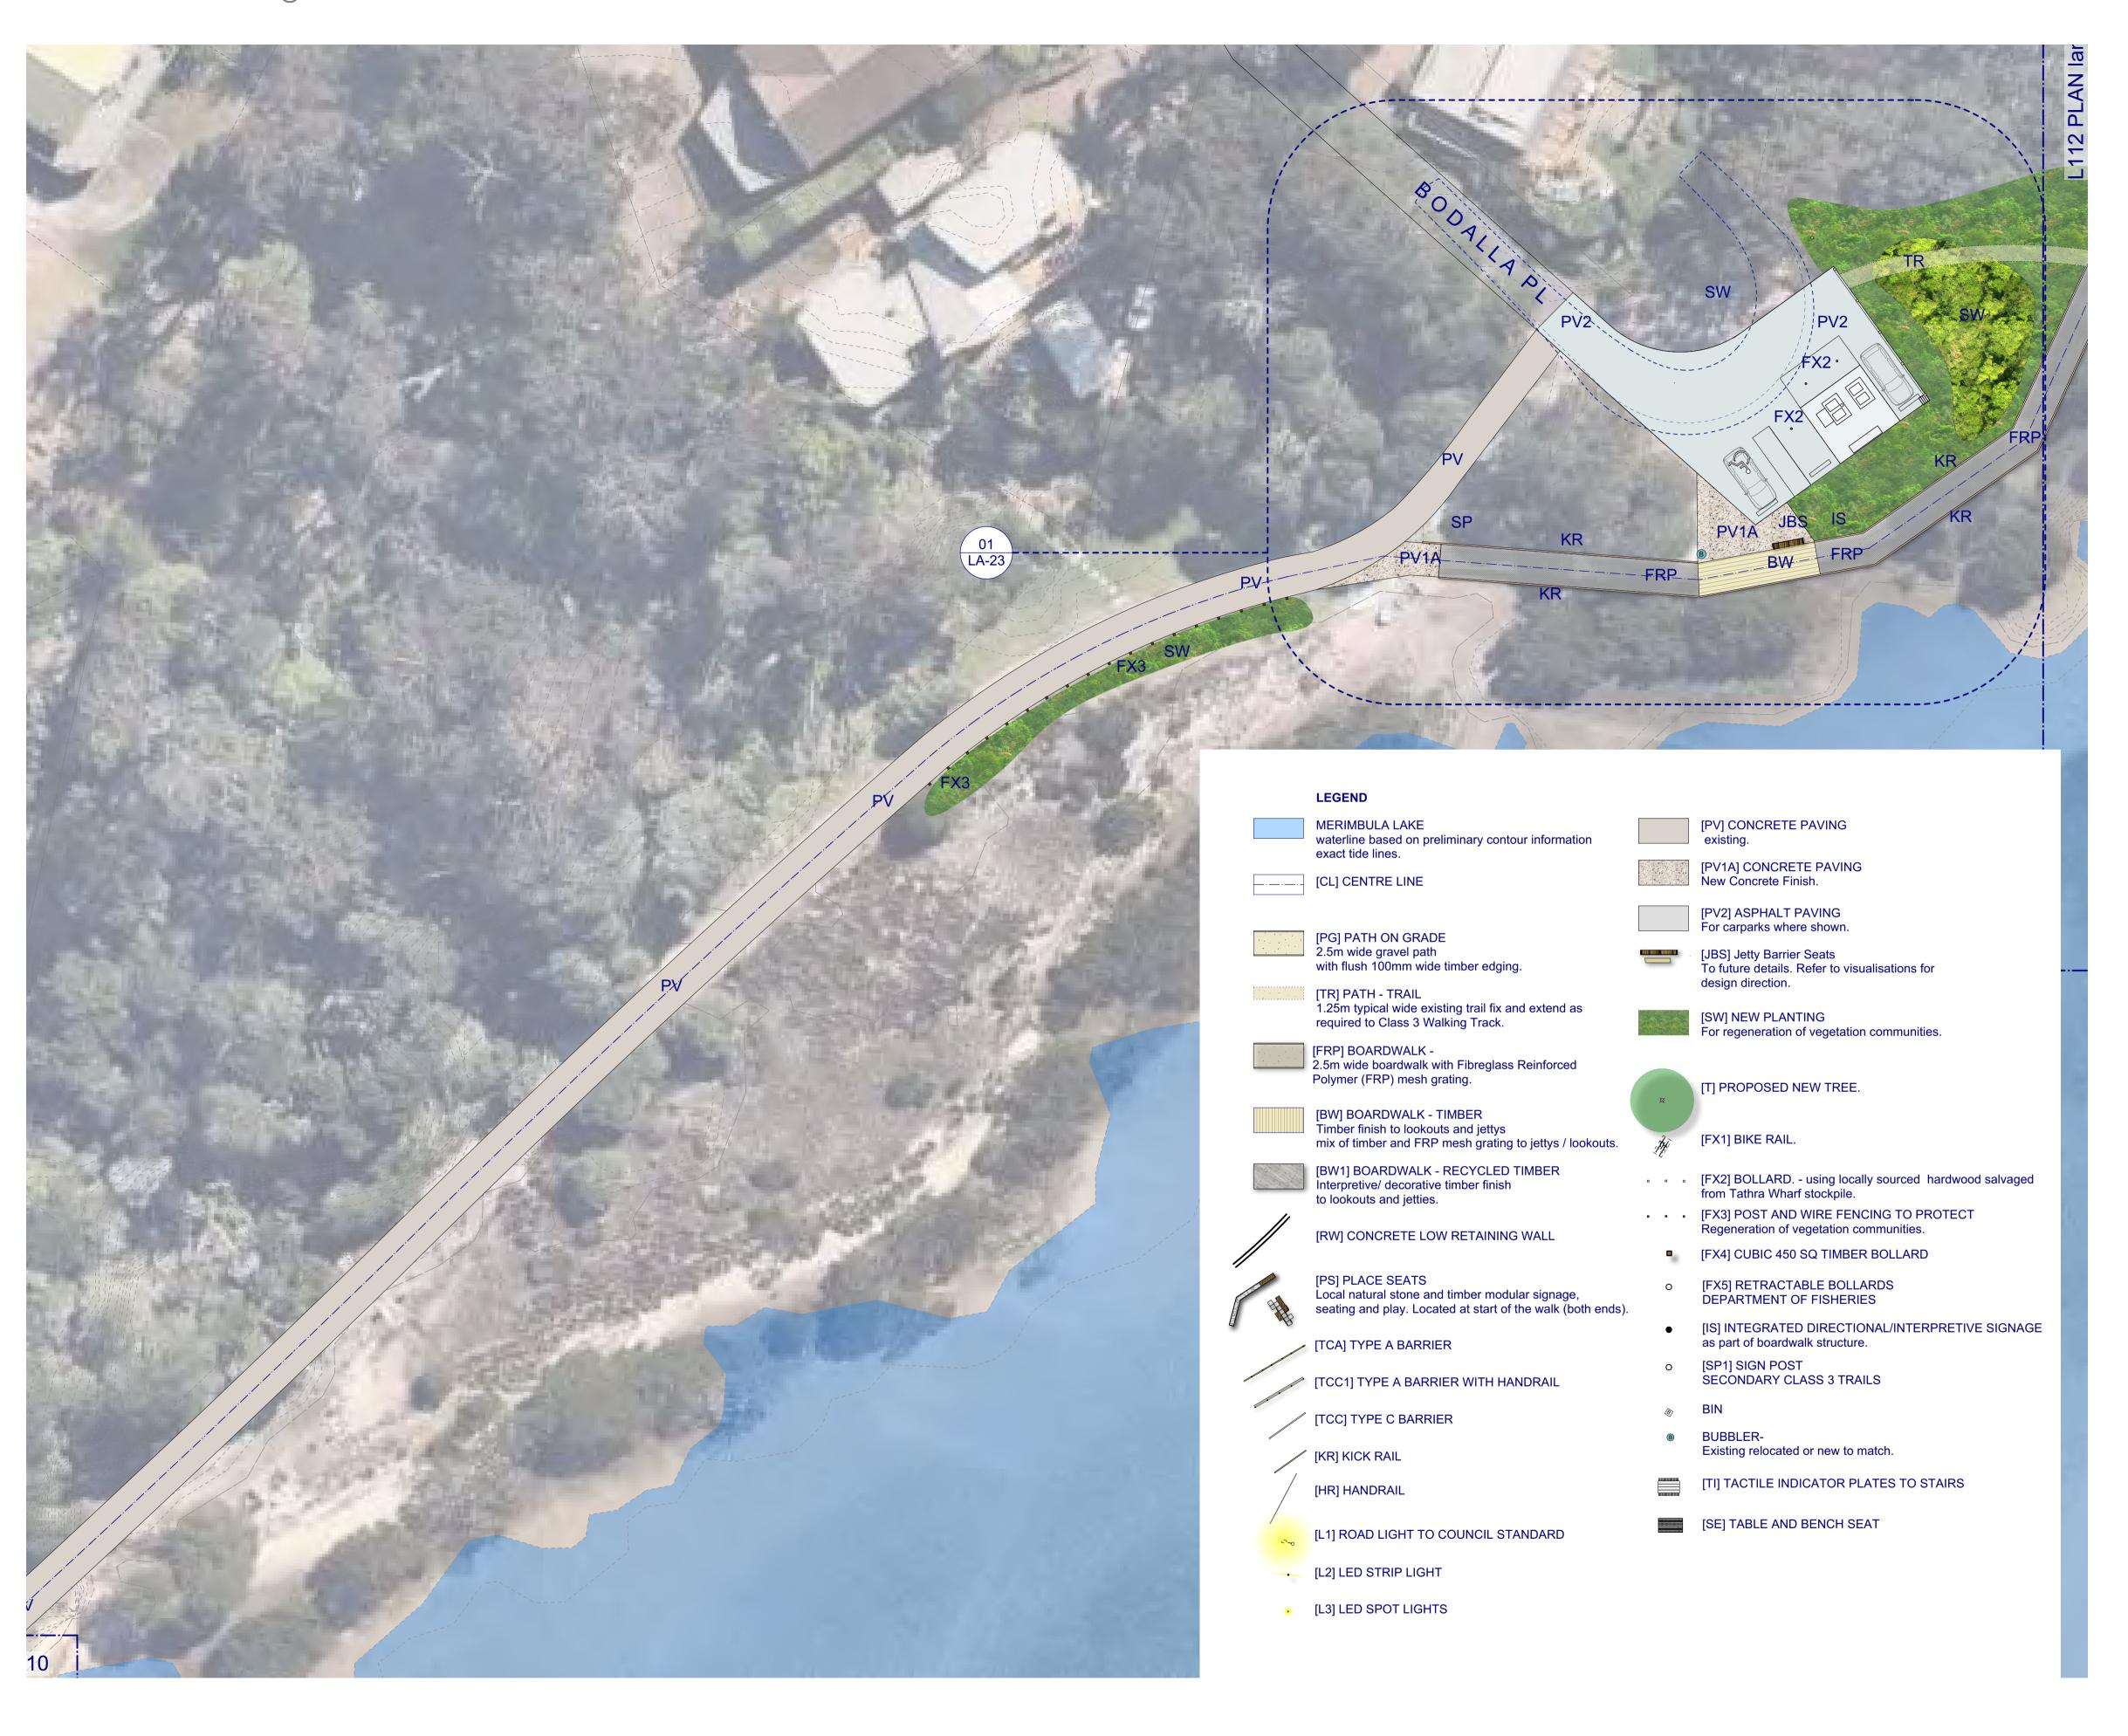
- Existing concrete vehicular ramp will be retained between Bodalla Place and the boardwalk.
- All kikuyu grass verges to be removed and revegetated to eliminate weed invasion risk of intertidal and saltmash vegetation. If necessary, damaged salt-marsh should be fenced off with post and wire fencing. To be confirmed by Ecological Consultant.

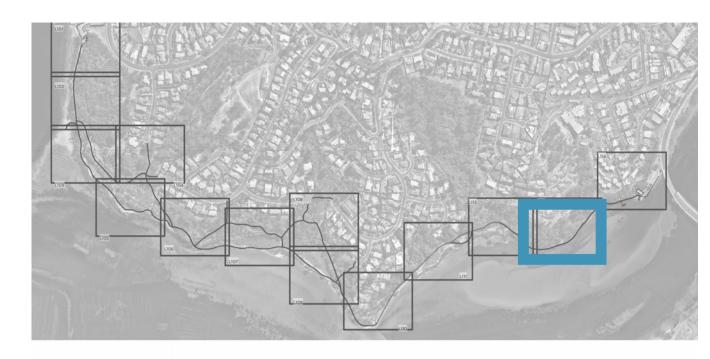
**KEY PLAN**

- The height of boardwalk adjusted to allow for king tides and prevent immersion.
- The existing rest area is upgraded in the same location. This retains a familiarity with the boardwalk between the existing and upgraded.

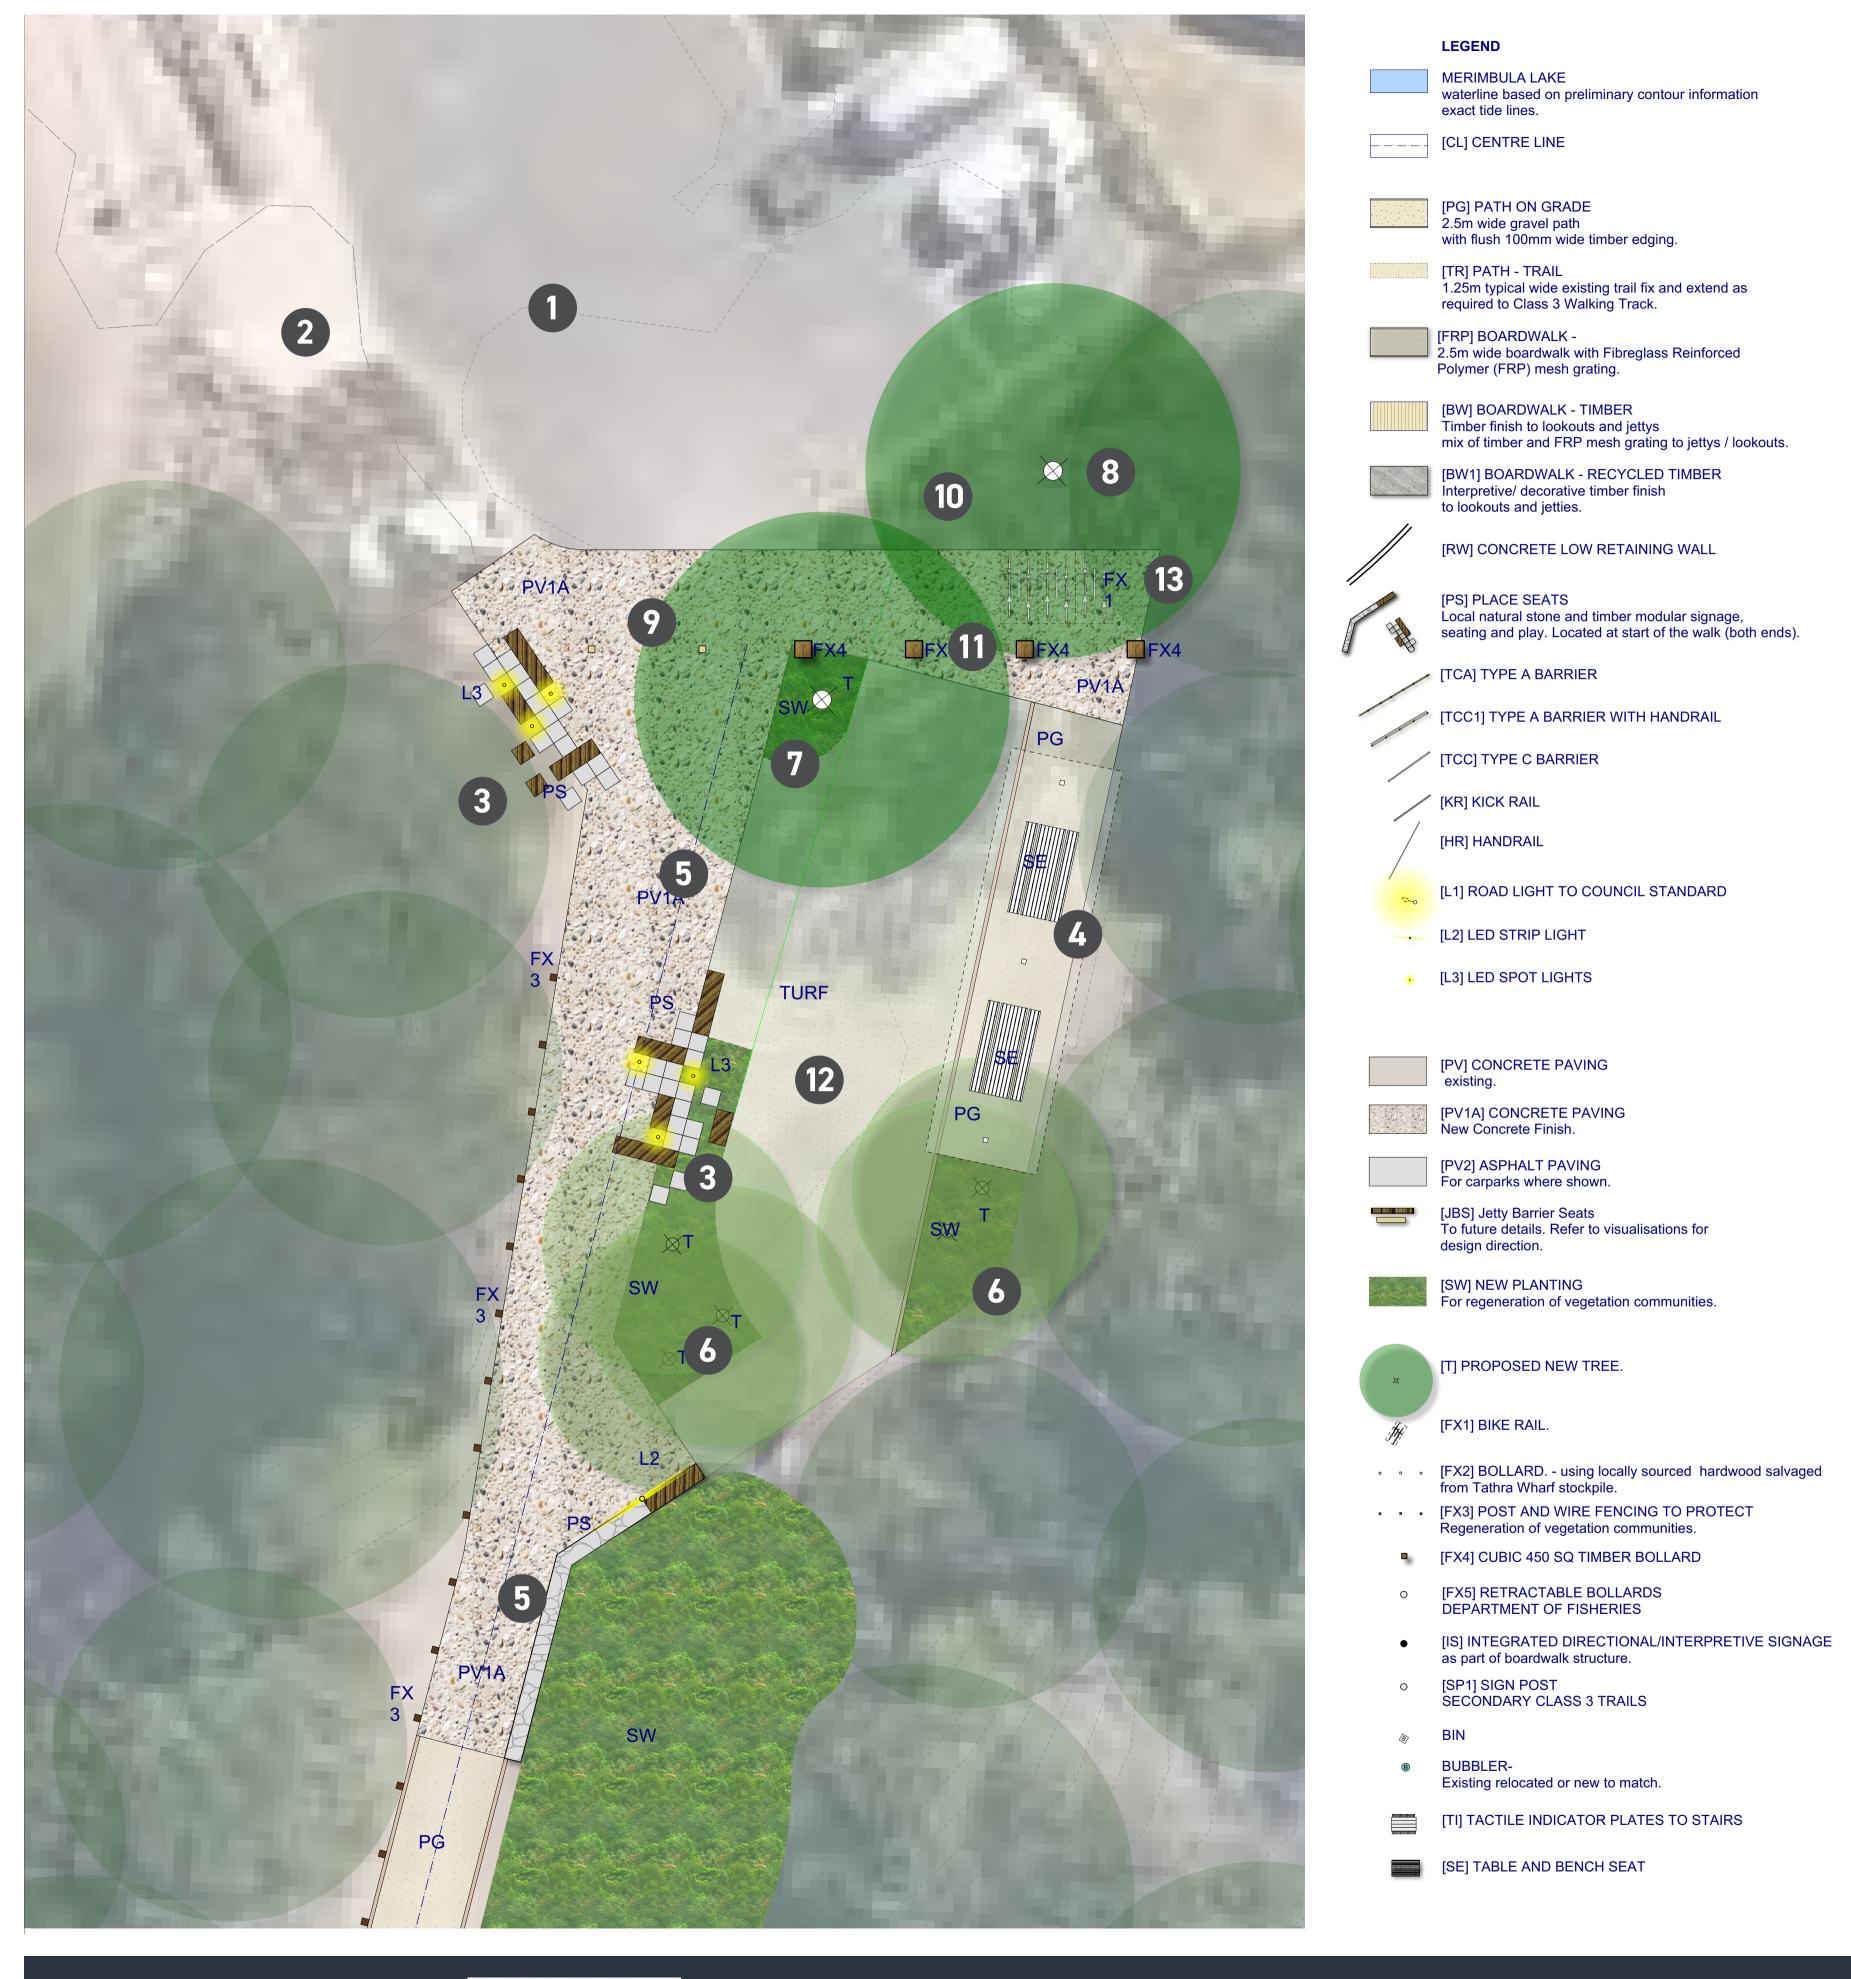
### Detail Plan 01 - Western Entry

- 1. Existing carpark retained, with no proposed alterations.
- 2. Existing boat ramp retained.
- 3. Interpretive artwork and playful structure. Opportunities for cultural expression and reuse of materials such as wharf timbers and local quarry stone. Opportunity to incorporate lighting with this important feature. (refer to precedents on LA-34)

- 4. Rest / meeting area including two picnic tables with small shade shelter to Council standard.
- 5. Signage to engage and inform visitors at the start of their journey.

- 6. New tree planting. Small groups of Melaleuca armillaris consistent with existing trees.
- 7. Littoral rainforest shade species planted as feature tree. Species to be verified to be consistent with those found on the nature trail.

- 8. New Eucalypt planting in groups to integrate car parking area with boardwalk.
- 9. Retain portal as a cultural marker for the original work installed by the Green Corps. Repair if necessary.
