# Merimbula Boardwalk and Foreshore Path

EASTERN ENTRY AND CARPARK UPGRADE.

### Design Development Principles

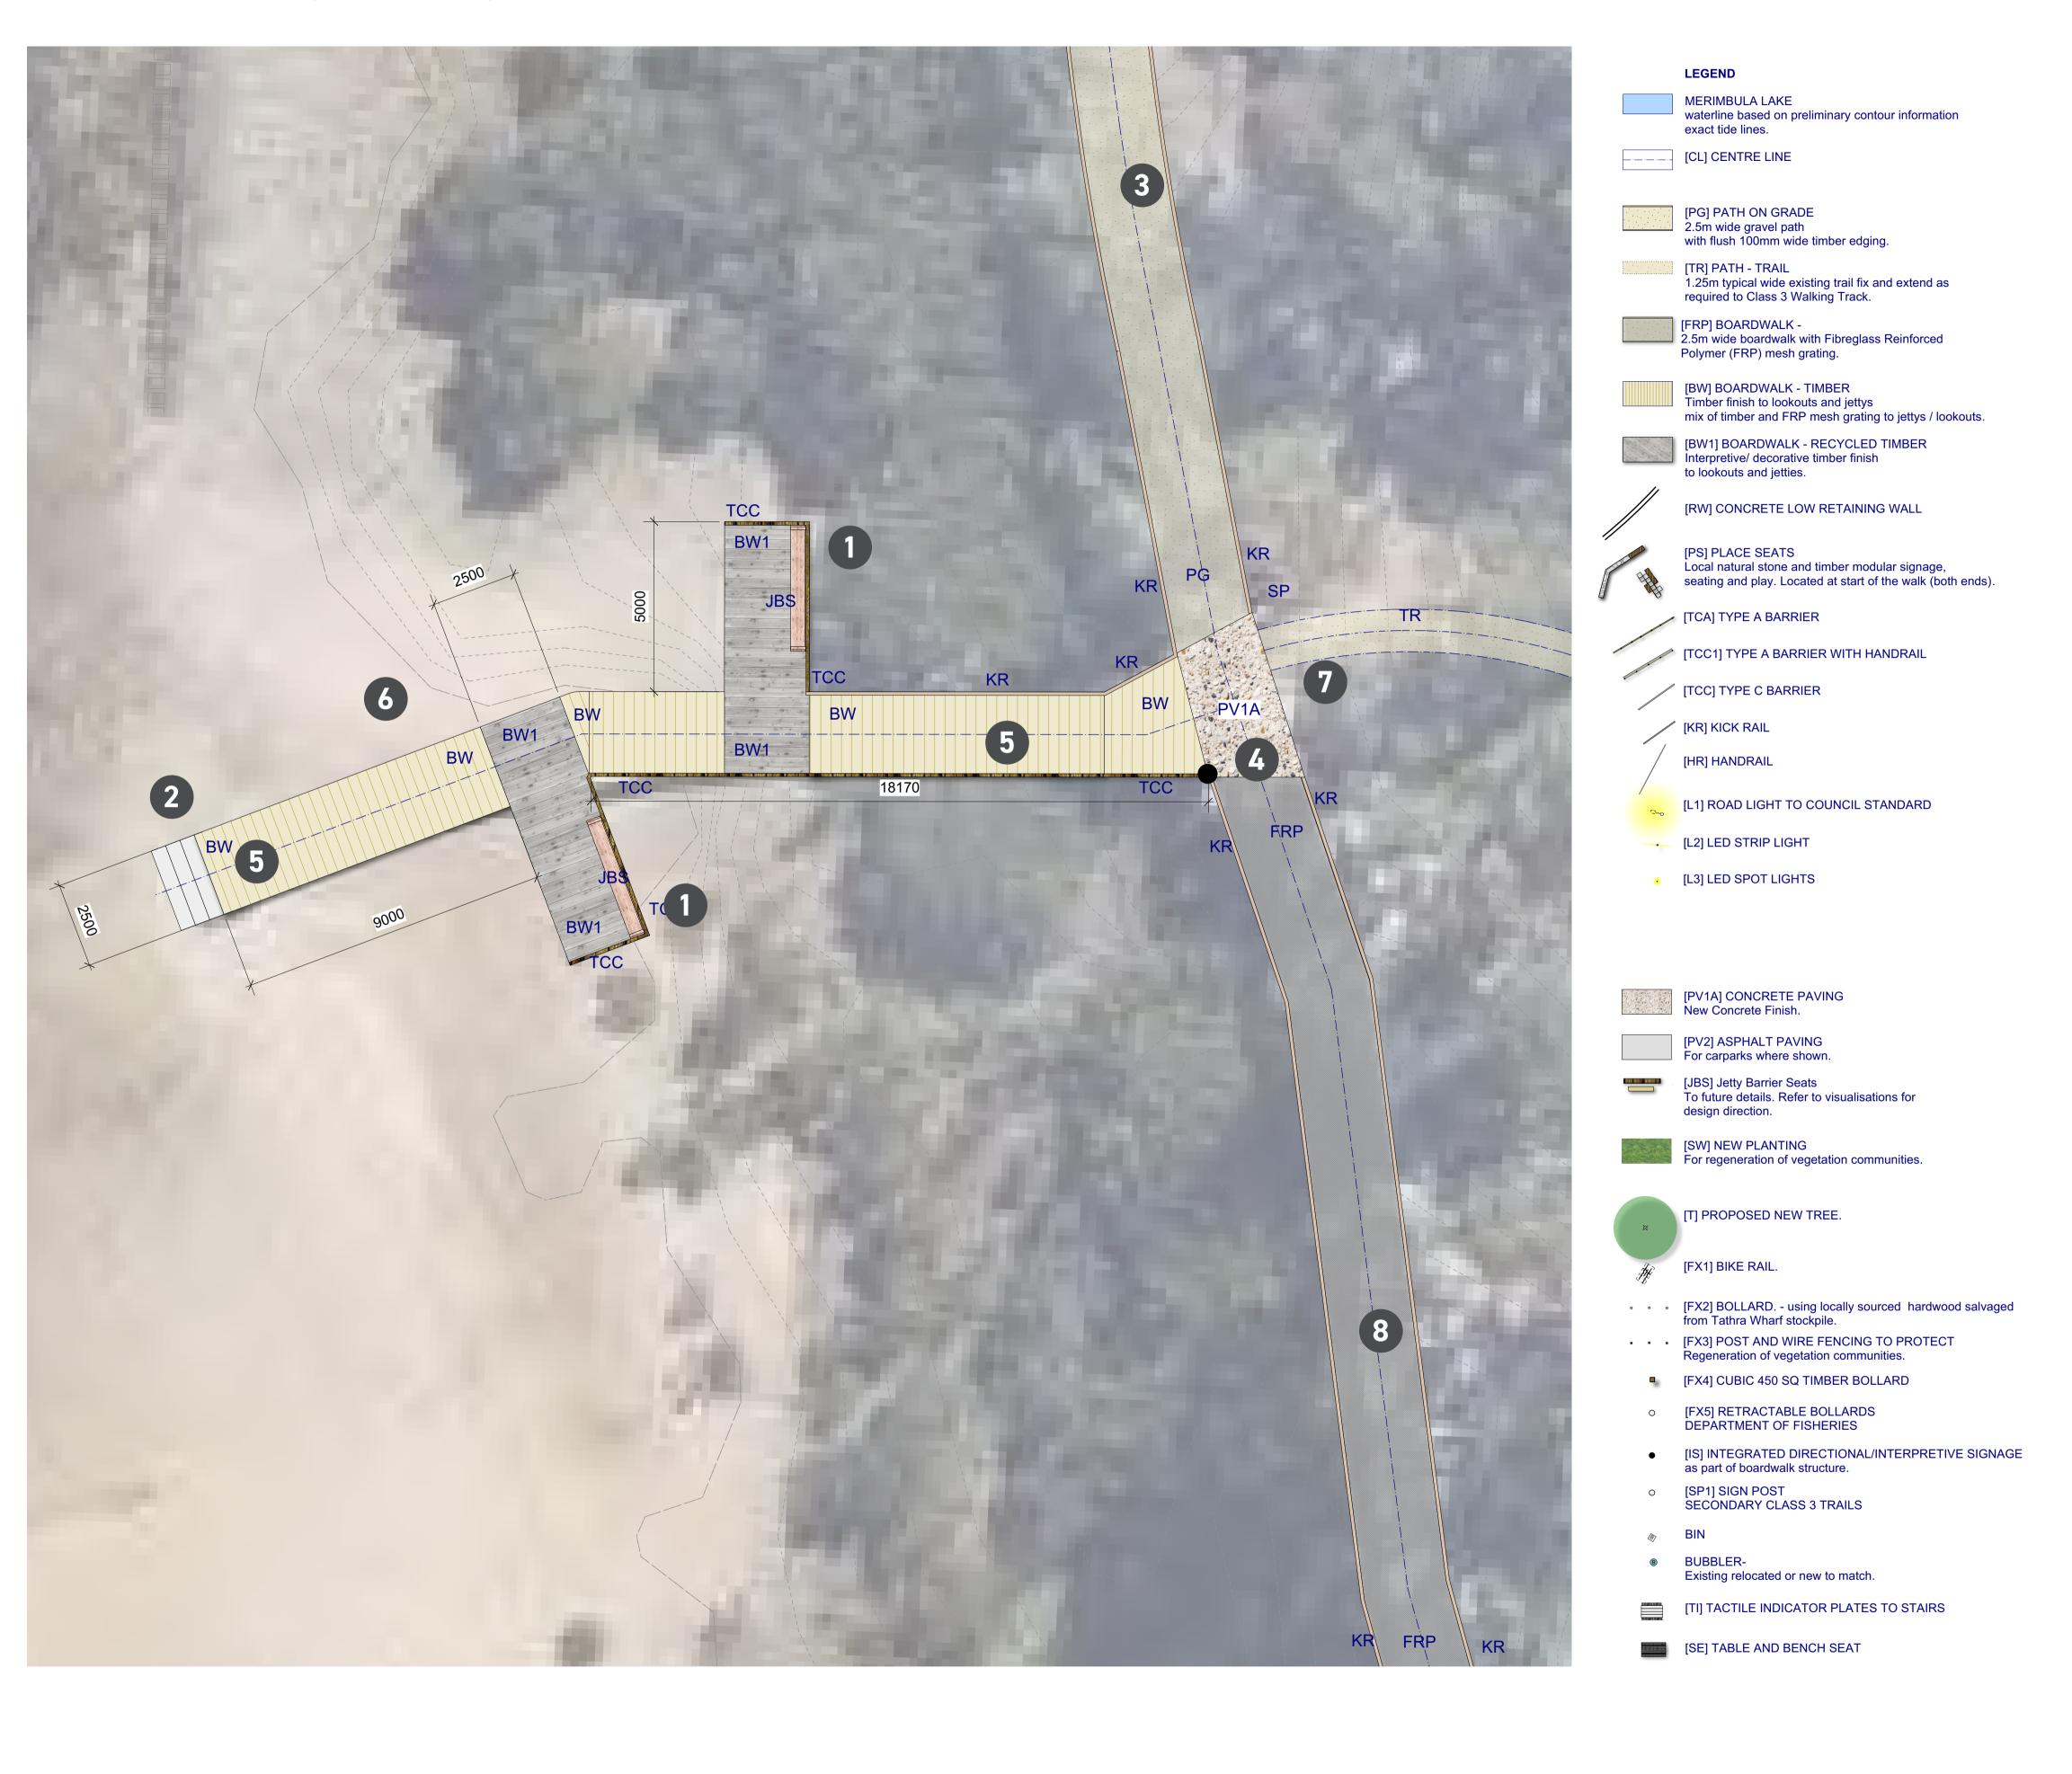
### Detail Plan O2- (JETTY O3)

- 1. Seat and rest spot provides views of oyster farms, mangroves and sunset. Two seating areas enable more options than currently.
- 2. Upgraded concrete steps to the tidal zone upgraded with new and expanded to provide further seating opportunities.
- 3. 2.5m wide gravel path on grade (PG) with flush 100mm wide timber edging
- 4. Decorative concrete at intersections and to highlight change of materials.
- 5. Timber boardwalk jetty. Potential for reusing boards or salvaged sections from council stocks. This also would allow interpretation opportunities. Mixed timbers would create a strong local story and create an patina of different weathered timber.
- 6. Bush track junction.

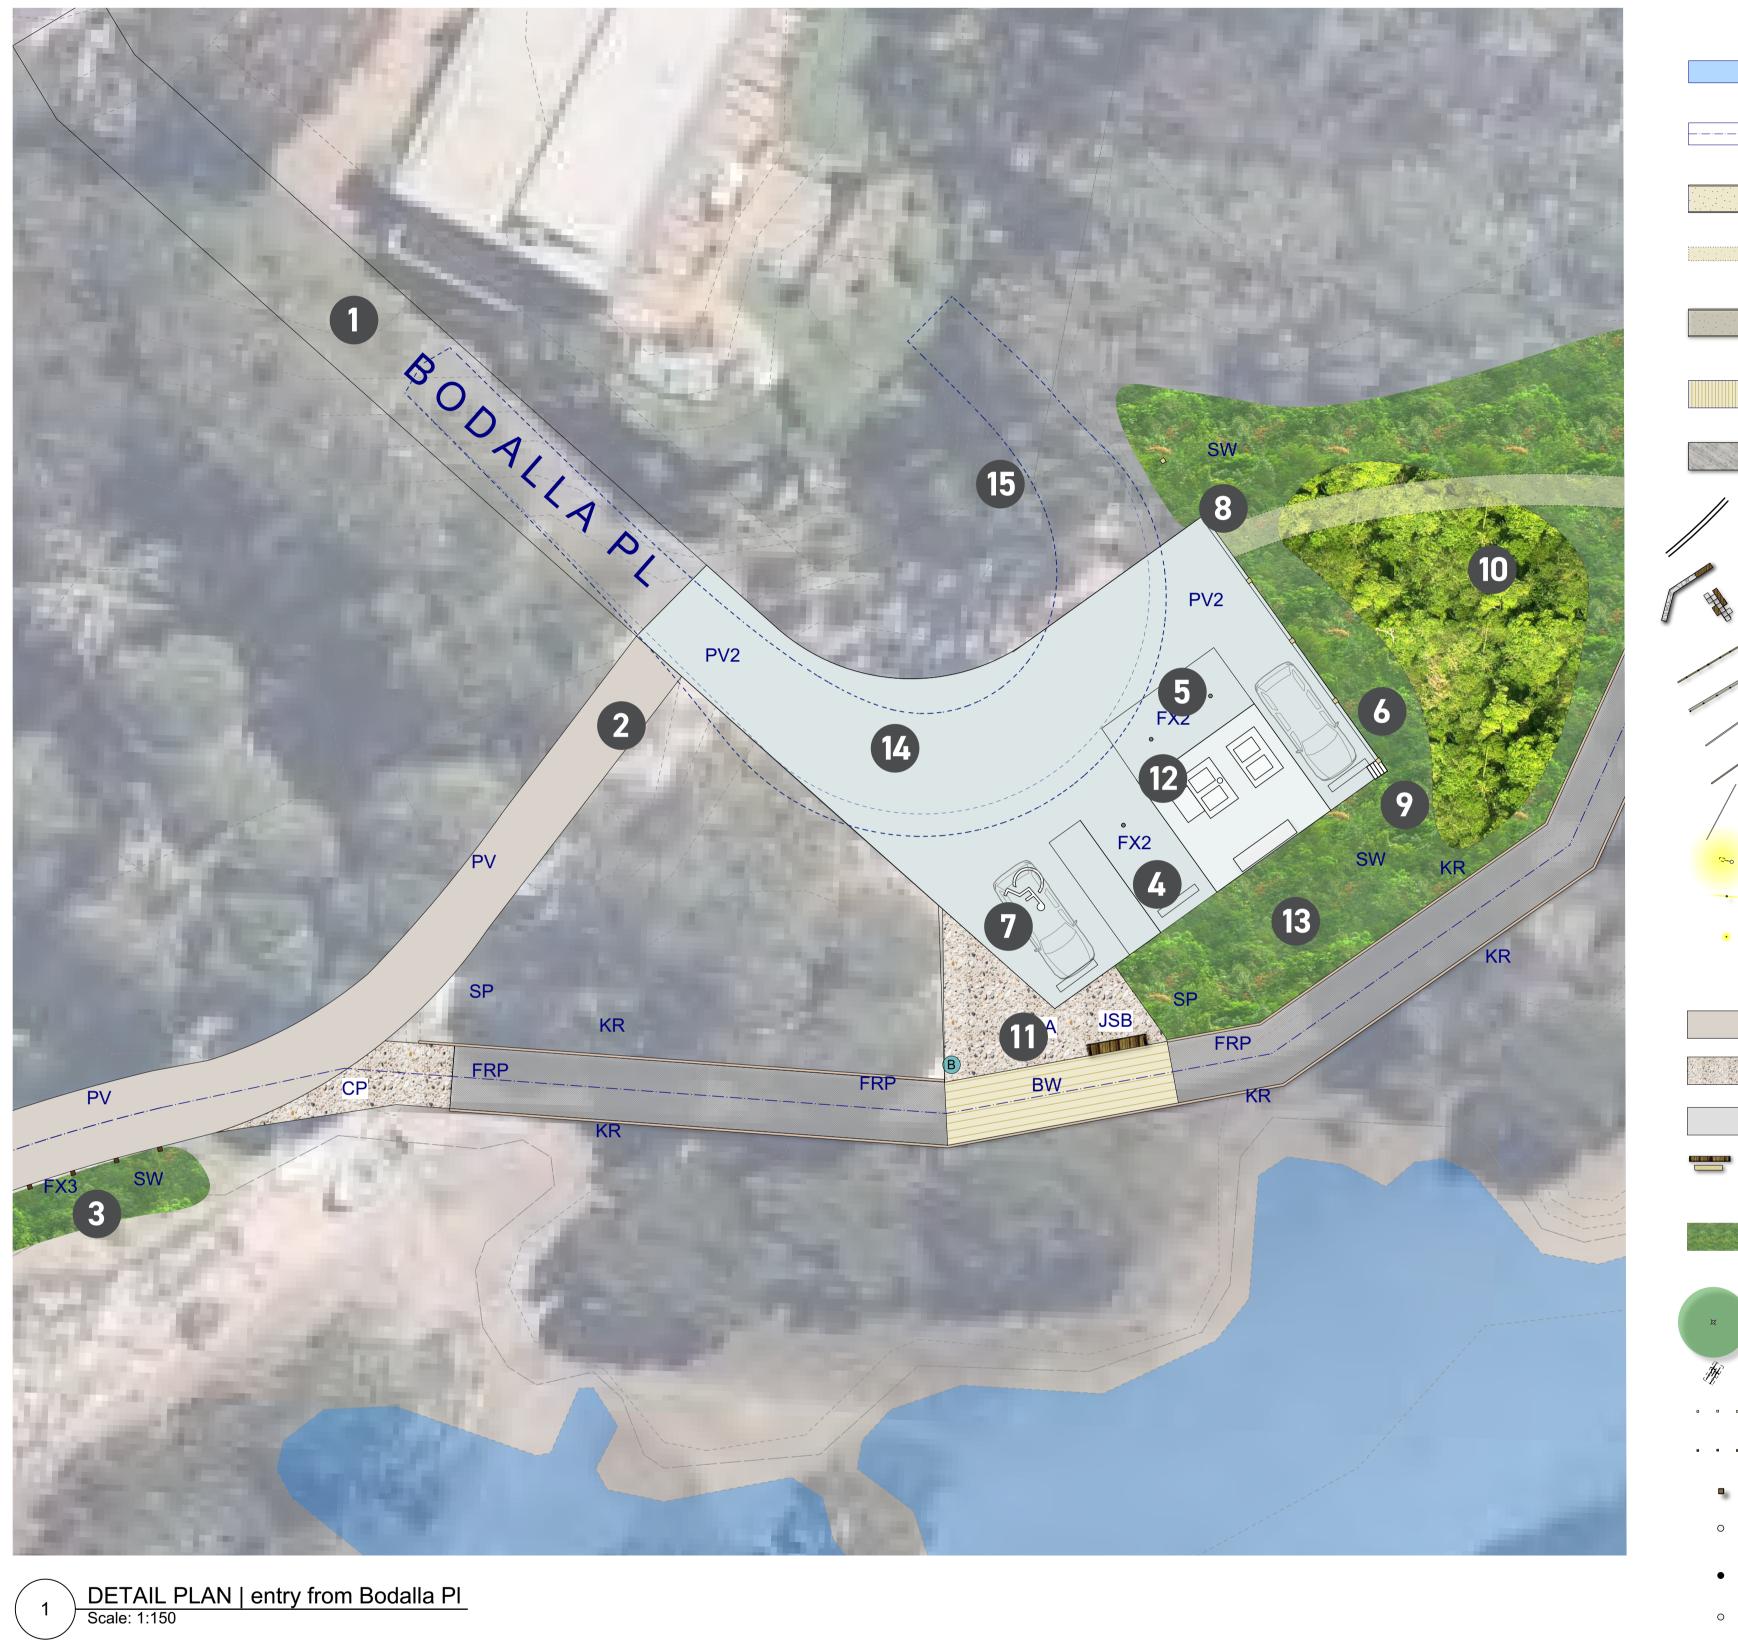
### Detail Plan 05

- 1. Existing Bodalla Place driveway maintained.
- 2. Vehicle access and gate retained.
- 3. Wire strand fencing to protect revegetation.
- 4. Dedicated Council carpark with bollard adjacent to sewage pump.

- 5. Hardstand adjacent to pump station with bollard for additional Council access.
- 6. Regular car space with wheel stop.
- 7. Disabled car space with wheel stop.

- 8. Dish drain perimeter to carpark (or upstand kerb if parking is to be controlled.)
- 9. Pit connection to drain carpark to biofiltration basin.
- 10. Biofiltration basis to treat carpark run-off and prevent shortcut and damage to the bush.

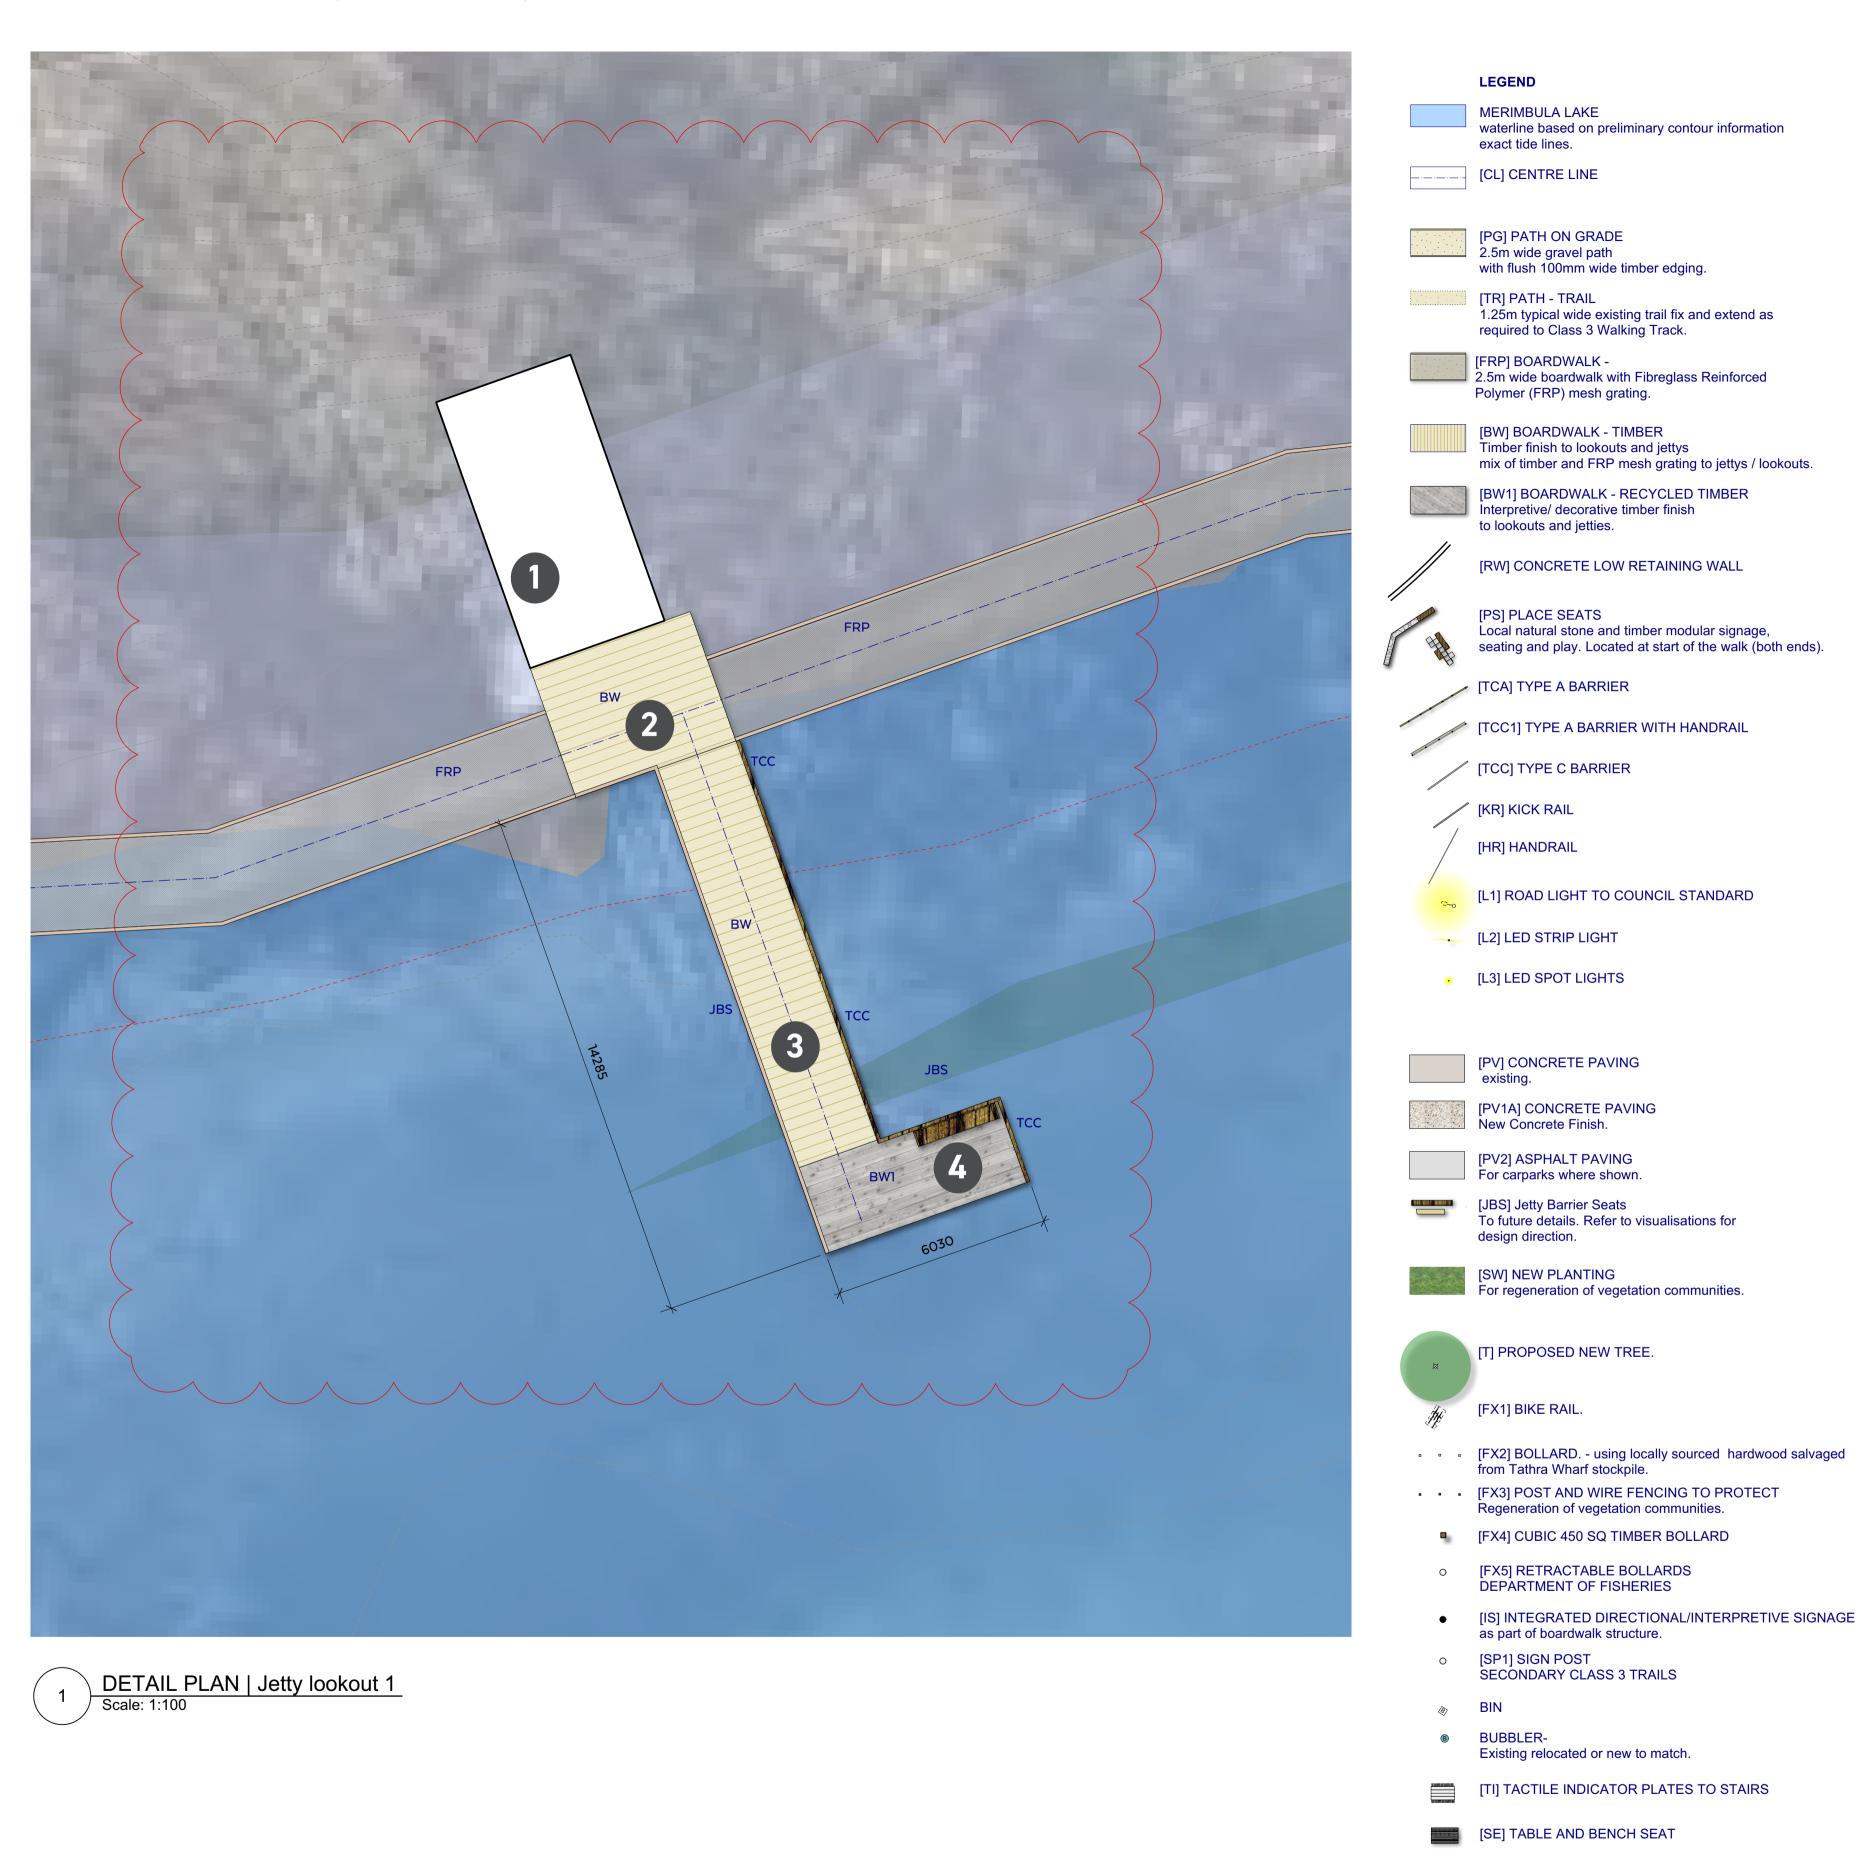
### Detail Plan 06 (JETTY 01)

- 1. Existing private boatshed.
- 2. Timber boardwalk in front of boatshed to maintain access. All of this infrastructure apart from the boatshed is a public asset.
- 3. New jetty with treatments consistent with other new work.
- 4. More generous seating, sightseeing and fishing. The alignment will be similar to existing to minimise impact on seagrasses adjacent to the channel.
- 5. The existing jetty will be upgraded to provide a 2.5 wide approach and larger platform. The jetty ladder will be replaced for safety.

- The existing jetty will be upgraded to provide a 2.5 wide approach and larger platform. The ladder will be replaced for safety. The footprint essentially stays the sae to protect seagrasses.

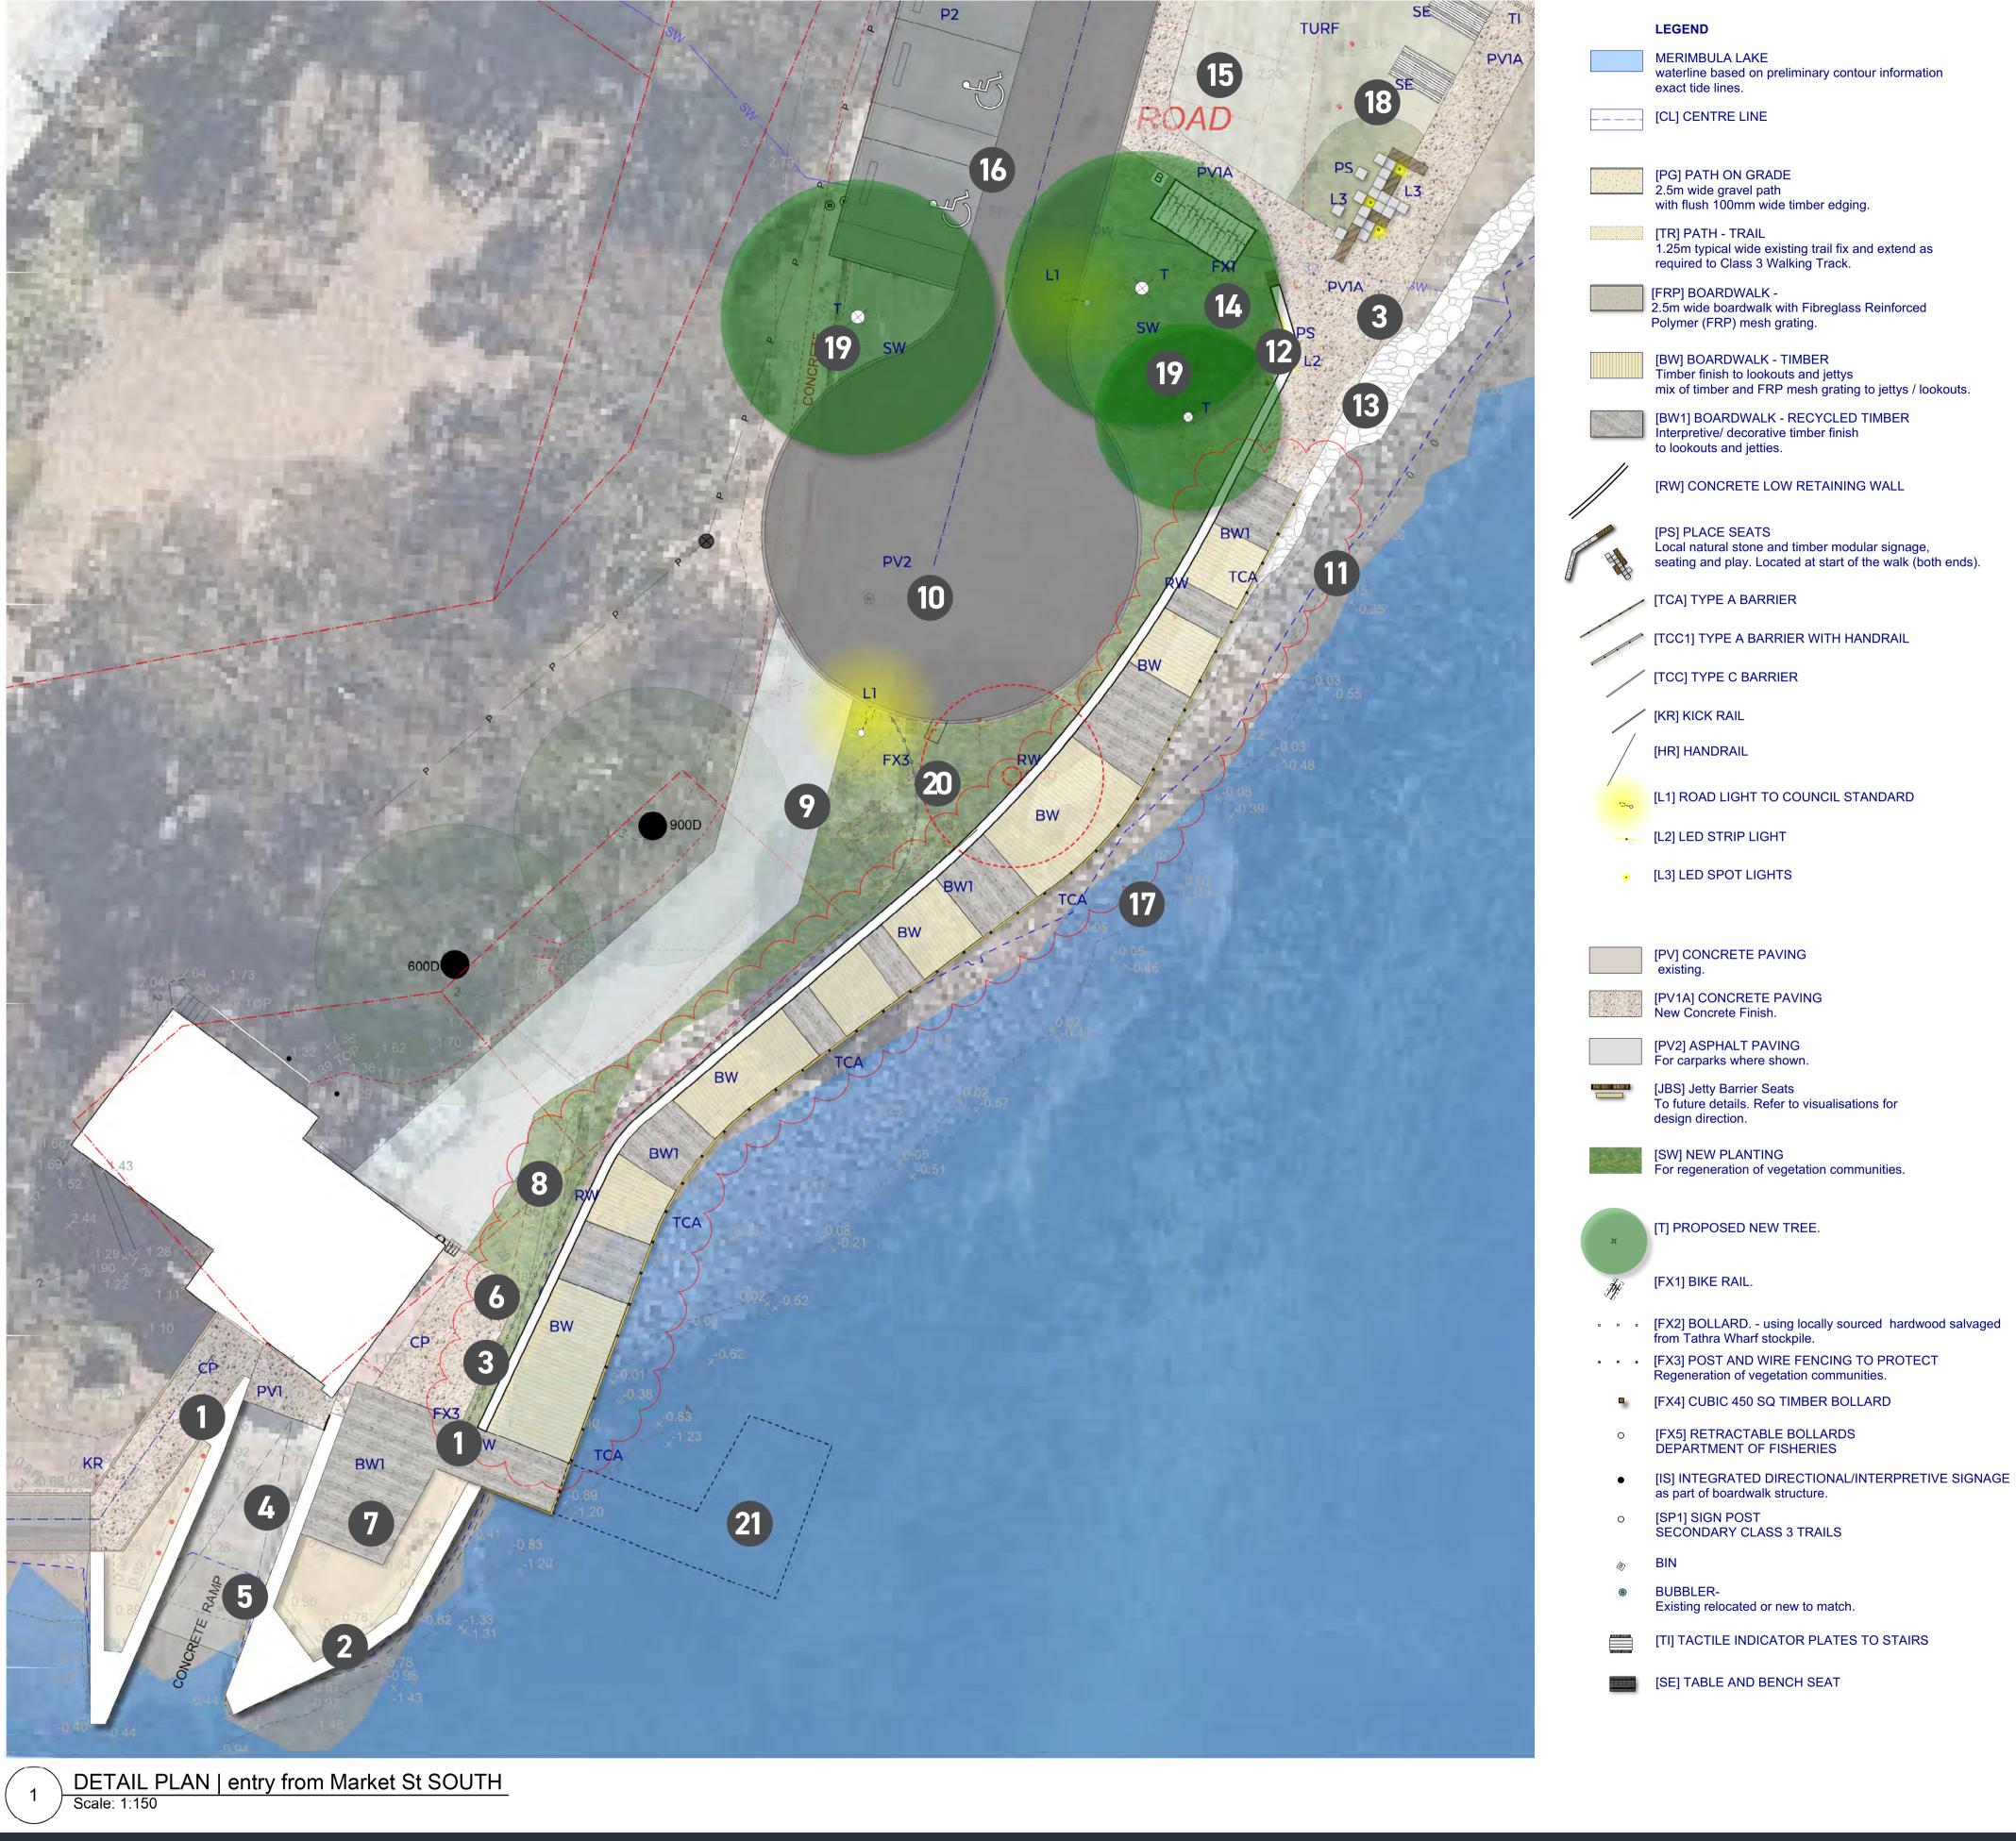
### Detail Plan 07 - Carpark South

- 1. FRP boardwalk following existing line and level to meet on grade paving.
- 2. Existing sea walls and gravel paving. Gravel upgraded with compacted rhyolite.

- 3. Crazy stone paving on grade.
- 4. Top of boat ramp/boardwalk threshold improved to meet minimum AS 1428.1 cross falls (1:40)
- 5. Existing boat ramp may need concrete screed or topping to meet level adjustment.

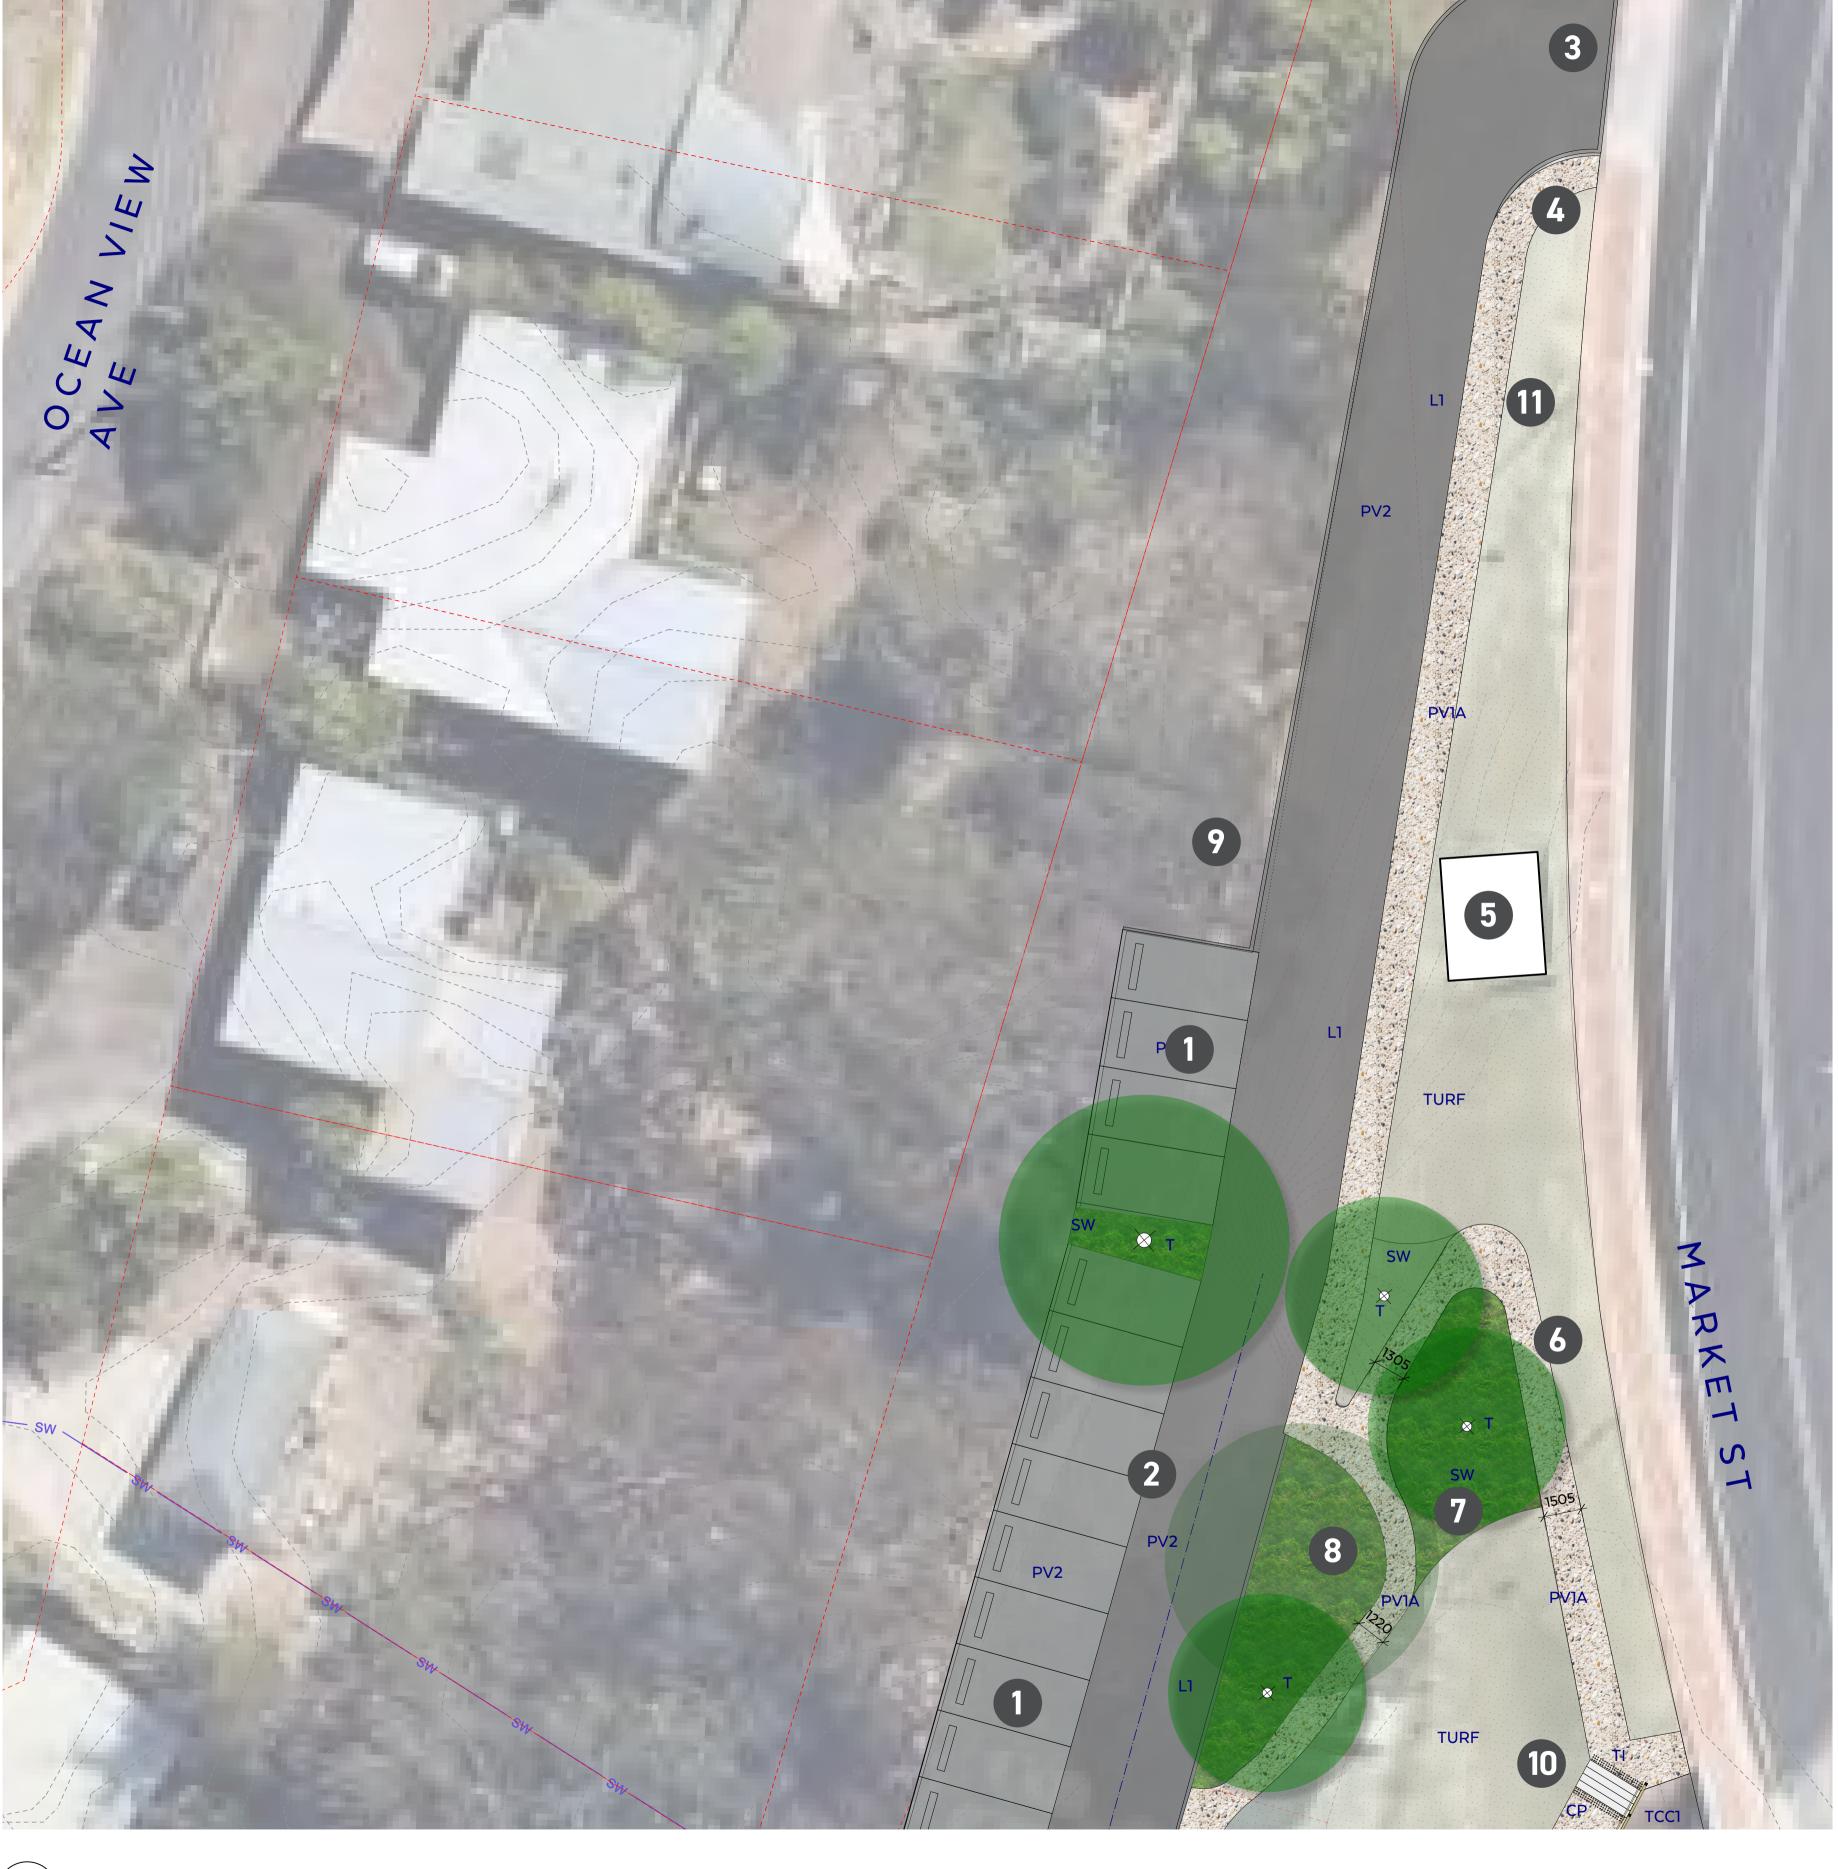
### Detail Plan 08-Carpark North

MERIMBULA LAKE
  waterline based on preliminary contour information
- [CL] CENTRE LINE

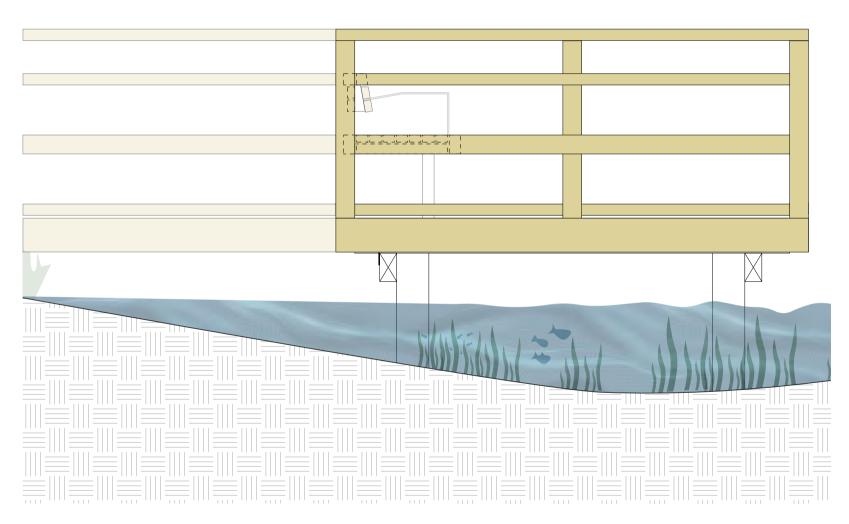
LOOKOUT SEAT side elevation
Scale: 1:20

LOOKOUT SEAT formal seating on lookout jetty's

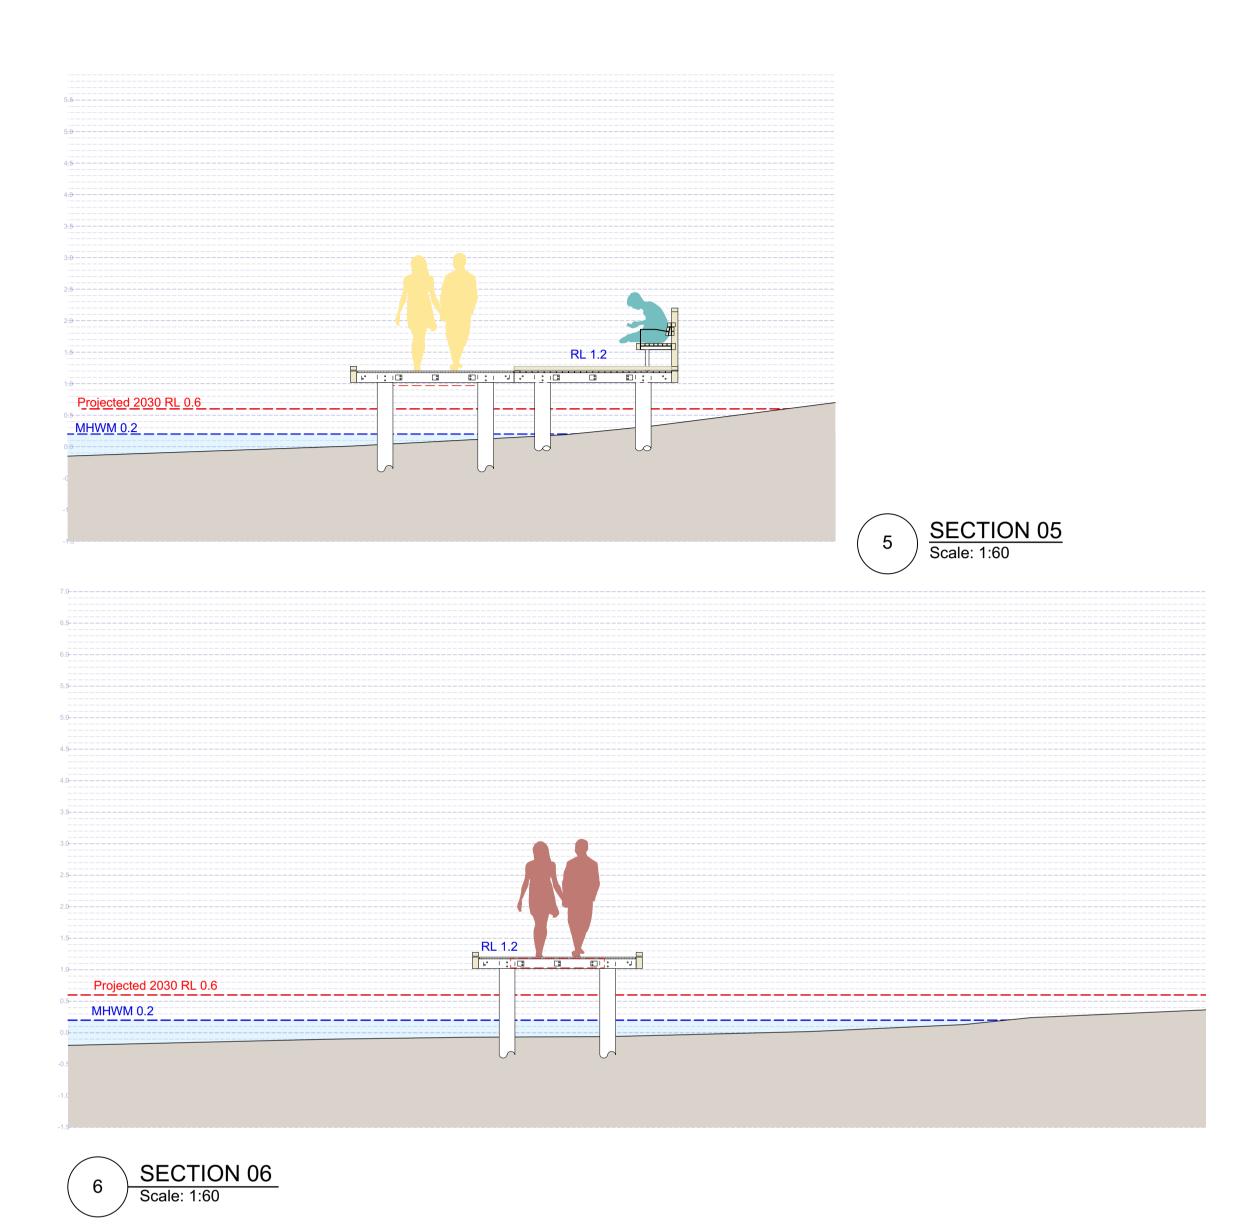
Mean high Water Mark and anticipated seal level rise above the MHW in 2050\*

\* the sea level rise planning benchmarks provided in the NSW Sea Level Rise Policy Statement (DECCW, 2009) have been adopted for this study. The benchmarks are a projected rise in sea level, relative to the 1990 mean sea level, of 0.4 metres by 2050 and 0.9 metres by 2100 (DECCW, 2009).

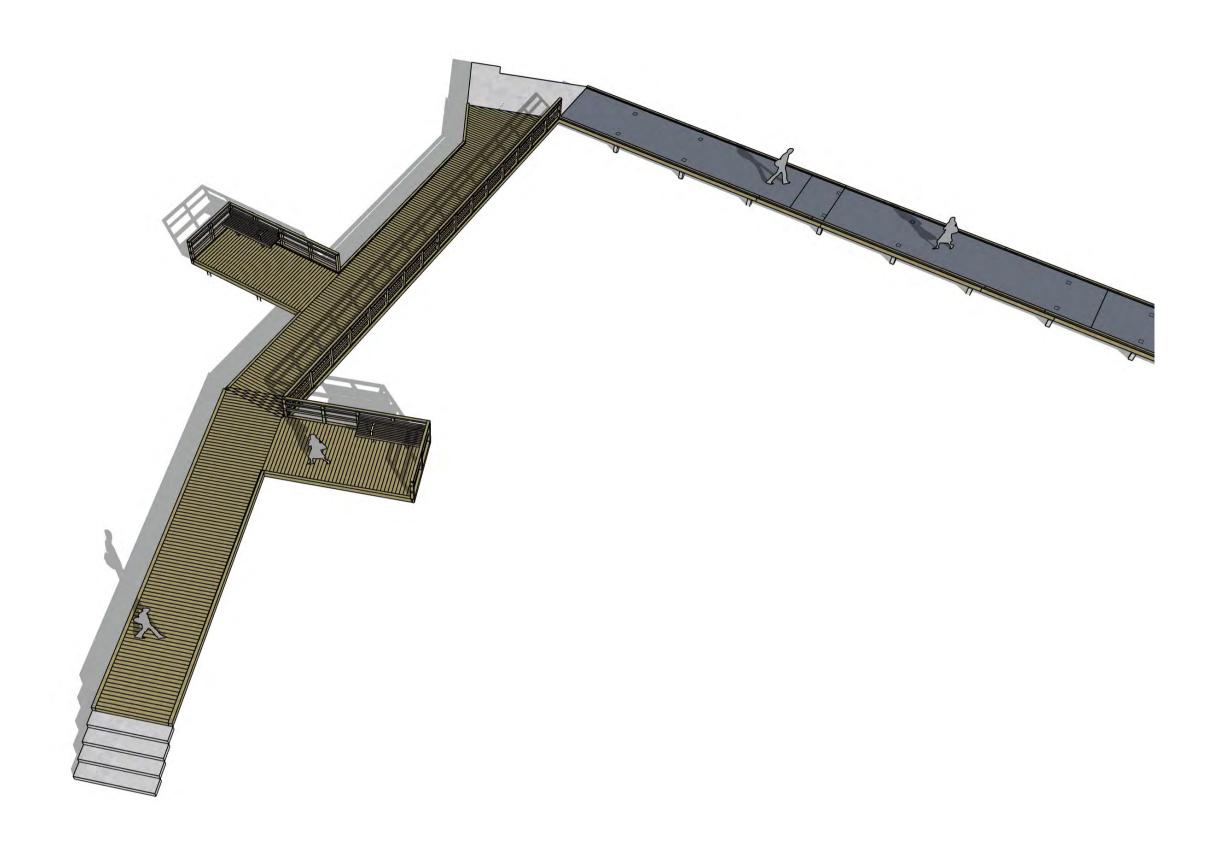
JETTY 03- Western end. Existing jetty rebuilt.

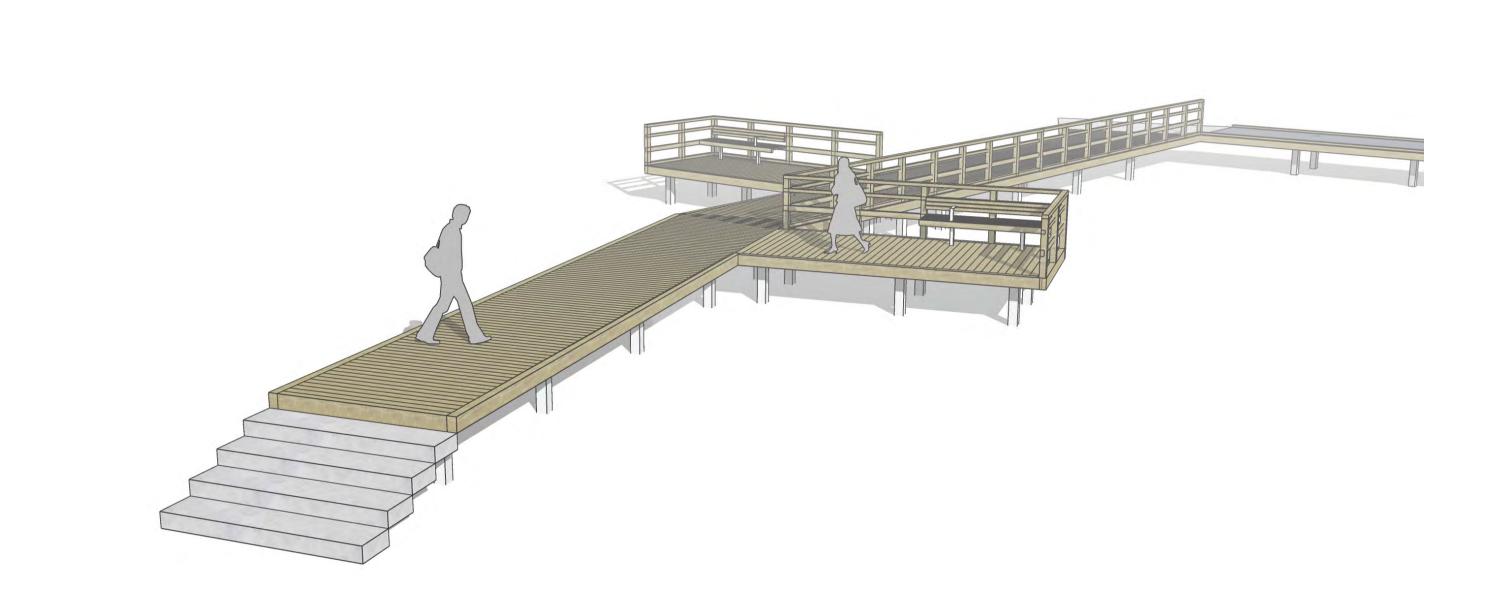
JETTY 03- Western end. Existing jetty rebuilt.
