# Merimbula Boardwalk and Foreshore Path

EASTERN ENTRY AND CARPARK UPGRADE.

### Design Development Principles

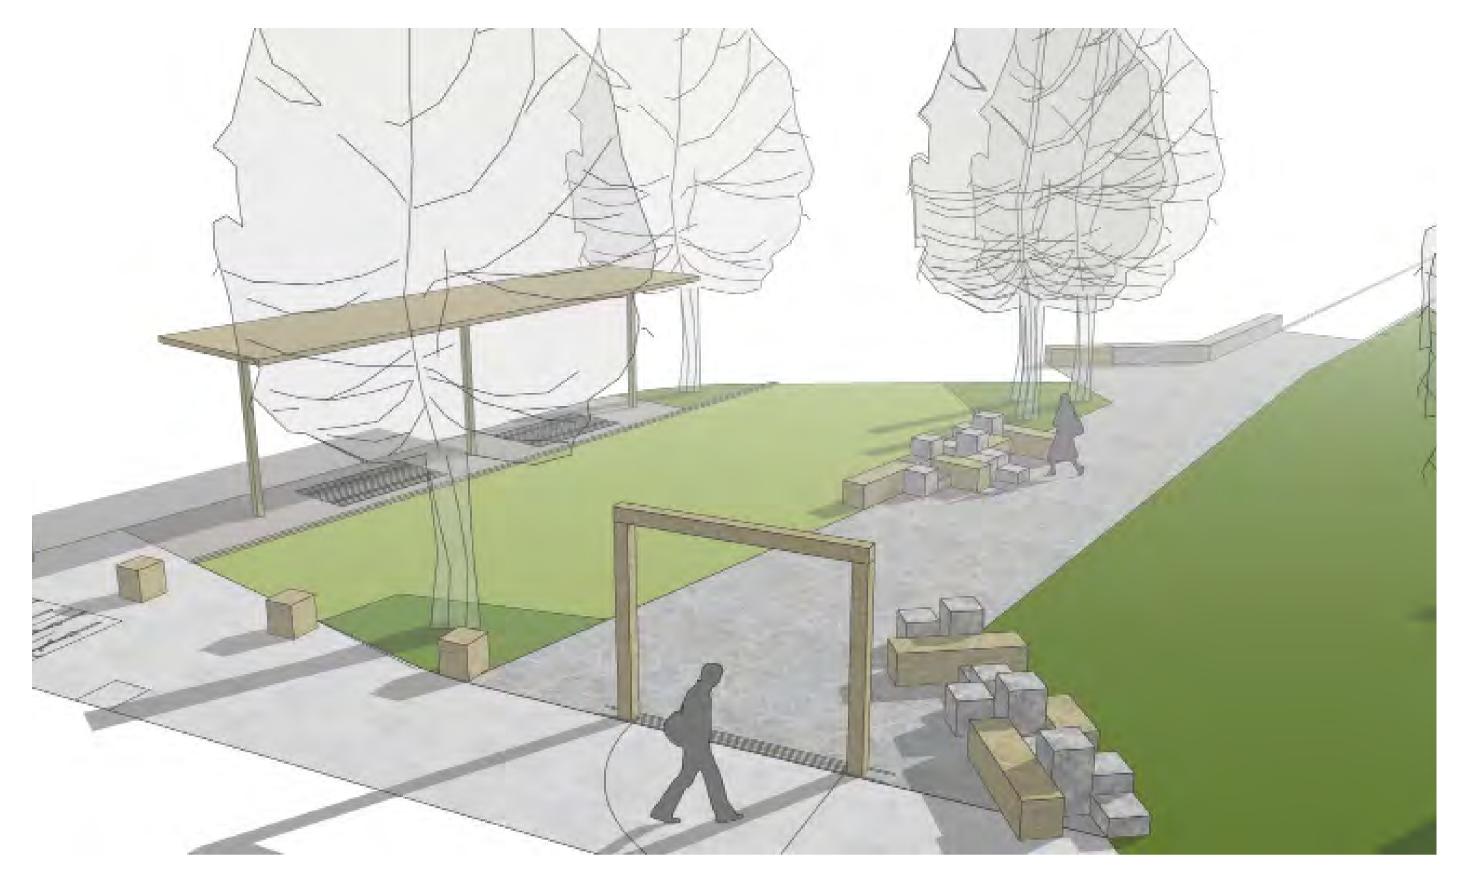
WESTERN ENTRY - Showing 'Parklet' entry artistic interpretative structures and existing gate portal retained.

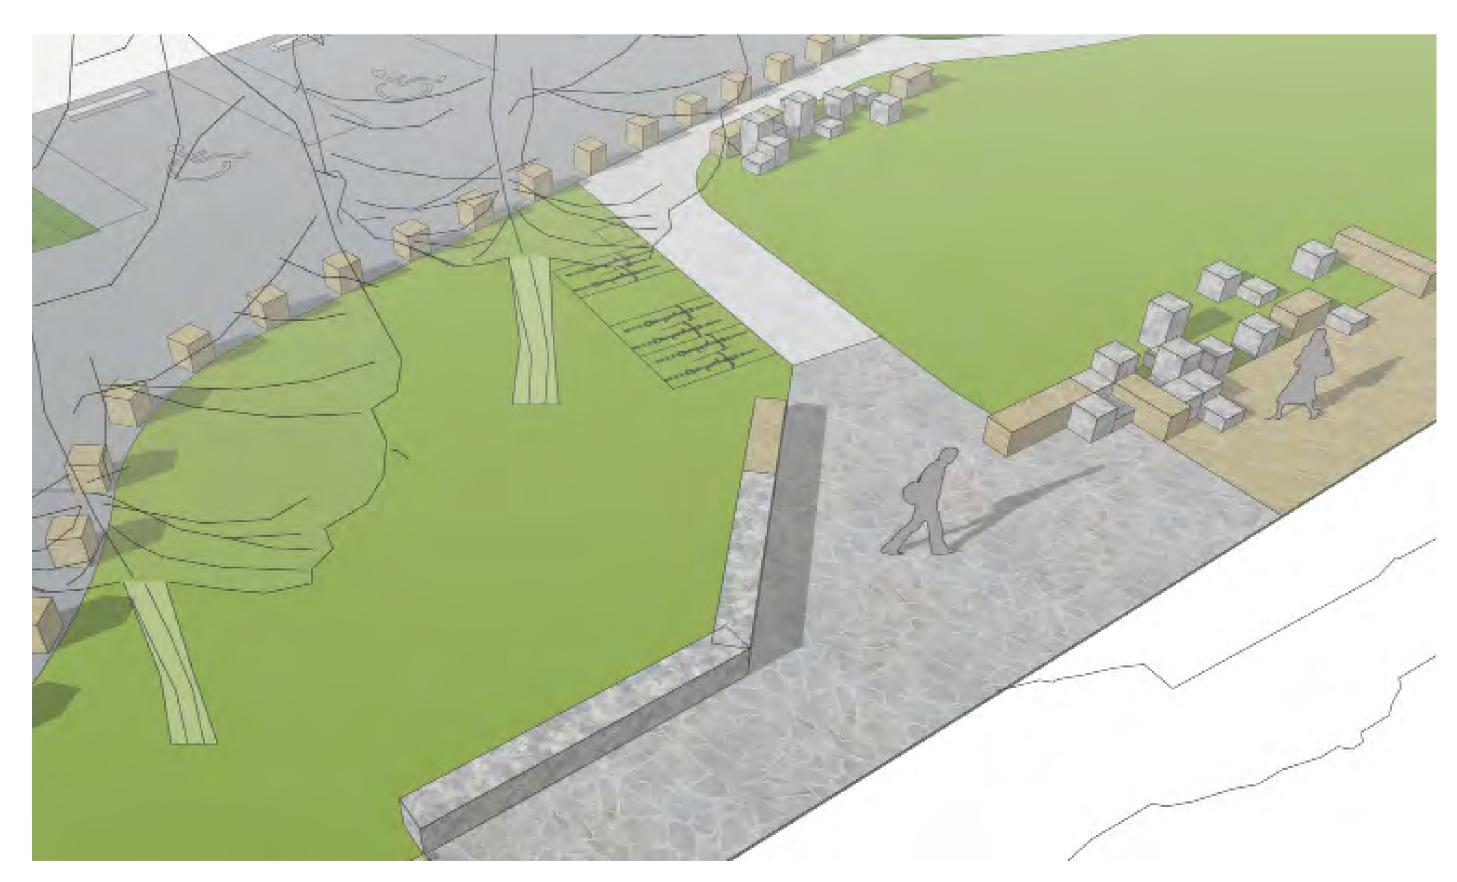
EASTERN ENTRY - Showing reclaimed 'Parklet' entry artistic interpretative structures and new carpark configuration.

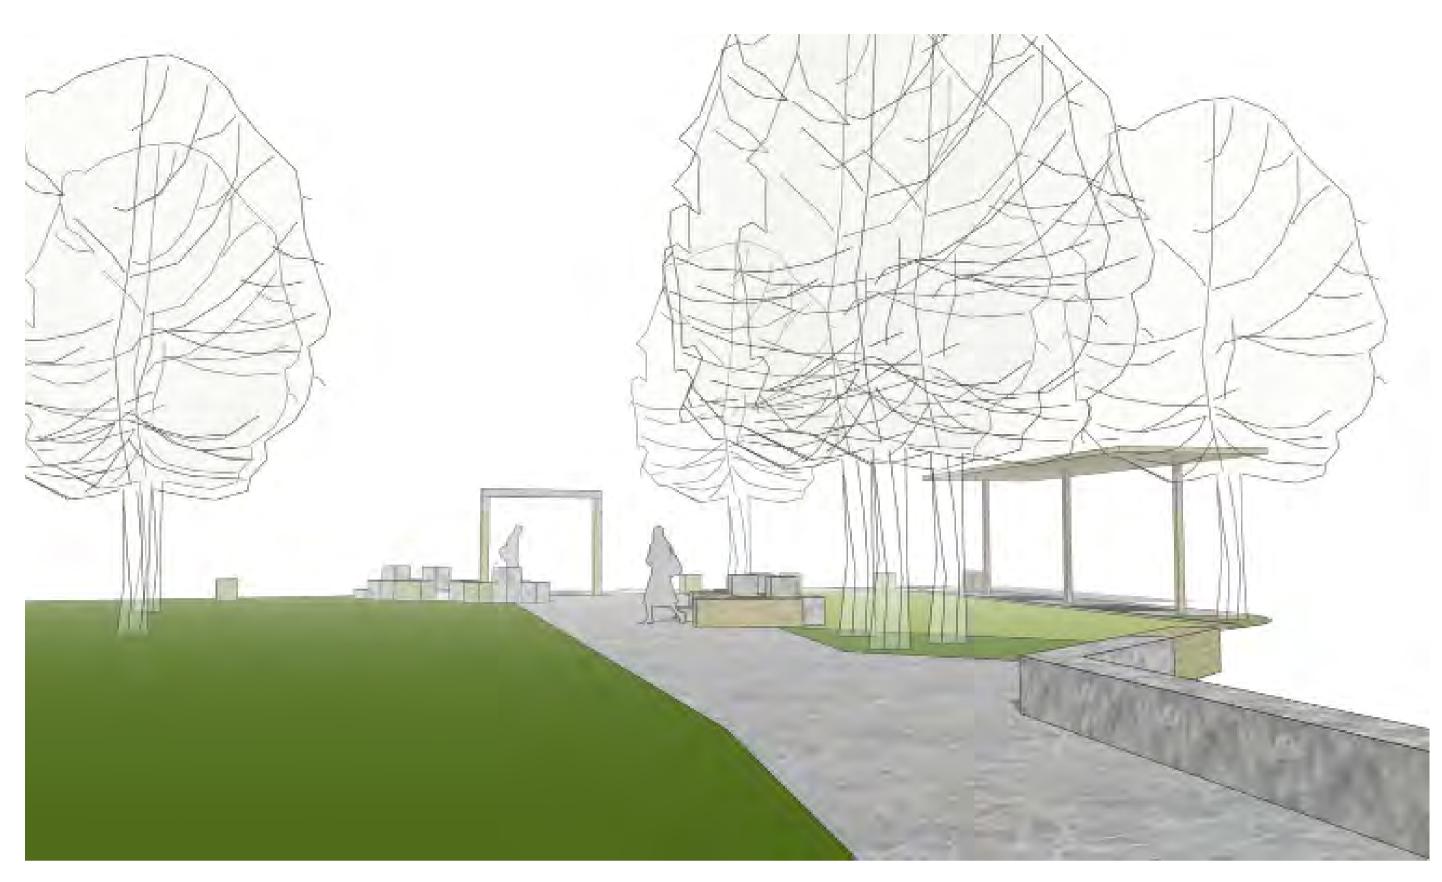
WESTERN ENTRY - Showing 'Parklet' entry artistic interpretative structures, entry sign and new shade structure.

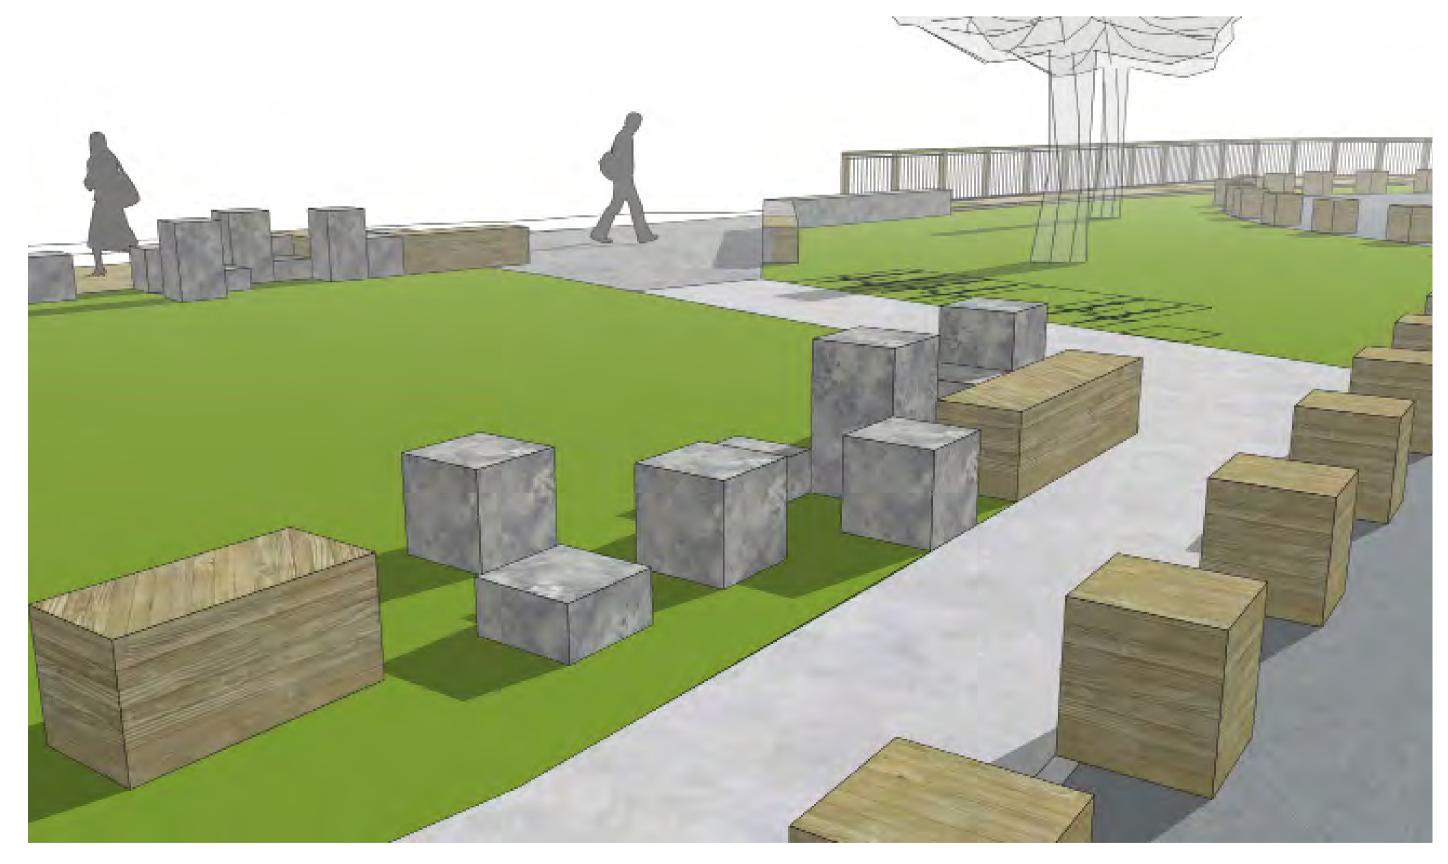
EASTERN ENTRY - Showing 'Parklet' entry artistic interpretative structures, entry sign and signature boardwalk statement.
